# ELIMINATION OF DAMAGE CARRIER TAPE FOR DFN8 2X2 PACKAGE IN PICKER MACHINE

Aprilyn C. Beñan

Test Process Engineering
Onsemi, Tarlac, Luisita Industrial Park, SEPZ, San Miguel, Tarlac City
Aprilyn.Benan@onsemi.com

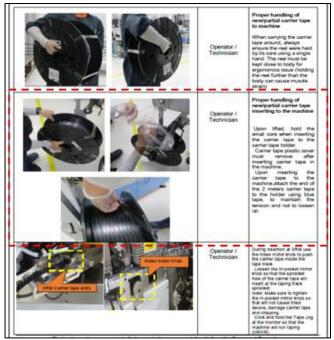
Conduct actual check if the set up procedure on proper installation is available and sufficient

Figure 8. No detailed procedure on proper installation of carrier tape at the handler and can contribute to damage carrier tape

4.5 No detailed set up procedure on proper installation: Create a detailed procedure in proper installation of carrier tape

The effectiveness of action was implemented upon creation of procedure was validated in proper installation of carrier tape. Proper handling during insertion was critical for the quality of the material. Next is the correct way in handling the carrier tape during insertion to the machine.
