Effective Failure Analysis Approach in Uncovering Gate-to-Drain/Source Tungsten Spur Fabrication Defect

Global Failure Analysis, Analog Devices Inc.,
Gateway Business Park, Brgy. Javalera, Gen. Trias, Cavite, Philippines 4107
Email: alex.delcastillo@analog.com; alfredjay.rafael@analog.com; jae.saladar@analog.com

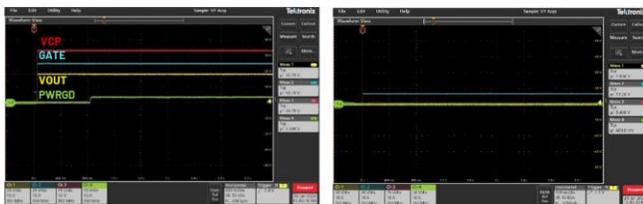
Electrical bench testing using an evaluation board was conducted. High quiescent current and abnormal output behavior was observed. See Table 1 and Fig.7.

Fig. 7. Oscilloscope snapshots showing abnormal output responses on a representative reject unit

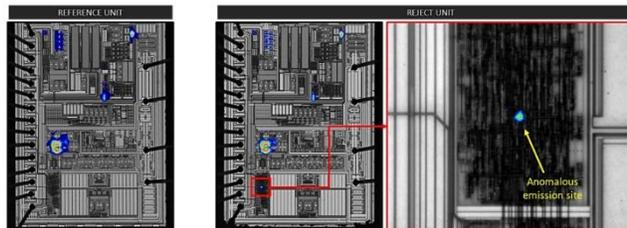
A cavity was created using laser in preparation for further decapsulation. Decapsulation using chemicals was done to expose the die. Photon emission analysis was performed to further isolate the location of the suspected defect, while biasing in the failing state. Anomalous photon emissions were observed. Refer to Figure 8.

Fig. 8. LEM results of a representative unit showed a presence of anomalous emission site when compared to a known good unit

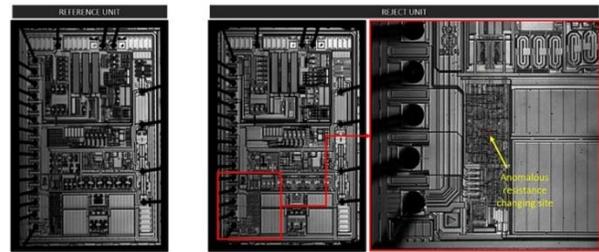
The unit was analyzed using OBIRCh, while biasing the unit in the failing state. OBIRCh results showed a presence of anomalous resistance changing site when compared to a known good unit. Refer to Figure 9.

Fig. 9. OBIRCh results on a representative unit showed a presence of anomalous resistance changing site when compared to a known good unit

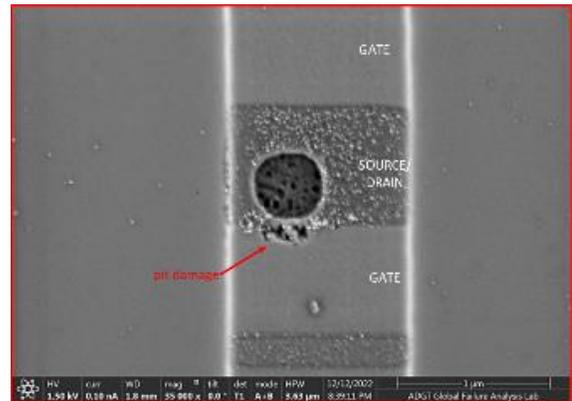
One (1) unit was subjected to chemical deprocessing to expose the transistors in the silicon substrate. Pit damage sites on the edge of the gate channel was observed, see Fig. 10.1. From the initial observation, the damage looks similar to an ESD damage. A typical ESD damage is shown in Fig. 10.2. However, the damage shown in Fig. 10.1 is not an indication of an ESD damage, but a result of the tungsten spur defect. The tungsten spur has been etched away by the chemical etchant leaving pits or damage at the defect site. Chemical deprocessing was not the preferred physical failure analysis approach for this type of defect, but rather FIB cross sectioning approach to keep the defect intact.

Fig. 10.1. Pit damage on the edge of the gate channel

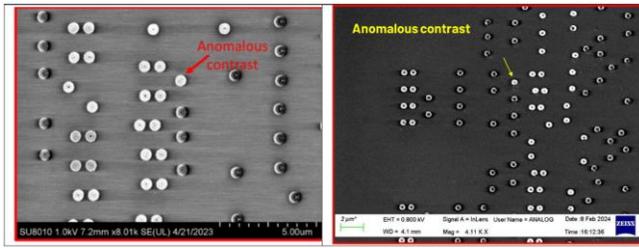
Several units were prepared for Passive Voltage Contrast analysis. Anomalous contrast was observed on the transistor

of digital circuitry, coinciding with the anomalous site as observed during LEM and OBIRCh. Refer to Figure 11.

Fig. 11. Representative PVC analysis results from two failing units

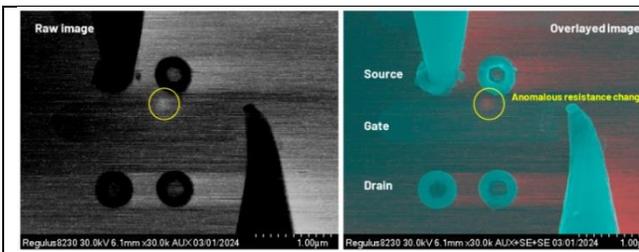
The unit that underwent to nanoprobing found with leakage failure was subjected to EBIRCh analysis, showing the anomalous resistance change site on Gate-to-Source channel of the suspected transistor. Refer to Figure 13.

Fig. 13. Anomalous resistance change on Gate-to-Source channel was observed

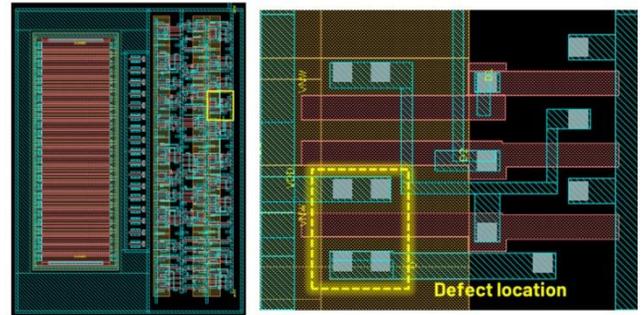
The schematics and layout through Avalon were reviewed to map the suspected component with respect to its circuit block, functionality, and electrical response based on fault localization results. Refer to Figure 14. The offset contact plugs and anomalous resistance change observed during EBIRCh were in the Sense Amplifier circuit block on the unit subjected to nanoprobing.

Fig. 14. Snapshot of the layout showing the location of defect

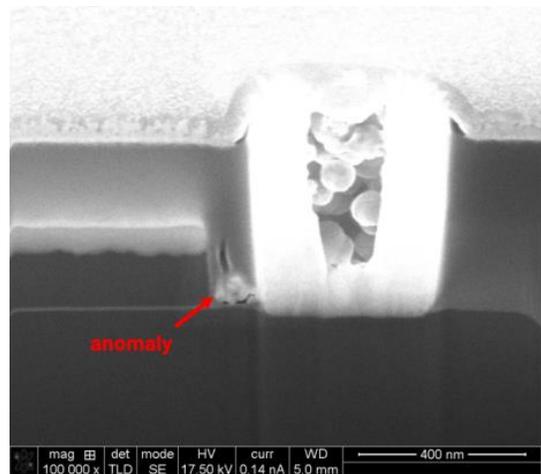
Investigation results from the fabrication site revealed that the defect occurred due to a breach of the Titanium Nitride (TiN) barrier at the bottom of the poly contact. The breach can occur in rare circumstances when the contact intersects with the spacer nitride. Critical dimension (CD) tightening was implemented at the fabrication site to address the defect.

FIB cross section on the suspected transistor revealed an anomalous material between the Source contact and Gate of the PMOS transistor. Refer to Figure 15. EDS results revealed traces of Tungsten on the anomalous material. Refer to Figure 16.

Fig. 15. SEM image showing the anomaly

Corrective actions in fabrication, such as Poly-to-Contact Direct Measurement (WAT monitored) and reducing the Contact Critical Dimension (CD) to create more clearance, have been completed. These measures should ensure that this issue will not recur in the future.

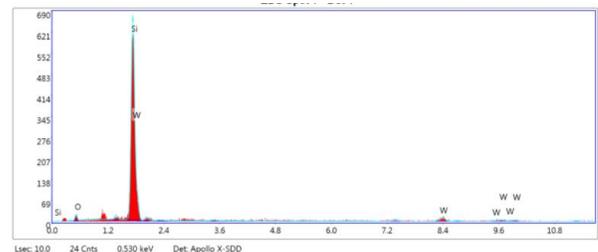
Fig. 16. EDS plot showing traces of Tungsten on the anomalous material

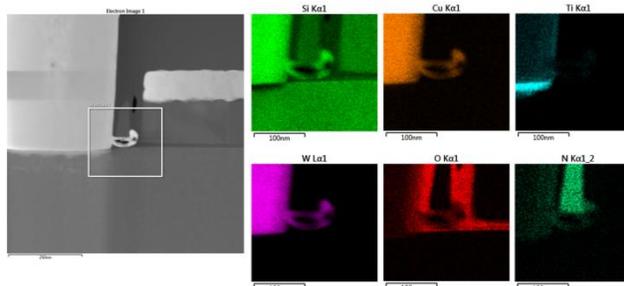
Another representative failing unit was subjected to TEM and EDS mapping. Refer to Figure 17.

Fig. 17. EDS mapping results showing the trace of the Tungsten
