ELIMINATION OF PEEL OFF UV ADHESIVE ON UV SHOULDER RMA DEFECT IN CATHETER ASSEMBLY

Lyka Mae D. Quillosa
Jaime Miguel C. Agustin

Medical Device Assembly Business Unit- Engineering Department
P.IMES Corp., Block 16 Phase 4, CEZ Rosario , Cavite
quillosa@pimes.com.ph, jagustin@pimes.com.ph

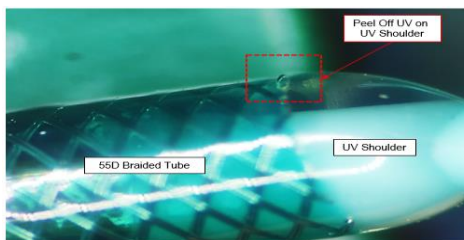
Figure 6. Peel Off UV Adhesive on UV Shoulder of Libero SG model

Therefore, RMA defect rate of **0.46%** of Peel-off UV Adhesive on UV shoulder of Libero SG encountered in FY2021 from Dec. 2020 to Nov. 2021.

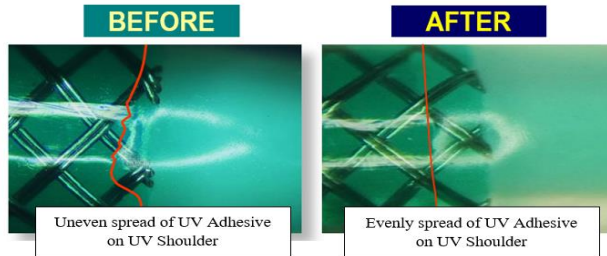
Figure 9. Uneven vs. Even spread of UV Adhesive on UV Shoulder

A.) ANALYSIS: Uneven spread of UV adhesive on UV Shoulder to 55D braided tube

ACTION: Evenly spread UV adhesive on UV shoulder to 55D braided tube

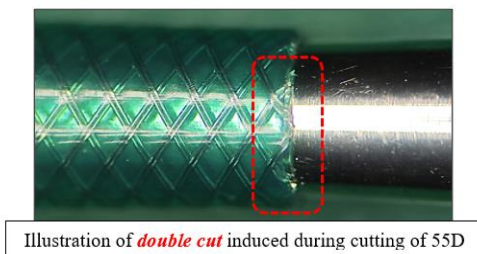
Illustration of **double cut** induced during cutting of 55D

B.) ANALYSIS: Accumulated dust particle on the roller During cutting process.

ACTION: Cleaning the roller part of cutting jig using air gun and cotton swab before and after use.

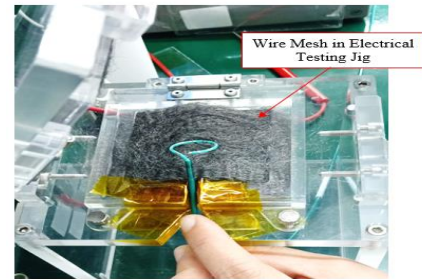
Figure 12. Wire Mesh in Electrical Testing Jig

C.) ANALYSIS: Extensive usage of wire mesh

ACTION: Replacement of wire mesh if worn out

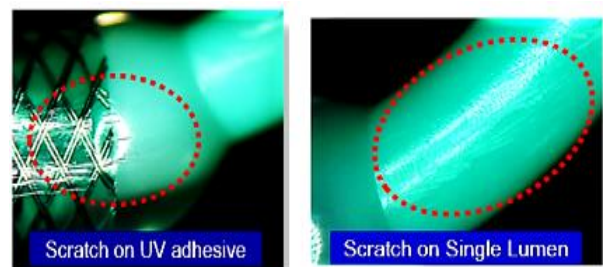
Figure 14. Scratch on UV Shoulder and Single Lumen

- Observed **scratch** on UV adhesive and Single lumen on shoulder part, that may potentially cause peel off through continuous process
- **7** out of **13** pcs of catheters found scratch on UV adhesive on UV Shoulder and Single Lumen with the average of **53.8%**.

It was observed that the cause of scratch on UV Adhesive on single lumen was the **porous and rough** material of *Extra Fine Wire Mesh*.

Due to the above observation, the formulated action plan is to replace the variant Extra Fine Wire Mesh into **Super Fine Wire Mesh** type.

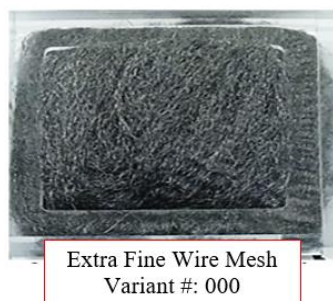
Figure 15. Extra Fine Wire Mesh

- This mesh has porous and rough that used for smoothing the wood surfaces, polishing stainless steel and copper.

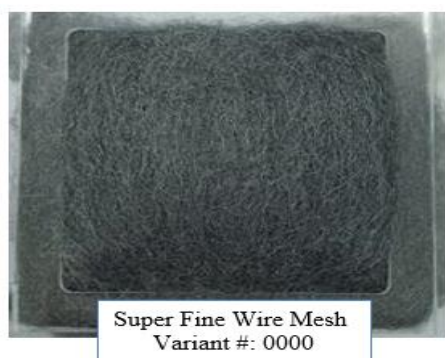
Figure 17. Super Fine Wire Mesh

- This mesh has a gentle abrasiveness that used for polishing glasses without use of water
