EXCESSIVE FLASHING REDUCTION ON PLAD SINGLE-DIE/ BI-RECTIONAL DEVICES THRU STACK HEIGHT ANALYSIS

Jason G. Sison
Primitivo L. Regencia Jr.

Process Engineering - EOL
Fastech Advance Assembly Inc,
Ampere Street cor. West Road Ligth Industry and Science Park 1
Cabuyao, Laguna, Philippines 4025
jgsison@fastech.com.ph, jrabella@fastech.com.ph, jlregencia@fastech.com.ph

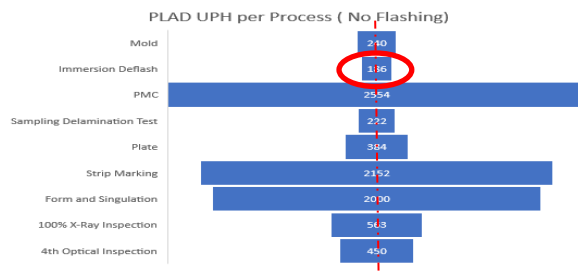
Fig 5: Manual Deflash UPH without flashing

As shown on funnel/ bottleneck process chart, Manual deflash process UPH was further reduced from 186 UPH to 78 UPH or reduction of 58.06% due to excessive flashing on 15KPCA devices.

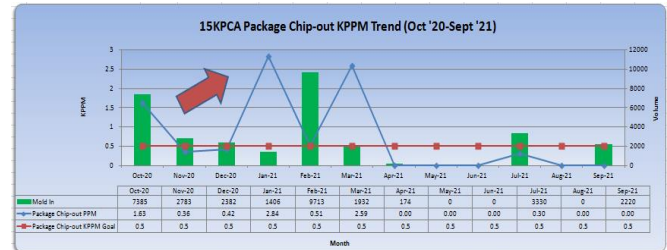
Fig 7: PPM Trend of Package Chip-out for 15KPCA

PPM rejection rate for package chip-out (2.84 KPPM) also increased due to difficulty in removing the thick flashing manually.

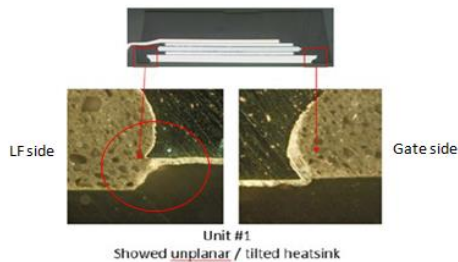
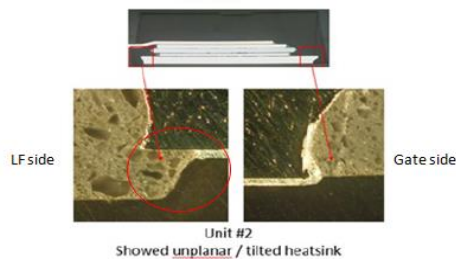
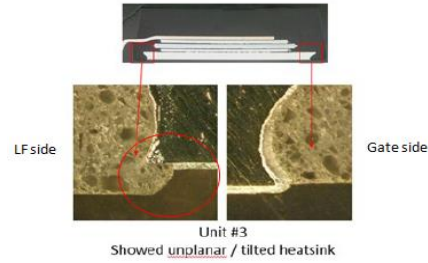
Fig 10: Cross-section of units with flashing on heatsink

As shown on heatsink surface measurement, sides Q2 and Q3 on affected units have depression of 0.020 to 0.082mm whereas the units with no flashing have no indications of depressed heatsink. Cross-section showed unplanar heatsink, see Fig 10.

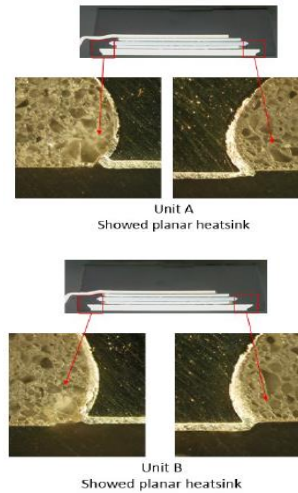
Fig 11: Cross-section of units without flashing on heatsink

Units without flashing on heatsink have evident planar heatsink with respect to the plastic mold perimeters shown of Fig 11.

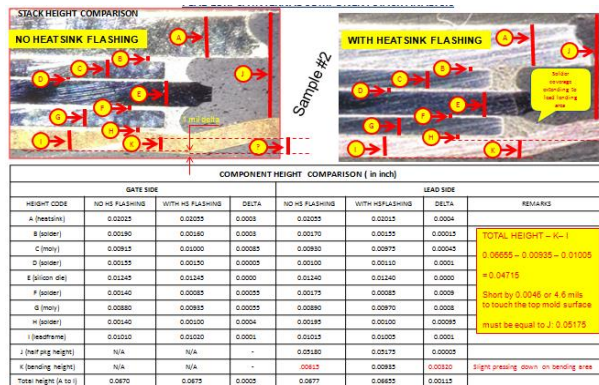
Fig 13: Assembly Stack height

Further validation on another set of samples showed lead bend height of 6.15mils on samples without flashing.

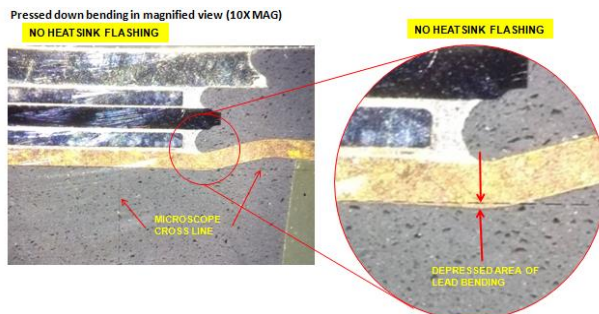
Fig 14: No HS flashing with pressing down of lead bend

- Two (2) units samples of units with NO FLASHING on heatsink showed the depressed area of lead bending adjacent to moly. It is an indication of lead bending height is below the minimum that potentially contributed by bending tool variation.
- Based on data, low bending height can eliminate the flashing on heatsink as it reached and touching the top mold surface.
- Bending height of with and without flashing showed the 2.5 mils and 3.2 mils delta

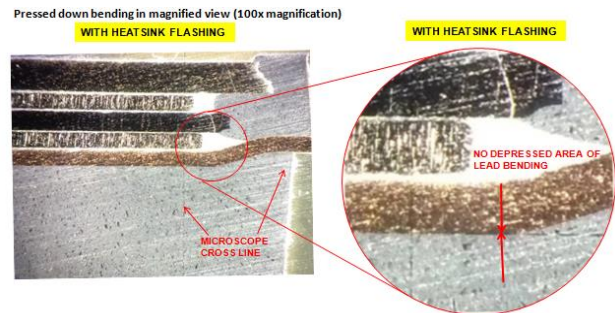
Fig 15: With HS flashing with pressing down of lead bend

- No abnormality noted on internal component stuck height measurement.
- No abnormality noted on lead bending and all passed the requirements. (No depressed lead bending)
- Bending height within the requirements do not touch the top mold surface thus creating the heavy flashing on heatsink.

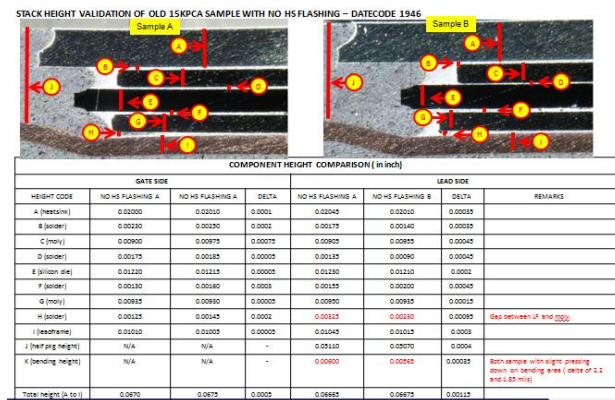
Fig 16: Old samples with No HS flashing

- Both samples showed slight pressing down on bending area (delta of 2.2 and 1.85 mils).
- Gap between leadframe and moly

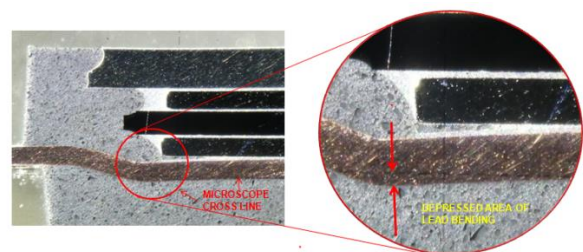
Fig 17: Old samples with No HS flashing

- 2/2 samples with NO FLASHING on heatsink showed similar depressed area of lead bending adjacent to moly.
- Depressed area of lead bending for both sample is 2.2 mils and 1.85 mils.
- Bending height of 5.65 – 6.0 mils on both samples with No HS Flashing (Specs: 9- 11 mils)
- Gap on between leadframe and moly on Leadframeside due to depressed area of leadbend.

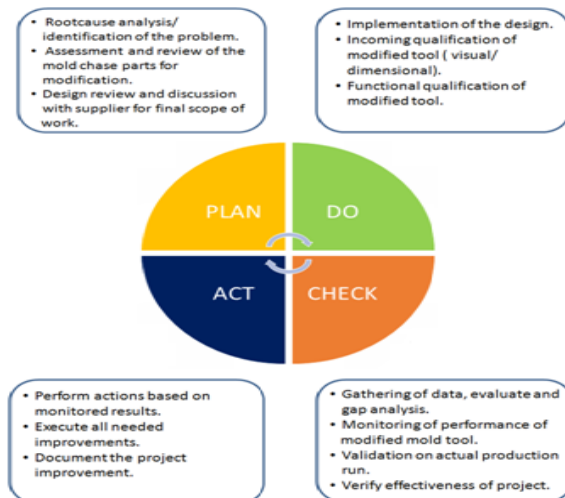
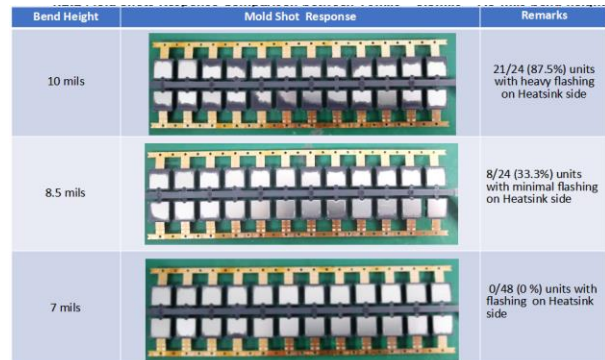
Fig 18: Mold Shot response per Lead bend height

1. All bent straps passed bend height initial specification window of 7.5-9.5 mils.
2. Minimal thick flashing on heatsink observed on all strips molded for 8.5 mils bend. For 10 mils - 90% of the units have thick flashing on heatsink.

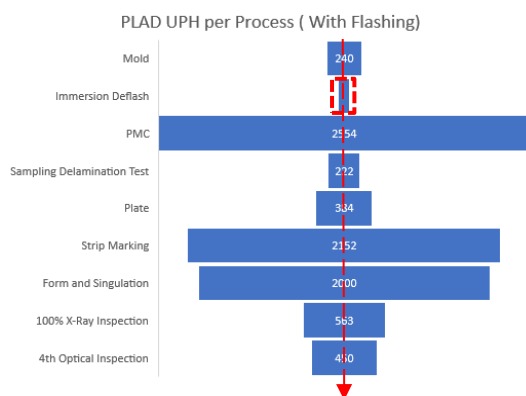
- UPH Improvement of 38.58% from 78 UPH to 127 UPH:

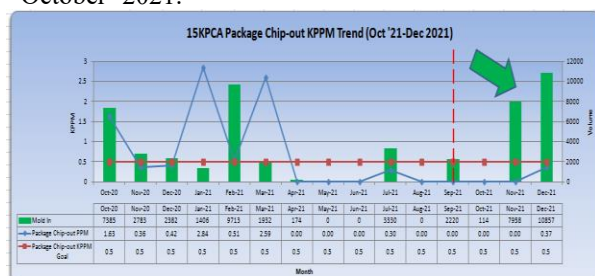
- Package chip-out PPM reduction from 3 KPPM to 0.37 KPPM. New lead bend height implemented last October '2021.
