## IMPROVED MOLD TOOL DESIGN ROBUSTNESS THROUGH THE DMAIC PROCESS

Walfredo Z. Peña  
Arnel S. Berlon  
Erikson J. Mapote

ATCB Central Engineering  
Nexperia Philippines Inc, LISP I, Cabuyao City, Laguna  
walfredo.pena@nexperia.com, arnel.berlon @nexperia.com, erikson.mapote@nexperia.com

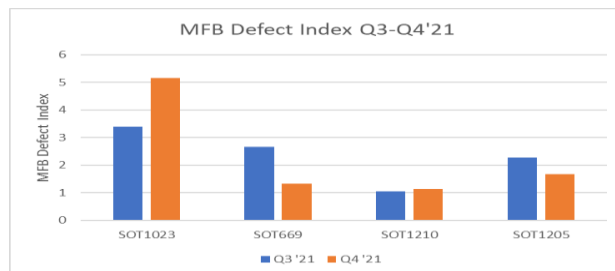
Figure 8: MFB defect index from Q3 to Q4 2021.

Figure 8 shows that the MFB yield losses are evident across the four package types of Clipbonded products. It means there's a fundamental issue causing this defect.

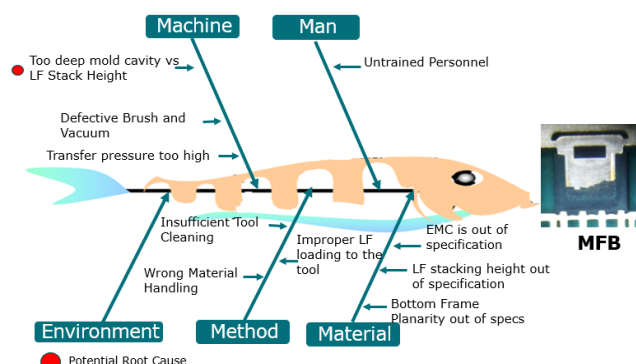
Figure 12: Ishikawa diagram for Mold Plastic at the Back (MFB).

Separate workshops were conducted with the OEM and the alternative supplier to get their input. Figure 12 shows the Ishikawa diagram for MFB. All potential root causes were listed by the team through brainstorming.

Table 1 shows the validation plan and results for each hypothesis. Among the 10 potential root causes, the “too deep mold cavity compared to the stack height of lead frame assembly” was identified as a root cause.

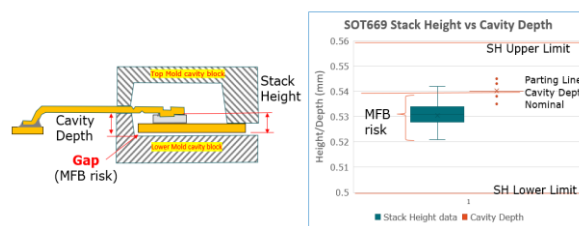
Figure 13: Gap between LF stack height and Mold Cavity Depth.

The identified root cause was thoroughly investigated. It was found that the gap between the cavity depth and the lead frame stacking height caused the MFB. As shown in Figure 13, the average actual stacking height was 0.53mm which was well within the limit. While the average depth for the mold cavity was 0.54mm which is the nominal also of the package parting line. Leaving a total gap of 0.01mm between the bottom frame and mold tool cavity surface. This is where the EMC penetrates. Any stack heights lower than the cavity depth are a risk to MFB.

On the other hand, if the mold tool cavity is too shallow and the lead frame stack height is too high, it could result in solder crack due to high stress during mold clamping. Therefore, it is necessary to balance the actual lead frame stacking height and the depth of the mold cavity.

The team has recommended reducing the mold tool cavity depth but must be within the maximum limit of PAD to close the gap and address the MFB without violating the form, fit, and function of the product. The +/- 0.025mm tolerance of PAD was seen as the opportunity to close the dimensional gap between stack height and the mold cavity tool depth. As explained in Section 3.3.2.1, there's a gap of 0.01mm between the cavity depth and the stacking height causing the EMC to penetrate resulting in MFB. Therefore, adjusting the cavity depth by 0.02mm would resolve the issue. Figure 17 shows the comparison of the original and the more robust design.

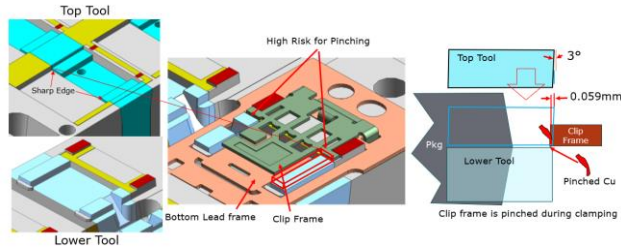
Figure 15: Defect mechanism of Copper on Plastic (CuP).

The defect mechanism of CuP was carefully analyzed during the workshop with OEM and an alternative supplier. Both suppliers agreed that this was a result of pinching when a

portion of the clip/lead frame is hit by the upper mold tool during clamping. Then the pinched copper mixed with the EMC on the succeeding mold shot resulted in CuP. Figure 15 shows the defect mechanism for CuP.

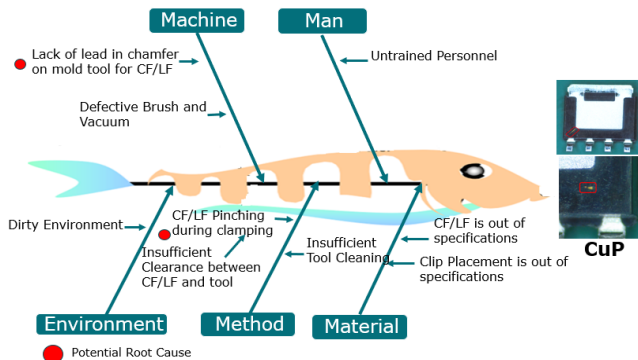
Figure 16: Ishikawa Diagram for Copper on Plastic.

Table 2 shows the validation plan and results for each hypothesis. Among the eight potential root causes, the lack of lead-in chamfer on the mold tool for the clip/lead frame and the insufficient clearance between the clip/lead frame and tool were confirmed as root causes.

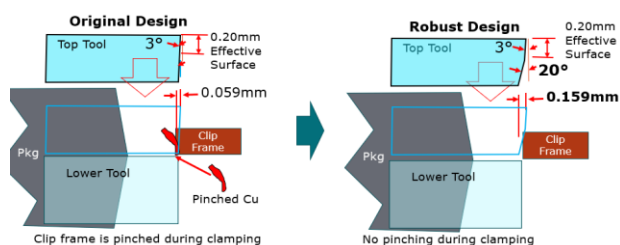
Figure 18: Comparison of original and the new robust design for CuP.

The variability in clip placement is inherited from the clip attach process. The root cause analysis confirmed that the maximum acceptable clip rotations could result in pinching and CuP when it reached the molding process. This was another focus of the team in enhancing the design of the mold tool. As shown in Figure 18, the original design has a 3° draft angle only with sharp corners which caused pinching during clamping. It was also found that the needed effective surface is just 0.20mm to prevent plastic leaks. With this realization, it was brought to an idea to enhance the outer portion of the

top tool by adding a 20° lead-in chamfer for self-alignment of the clip/lead frame during clamping without pinching.

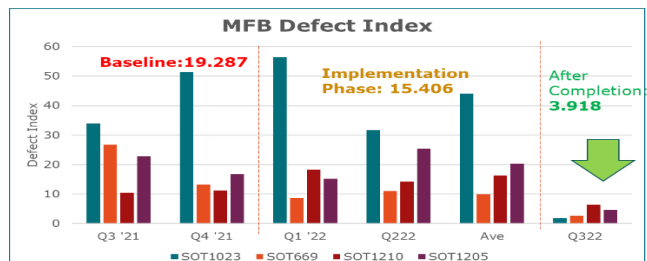
Figure 20: MFB defect index comparison before and after project implementation from Q3 of 2021 to Q3 of 2022.

Figure 20 shows that the MFB defect was reduced from a 19.287 defect index baseline in Q3 and Q4 of 2021 to a 3.918 defect index in Q3 of 2022 after the completion of tool

replacement. This was equivalent to an 80% reduction, which is above the set target of this project.
