**INNOVATION AND INCLUSION OF POU DESICCANT DRYER TECHNOLOGY TO  
ELIMINATE PAD DISCOLORATION CAUSED BY INTERACTION OF CDA  
MOISTURE TO METALLIC LGA PADS**

**Reinadd Jan B. Abad  
Judioz M. Manejero  
Ivan B. Veridiano**

**WT & TNF Process Engineering – B2F2 Operations  
STMicroelectronics Incorporated  
#9 Mt. Drive, LISP2, Brgy. La Mesa, Calamba City, Laguna 4027  
[reinaddjan.abad@st.com](mailto:reinaddjan.abad@st.com), [jude.manejero@st.com](mailto:jude.manejero@st.com), [ivan.veridiano@st.com](mailto:ivan.veridiano@st.com)**

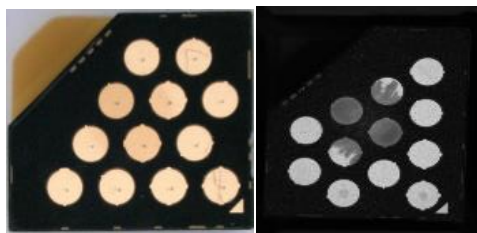
Figure. 1. Pad Discoloration Defect

This technical paper describes a discoloration related failure mechanism in Gold (Au) LGA pads. The discoloration is caused by severe oxidation of Nickel (Ni), which in extreme severity leads to electrical fails due to increased contact resistance. The root cause for the Au/Ni oxidation is illustrated as due to the porosity of the immersion gold and the synergistic degradation of the pores during the downstream backend and assembly's processing. Further discussion of this problem mode necessitates to mitigate the degrading impact of the end of line processes on gold surface finish, and eventually elimination of the discoloration related quality issue.

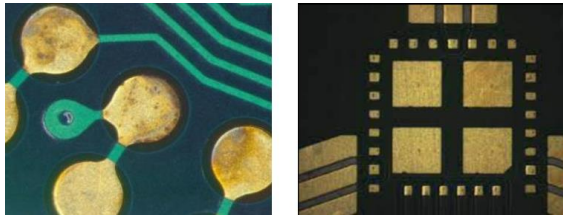
Figure. 5. PCB with Metal Pad Discoloration

When metal is exposed to moisture which contains oxygen, this causes reaction where the metal ions bond with the oxygen atoms and creates an oxidation. This can manifest in the Printed Circuit Boards (PCB) or Metallic pads which is usually composed of Au (Gold).

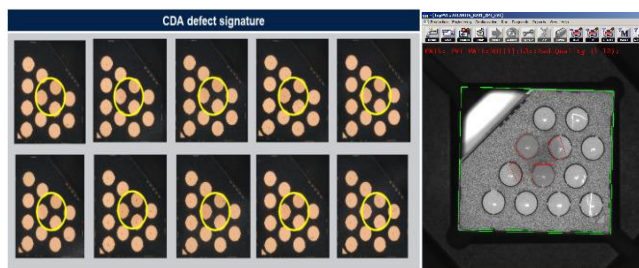
Figure 10 & 11. CDA Defect Signature

Sample photos of reject modules after 100% visual inspection showed pad discoloration defect signature which are localized on the center pads of the module. AOI cosmetic validation on affected modules showed visible pad discoloration with difference in light contrast. Affected modules failed at top station during PVI inspection. See Fig. 10 & 11.

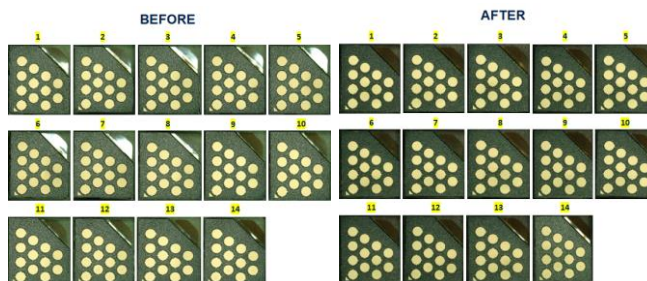
Figure 12 & 13. Before and After Images after Gang Pick

Remarks: After simulation on Gang pick, there are no signs of Pad Discoloration or any substance on pad.

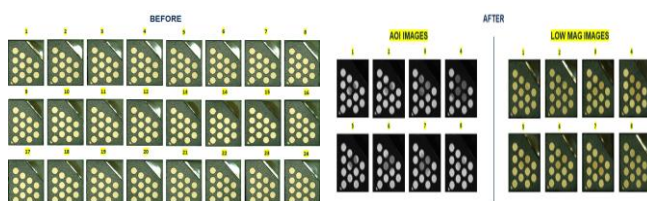
Figure 14 & 15. Before and After Images after Turret Nozzle Simulation

Remarks: 8 out of 24 units observed with pad discoloration after simulation at turret nozzle.

Observed that all Turret Nozzles (Turret 1 to Turret 24) are having liquid substance (water) which is the most probable cause of Pad discoloration on Bottom part of module after the experiment.

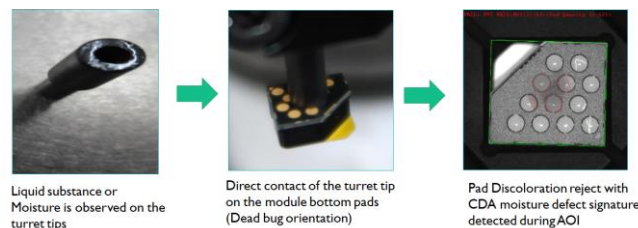
Figure. 17. Pick and Place of Module

CDA Supply is directly connected to the ASTI Tape and Reel machine where the air supply goes to the turret tip for pick and place of modules. The liquid substance or moisture observed on the turret tips is directly in contact with the module bottom pads at dead bug orientation. Pad

discoloration reject is evident on the contact point between the turret and module part referring to below Figure. 17.

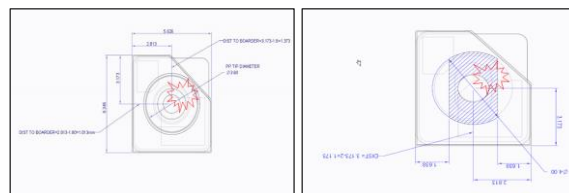
Figure. 19. Superimpose of Turret and Gang Pick vs Defect location

Superimposed image of the Turret tip and Gang pick shows that the defect location of Pad discoloration is coinciding with the contact points of the pick-up tool head.

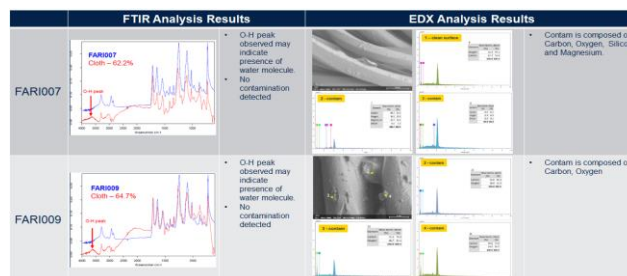
Figure. 23. FA Result of Input to ASTI Machine

Result: OH peak observed are indicative symptoms for presence of water molecules.

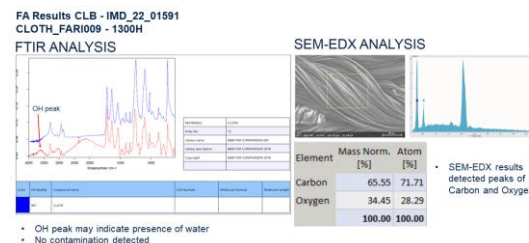
Figure. 24. FA Result of Cloth Samples

Result: OH peak observed may indicate presence of water molecules

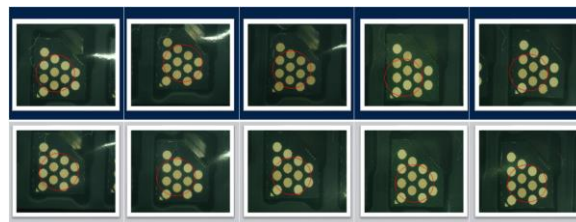
Figure. 35. Pad discoloration still observed after 1 hr staging in room temperature inside carrier tape

Results of experiment show that the Pad discoloration is still prevalent after 3 hours dry staging under room temperature placed in carrier tape. Based on risk assessment, it was observed that the discoloration on pads remains intact after staging via tray or carrier tape (1hr-->2hrs-->3hrs) when exposed in standard clean room temperature, hence this phenomenon does not disappear after processing which signifies that this defect may reach up to end customer.

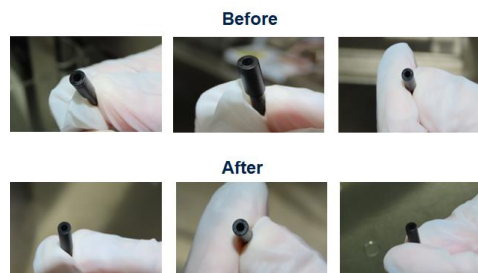
Figure. 36. Turret Tip Checkout

Item	Activities:	Result:
1	Purging Turret Nozzle	Dry Nozzle Observed
2	Nozzle Check	No significant water marks observed on turret tips compared to previous condition

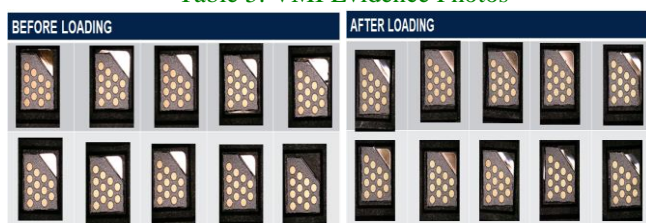
Table 6. VMI Result

Item	Activities:	Result:
1	Run 1 Dummy tray	No signs of any Pad discoloration observed on the units after 100% VMI
2	Do cycle run (2x)	
3	100% VMI (Before and After)

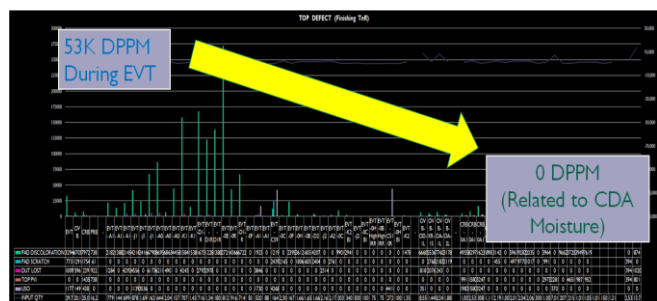
Figure. 39. Pad Discoloration Elimination

From 53k DPPM during EVT stage related to pad discoloration defects, significant reduction of Pad discoloration was observed from OVB to CRB milestone with zero occurrence of Pad discoloration related to CDA moisture. This has significantly improved the overall Yield in preparation for the Mass production.

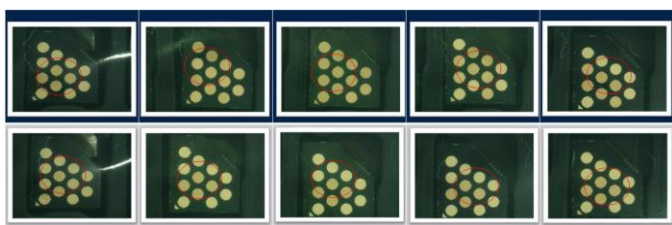
Pad discoloration still observed after 2 hrs staging in room temperature inside carrier tape

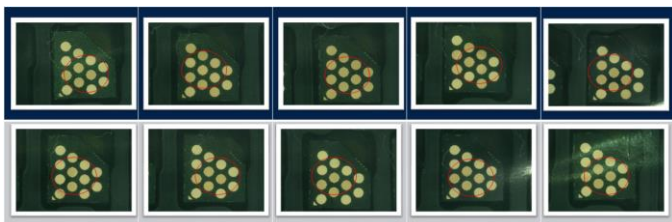
Pad discoloration still observed after 3 hrs staging in room temperature inside carrier tape
