## PNP HEAD MATRIX II ASYNCHRONOUS PICK BODY STROKE; CAUSES, EFFECTS AND SOLUTIONS

Automation Technology Solutions Engineering  
P. IMES Corp., Block 16, Phase IV, Cavite Economic Zone  
Rosario, Cavite, Philippines  
caday@pimes.com.ph

### ABSTRACT

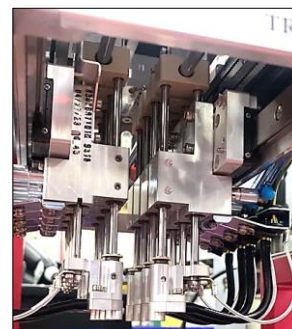
GOOD Pick Body Stroke

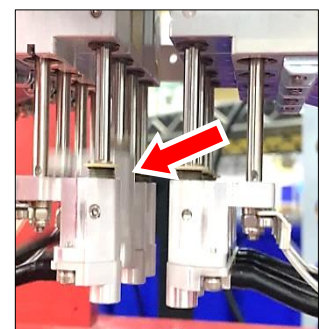
**Brake Counter Tes Requirement** – The eight (8) Pick Bodies Assembly on Master X-Pitch and Slave X-Pitch must be able to lower its *pick tips synchronously* when the brake released.

Asynchronous Pick Body Stroke

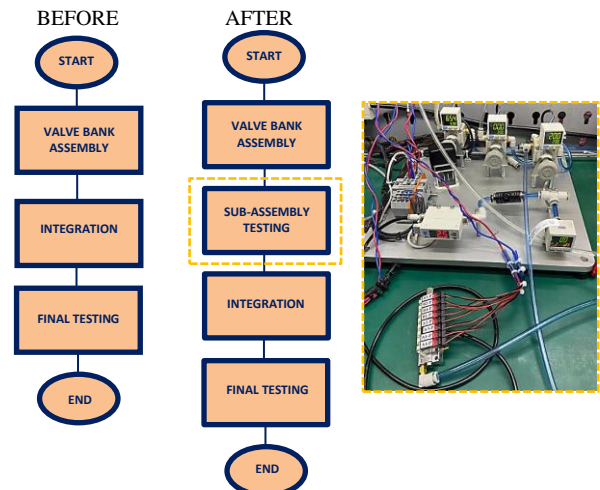
Figure 23. Valve Bank Assembly Testing was added on the existing process flow.

**Before:** No sub-assembly testing was conducted after Valve Bank Assembly.

**After:** Sub-assembly testing of Valve Bank Assembly was added before Integration process.

Different combinations of Valve Base values were installed and tested as a set (x8 Valve Bases per set), and based on the results, a good Valve Bases' values would range from 4.8 to 6.0 PSI. This helped to generate Manufacturing Test Instructions (MTI) and determined the passing criteria for Valve Bank Assembly.

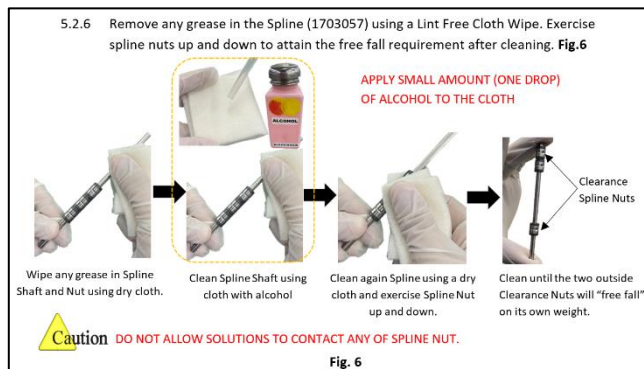
Figure 26. Defined process for proper cleaning of Spline.

**Before:** No defined process for proper cleaning of Spline.

**After:** Use of Alcohol to wipe off any corrosion oil applied on Spline.

Pick Body Assembly is more likely to pass the Brake Counter Test if Spline has experienced an adequate cleaning of Spline Shaft and enough exercising of Spline Nut regardless of what chemicals have been applied to it. To achieved the “free falling” of Spline more quickly, it is advisable to use an *Ethyl*

*Alcohol* on cleaning the Spline rather than Lubricant. According to *CPLabSafety*, Ethyl Alcohol has an A-Excellent compatibility with Stainless Steel.

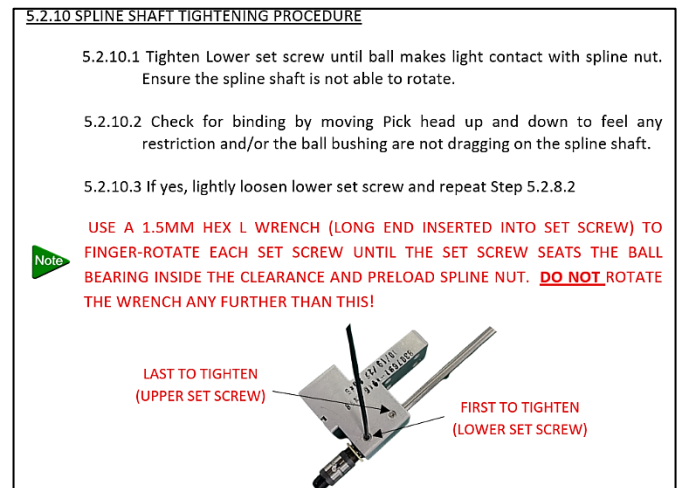
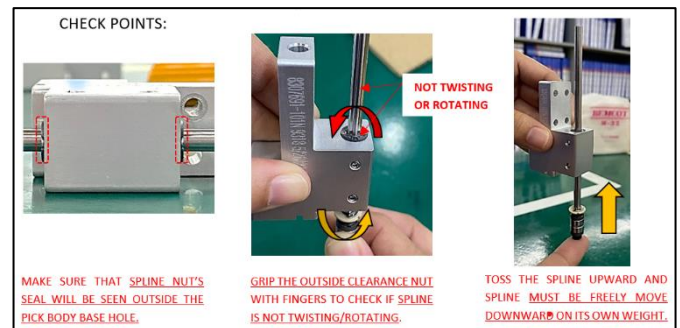
Figure 28. Defined process for proper tightening of set screw

**Before:** No defined process for proper tightening of set screw installed onto Pick Body Base.

**After:** Spline Shaft tightening procedure was defined.

To get the proper tightening of set screw, several torque values were simulated. Since we had already reached the smallest value of 0.01Nm that our meter could read, we were unable to get the precise value. That is how I arrived at the solutions listed above, which I verified after trying to simulate different torque values.

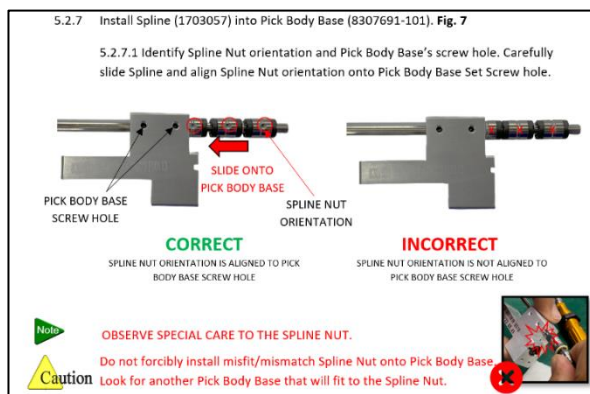
Figure 30. Defined precaution on installation of Spline Nut.

**Before:** No defined precaution on installation of Spline Nut onto Pick Body Base.

**After:** Identified a precaution on installation of Spline onto Pick Body Base.

If no Pick Body Base will fit onto Spline Nut, it will declare as a material defect and Product Engineer will coordinate to the buyer of the parts.

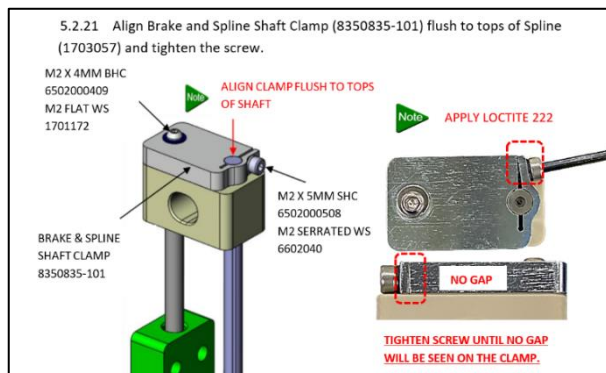
Figure 31. Defined process for proper tightening of Brake and Spline Clamp.

**Before:** No defined proper for proper tightening of Brake and Spline Clamp.

**After:** Proper tightening of Brake and Spline Shaft Clamp must be no gap will be seen between the clamp.

Since clamp has different sizes of gap, we were unable to get the precise torque value.

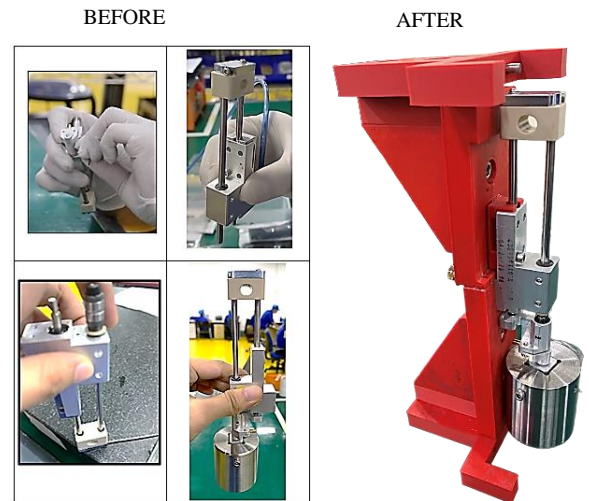
Figure 32. Actual scenario of with and without Jig used

**Before:** No proper handling during assembly process.

**After:** Provided a Pick Body Assembly Jig.

Based on actual run of the prototype, a lot of good feedbacks were received from the primary user of the jig. Aside from ergonomically designed, quality, and cycle time were also improved.
