## PROBE DAMAGE REDUCTION USING KAIZEN METHODOLOGY

Probe Department – Production and Engineering  
Allegro MicroSystems Philippines, Inc. 4756 Sampaguita St., Marimar Village 1, Sun Valley, Parañaque City  
[vacasio@allegromicro.com](mailto:vacasio@allegromicro.com), [mcarlos@allegromicro.com](mailto:mcarlos@allegromicro.com), [membang@allegromicro.com](mailto:membang@allegromicro.com)

### ABSTRACT

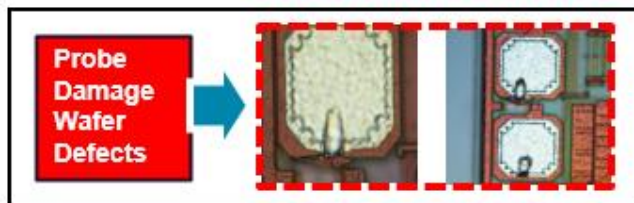
Visually the product would manifest its probe mark touching the bond pad boarder area which could expose the base metal (see Figure 2).

Figure 2. Reject probe marks that exposes oxide beneath the bond pad metal.

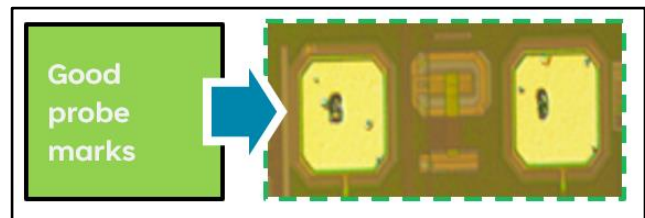
For the criteria, the good and acceptable probe marks must be inside or within the bond pad and or as much as possible at the center of bond pad as optimal setting (see Figure 3).

Figure 3. Good and Acceptable probe marks inside the bond pads.

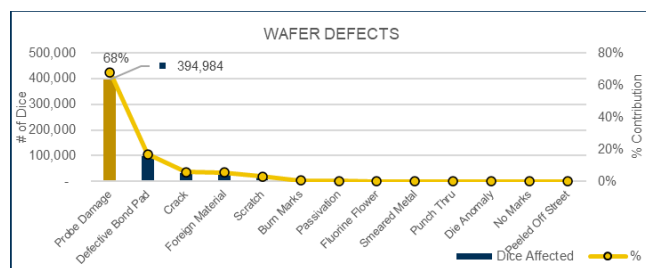
Focusing on the wafer defect level, first level pareto analysis shows that the top contributor is Probe Damage with a total of 395k units or equivalent to 68% of total defect from Q1 to Q2 FY23 (see Figure 4).

Figure 4. Probe Damage is the top wafer defect.

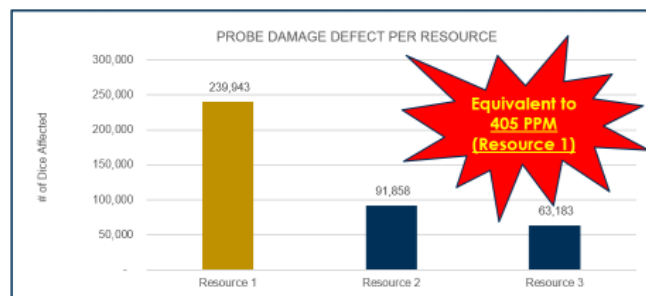
On second level analysis, the team focused on device resource levels (Resource 1, Resource 2, Resource 3) and the high occurrence of probe damage is coming from Resource 1 resource with a total of 239k die affected or 61% contribution of the total probe damage defect of the same period and is equivalent to 405 ppm (see Figure 5).

Figure 5. The top resource is Resource 1 with probe damage.

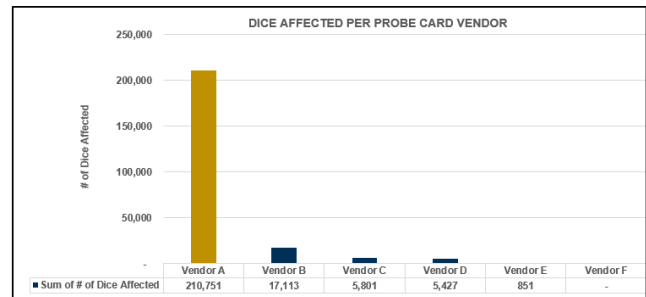
The top probe card vendor inducing high defect of Resource 1 is Vendor A with equivalent of 210k die or 88% contribution from 239k die affected (see Figure 6).

Figure 6. The top source is Vendor A probe card vendor.

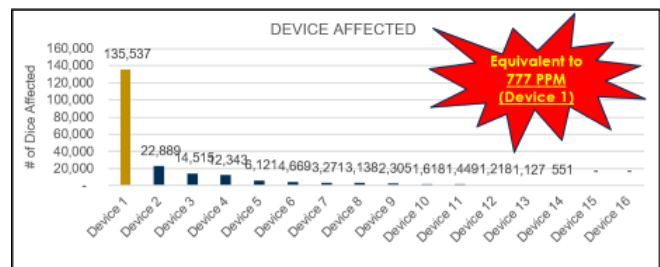
The top device producing high defects of Resource 1 is Device 1 with a total of 135k die or 56% contribution of 239k die affected of probe damage and equivalent to 777 ppm with 174k PHP scrap value (see Figure 7). Based on the device pareto of probe damage, all devices affected are all tested at HOT process.

Figure 7. The top device with probe damage is Device 1

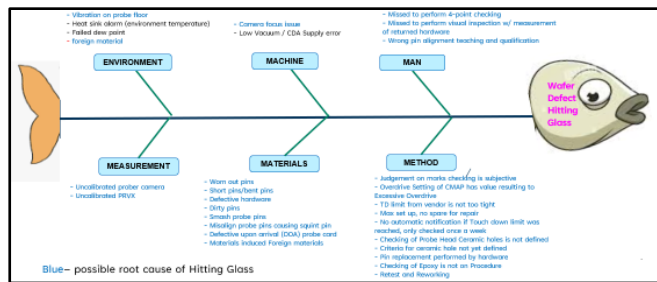
By Probe process mapping and Fishbone Diagram (see Figure 8) the team identified possible root causes of probe damage. From the identified root causes, the team performed validation testing plan (see Figure 9) to confirm the hypothesis. Among the validated processes, the top contributors of wafer defect probe damage are: 1) No probe pin alignment on every wafer; 2) Excessive running overdrive setting; 3) Marginally passing probe mark alignment; 4) Defective epoxy; 5) Vibration from generator.

Figure 8. Fish bone diagram identified contributor of probe damage. The items in blue box are the possible root cause.

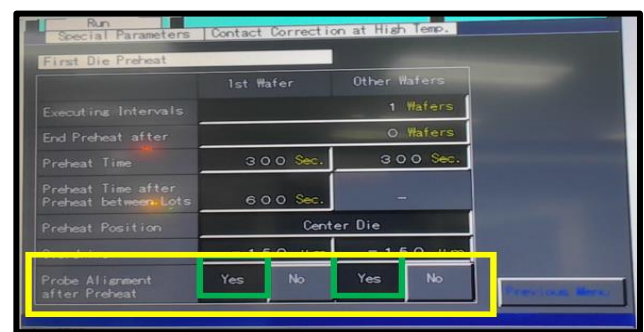
During investigation, the signature of occurrence happens in every start or change of wafer. Defect manifested on a sudden shift of whole pad probe mark alignment on all probe pads. The team examined the behavior of process and referred to the equipment manuals for reoccurrence of problem and found out that the nature of the issue can be corrected by performing pin alignment using the auto alignment feature of the prober. Enabling this feature will execute the pin alignment in every change of wafer (see Figure 10). The pin alignment consumed 15 seconds per wafer and had no major impact with the capacity since the hot testing set up for Resource 1 increased only with the average of 0.01%. This procedure was documented at PRC- 0002752 (Prober Wafer Parameter Settings).

Figure 10. Enabling auto alignment feature of prober after Preheat on every change of wafer.

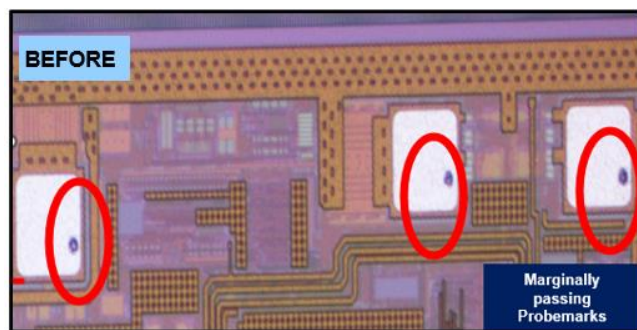
The team found out that the acceptance of probe marks is not at optimum location during device set up and qualification. All probe marks inside the bond pads including marks close to the border of the pads are being accepted (see Figure 13).

Figure 13. Subjective acceptance of probe marks near outside the boarder of the pad.

To reduce the wafer defects and correct the practice, the team created Probe marks Alignment templates for all devices based on actual bond pad size (see Figure 14). This template will be used by the operator as Go-No-Go reference for probe mark size and location. It was disseminated with the team and the procedure was updated in document WIN-0000645 (Operator Work Instruction) to include the use of probe mark template to check the probe mark alignment.

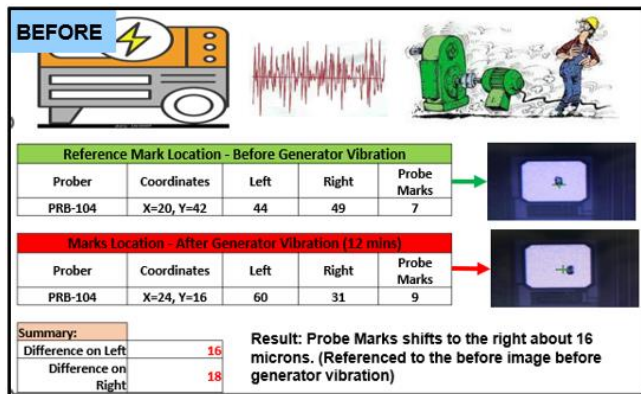
In AMPI, testing of power generators is a regular activity as part of the Facilities maintenance. During these times, all machines located near the generator area experienced probe damage because of the floor vibrations affecting equipment stability. The probe mark locations are shifting to different locations about 16 microns in average (see Figure 16).

Figure 16. Reference Probe mark location

The team simulated an event and justified that generators testing is one of the factors that resulted in probe damage. As corrective action, the team created an OCP-0000059 (Probe Out of Control Action Plan) procedure - to STOP the machine during generator testing but only the machine nearest to the location or 5 meters to be exact. The probe pins or needle

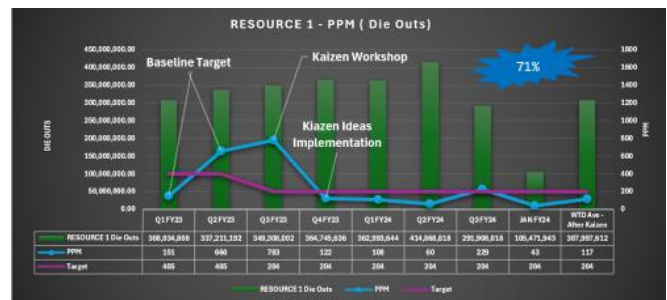
The project aimed to reduce wafer defect probe damage by 50% or an average of 204 ppm for Resource 1. The baseline target is Q1-Q2 FY23 and Lean Workshop started on Q3FY23. After Lean ideas and improvement implemented on Q4FY23, from more than 300M die outs or processed qty there is a significant drop from 783 ppm to 122 ppm. Though it had an increase again on Q1FY24 to Q3FY24 but those are all not included in the targeted scope upon identifying the Lean Actions on Device 1 and Vendor A setups. For Q1FY24, the issue encountered was related to Machine or Camera problem while for Q2FY24, encountered Method issue as shifting marks at Cold process where the auto alignment improvement is not yet applied to Cold process and last for Q3FY24 encountered Method issue, which the defect induced from other facility and not yet applying the AMPI controls. All issues encountered are out of scope coverage. Then, it is notable that from January FY24, wafer defect probe damage significantly decreased to 43 ppm level and achieved the average of 117 ppm level or 71% improvement (see Figure 18).

Figure 18. Wafer defect probe damage for Resource 1 (ppm level).

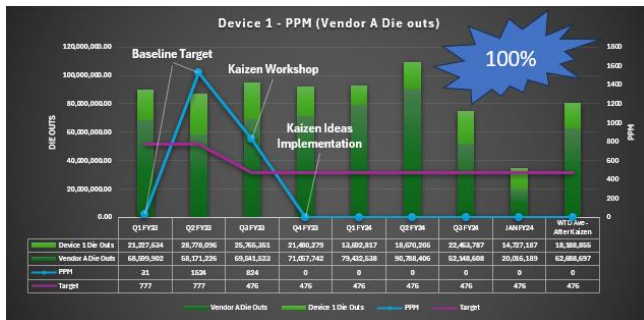
Moreover, the aim of this project is to reduce wafer defects for Device 1 which is the top device with the highest occurrences of wafer defect probe damage. The baseline data used is from Q1-Q2FY23, and the Lean activity started Q3FY23. Since Lean ideas and improvement implementation started last Q4FY23, wafer defect probe damage significantly reduced from 824 ppm to ZERO (0) ppm level or 100% improvement for Device 1 (see Figure 19).

Figure 19. Wafer defect probe damage for Device 1 (ppm level).

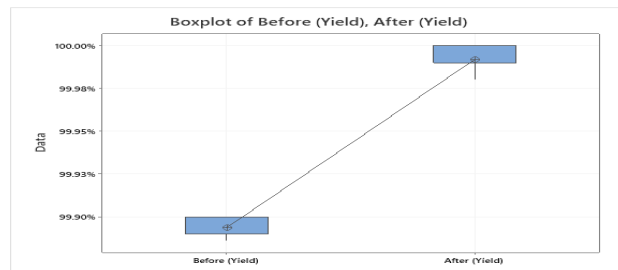
The team performed significance testing (see Figure 20) in terms of yield via Minitab and the result of 0.1% yield improvement is significant. In terms of number of dice, 0.1% is equivalent to 135,537 dice rejects. This resulted in cost avoidance of 174k PHP semiannual or 348k PHP per annum.

Figure 20. Two Sample T-Test of Before and After Yield shows significant yield improvement after implementation of corrective actions.
