REDUCTION OF CRUMPLED STRIPS OCCURRENCE FOR SOHED AT MECO-01

Assembly Process Engineering Department
Allegro MicroSystems Philippines, Inc. 4756 Sampaguita St., Marimar Village 1, Sun Valley, Parañaque City
vcaragayan@allegromicro.com, rrodriguez@allegromicro.com, ipalomo@allegromicro.com

32nd ASEMEP National Technical Symposium

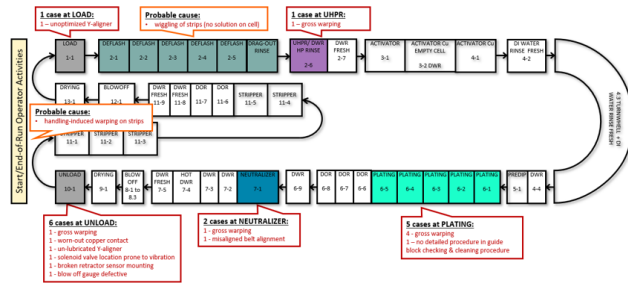
Figure 6: Crumpled Strips Mapping at MECO-01

In Figure 6, mapping was done to identify the specific cells where crumpled strips were encountered. Eight (8) of 15

cases were incurred inside the cells of UHPR, Plating and Neutralizer while the rest were at Load and Unload sections.

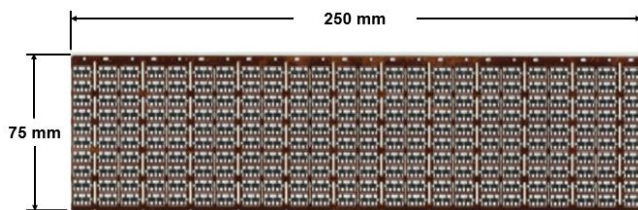
Figure 7. Photo of SOHED Leadframe.

Allegro Microsystems Phils., Inc. (AMPI) had shifted to high-density (HD) leadframes to generate more units per strip to increase productivity and attain higher output. However, one of the major drawbacks faced was strip warpage which is inherent even prior to the Tin Plate process. As discussed by Wyant, et al.1, “lead frame packages continue to become thinner, the capability to handle wider leadframes becomes more difficult. Becoming both wider and thinner, the strip’s ability to handle die mass will decrease, causing the strip to bow during handling operation.” Among all products, SOHED (see Figure 7) with dimensions of 75 mm X 250 mm and 480 units per strip, has the worst strip warpage that manifested in two types:

- Concave warping: Facing the outside PVC roller
- Convex warping: Facing the inner PVC roller

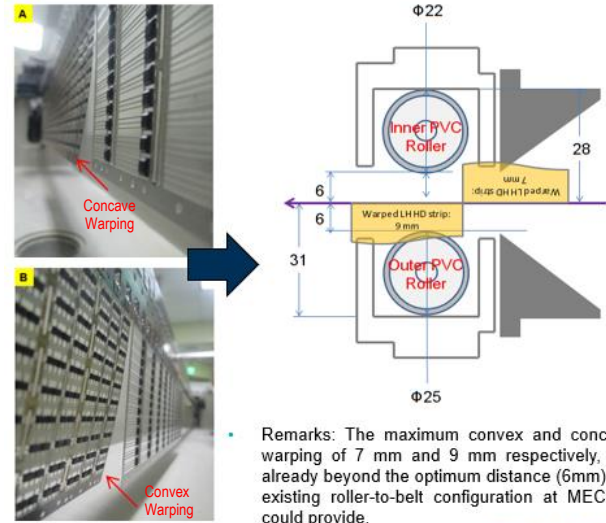
Figure 8. Correlation of Warped SOHED HD Strip and Solution Slot Assembly.

The maximum concave and convex warping measured on SOHED strips were 9.0 mm and 7.0 mm, respectively. These strip warpages are already beyond the optimum distance of 6 mm that the existing roller-to-belt set-up at MECO-01 could accommodate, see Figure 8. Based on data, 46.67% (7/15 occurrences) of SOHED crumpled strips were due to strip warpage.

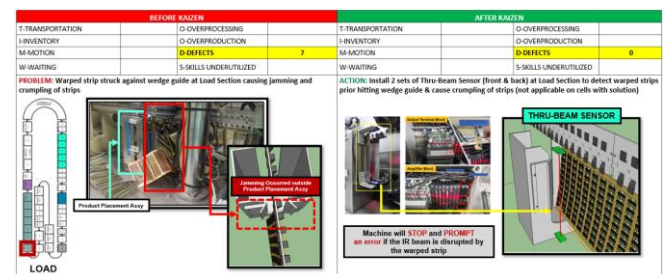
Figure 9: Thru-Beam Sensor Installation at Entrance of Product Placement Assembly.

The defect mechanism revealed that the bottom rail of the first affected strip was deformed as it hit the nicked area of strip aligner. The deformation had aggravated into crumpled strips; thus, it caused jamming of succeeding strips. Non-detection of affected strips was due to the absence of sensor at entrance of Product Placement assembly.

As corrective action to the root cause, the polypropylene strip aligner was changed into stainless steel material. Meanwhile, for the escape cause, two thru-beam sensors were installed at entrance of Product Placement, see Figure 9. By operation, the thru-beam sensors will flag an error once warped strip crosses the optical axis between transmitter and receiver, thereby stopping the process.

The distance between two the thru-beam sensors was set to 7 mm to ensure that warpage greater than that will be arrested. Refer to Table 2.

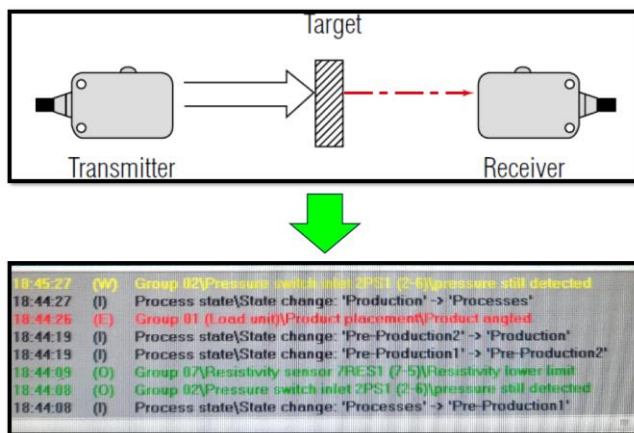
Figure 10: Thru-Beam Sensor Functionality and Error Validation.

Functionality testing and dummy qualification results showed that “Group 01 (Load Unit/Product Placement/Product Angled)” error was prompted by the system upon detection of leadframe across the optical axis between transmitter and receiver, see Figure 10. To rectify this, the operators should straighten the strip before reloading.

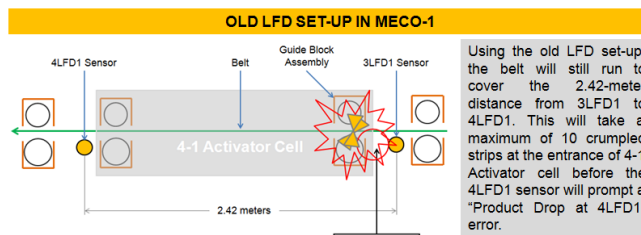
Figure 11: Crumpled Strips Escape Cause Mechanism

At Tin plate (TP), the belt conveys the strips from load to unload. The strips will pass through narrow cells wherein occurrence of crumpled strips and product drop are highly feasible. To detect these issues, MECO machines are equipped with “Product Drop Function” using leadframe detect (LFD) sensors. By design, the Product Drop Function is used to detect if a product is dropped between LFD sensors. With the belt direction running from right to left, the reference sensor is located on the right side. This means that each LFD sensor is the reference for the next LFD sensor. For example, with the design of 4-1 Activator cell in MECO-01, 3LFD1 is the reference sensor for 4LFD1 sensor (see Figure 11). The distance between 3LFD1 and 4LFD1 sensors is 2.42 meters which is equivalent to 9 SOHED strips. Since there was no LFD sensor installed in the entrance of 4-1 Activator cell, nine strips will be crumpled first at entrance 4-1 Activator before 4LFD1 sensor will prompt an error, upon sensing the absence of strips seen by 3LFD1 sensor. Since multiple strips are affected, this scenario usually results in maverick lot.

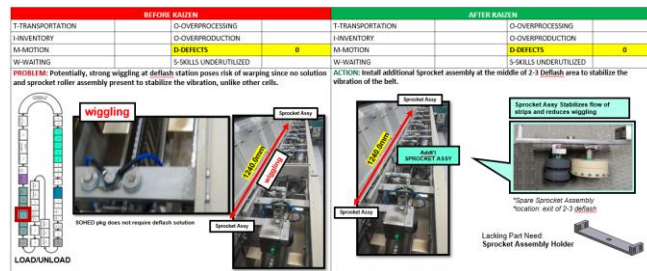
Figure 14: Strip Wiggling Issue at 2-3 Deflash Before and After Kaizen.

During GEMBA walk, excessive belt and strip wiggling were observed at 2-3 Deflash cell. Excessive belt wiggling is one of the potent factors of crumpled strips. This usually happens when warped strips strike against the guide block due to diminished and or restricted passage area. In this case, excessive wiggling was due to 1) the absence of solution in Deflash section and 2) limited number of sprocket rollers installed. As defined through design of experiment (DOE), SOHED does not require Electrolytic Deflashing and Ultra High-Pressure Rinse (UHPR) processes to minimize delamination. So, this factor is not controllable. On the other hand, the sprocket rollers at 2-3 Deflash were far from each other that it has gap of 1240 mm. As shown in Figure 14, this was addressed by installing additional sprocket roller in the middle of 2-3 Deflash cell to stabilize belt vibration.

To validate this result, five and 25 runs were processed. All lots had zero crumpled strips which proved that additional sprocket roller is effective in controlling wiggling-induced crumpled strips.
