REDUCTION OF DIGHSB BOARD FAILURE IN DEVICE “S”

Test Maintenance Engineering Department
ams OSRAM, #2 Makiling Drive, CIP2, Brgy. Milagrosa, Calamba City, Laguna
Jasten.Duremdez@ams-osram.com, Ian.Estanislao@ams-osram.com, Philip.Bullas@ams-osram.com

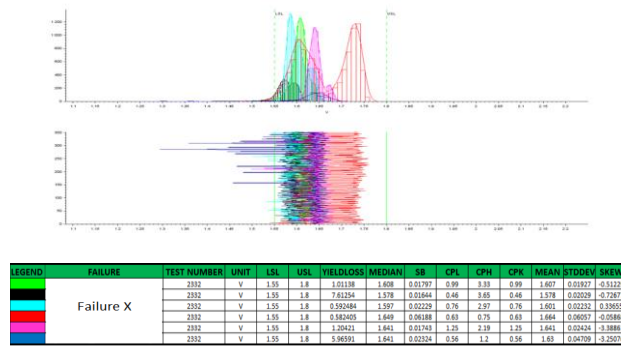
Fig. 1. Above shows the current Process Performance.

The data shows the process performance of different lots that manifested the Gross “Failure X”. Based on the graphical presentation, the process is out of control which is why this is the reason that DIGHSB board of different test systems becomes defective. The data is right skewed which indicates that the process is not good.

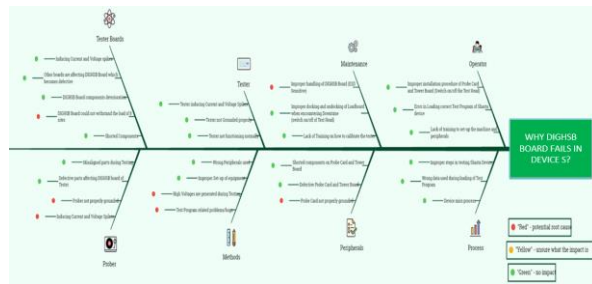
Fig. 2. Ishikawa or Fishbone Diagram

Above is the Ishikawa or Fishbone Diagram that identifies the possible root-causes of the problem. Potential culprit of the problems are Improper handling of DIGHSB Board - ESD (Electrostatic Discharge) Sensitive, DIGHSB Board could not withstand the load of 8 sites, Prober not properly grounded, Prober inducing Current and Voltage Spikes, High Voltages are generated during Testing, Test Program related problems/bugs and Probe Card not properly grounded.

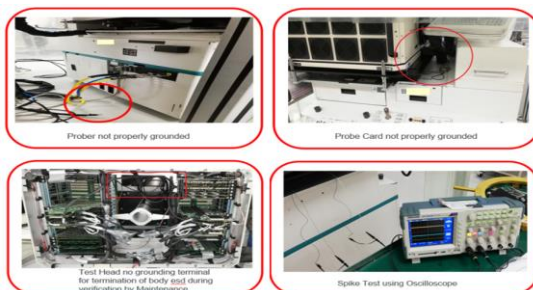
Fig. 3. Potential root-causes of the Problem

Root-causes of the Problem were identified thru Gemba Walk, Observation and Analysis at the line.

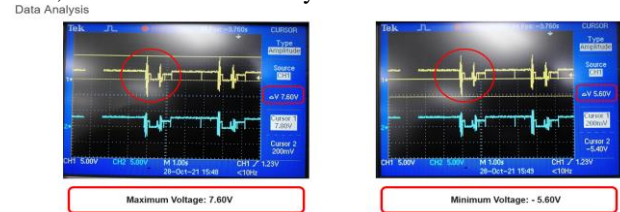
Fig. 4. Data Analysis using Oscilloscope

The data shows the Spike Test of Voltage using Oscilloscope. The Yellow signal is from sites 1-4 and the Blue Signal is from sites 5-8. It indicates that Bin 7 or Reject unit has Maximum Voltage of 7.6V and Minimum Voltage of - 5.6V in a single test. This resulted to Gross “Failure X”. DIGHSB Board becomes defective and has been replaced to make the set-up okay and available for testing.

It was identified by the Team that the culprit of the problem are High Voltage Spikes generated on single test. This makes the DIGHSB Board Defective.

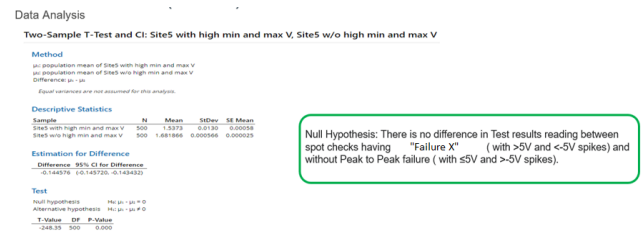
Fig. 5. Data Analysis using Two-Sample T-Test

Using Two-sample T-Test, Null hypothesis is rejected because P-Value is less than 0.05.

It was observed that there is a difference in Test Result Readings between spot checks having “Failure X” and without “Failure X”.

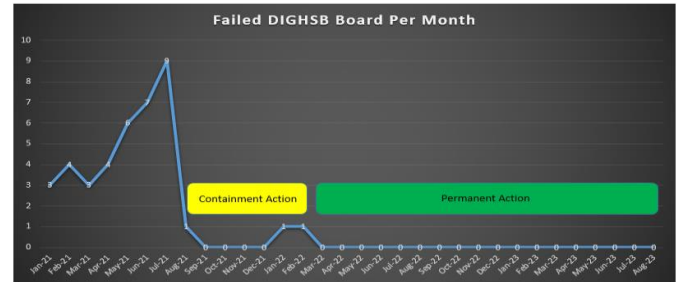
Fig. 9. Trend Chart of DIGHSB Board Failure

Based on the pilot run of all solutions, the target of 70% reduction of defective DIGHSB Board is achieved. Zero board failure has been achieved from March 2022 to August 2023.

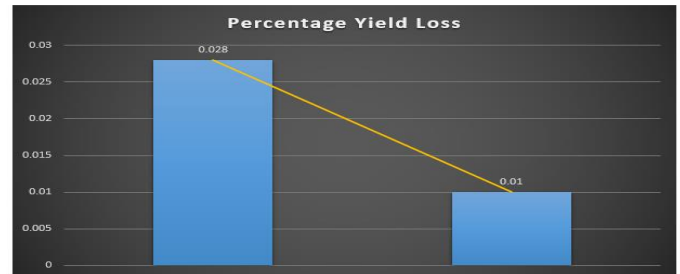
Fig. 10. Percentage Yield Loss

Percentage Failure X was lessened from 0.028% to 0.01%.

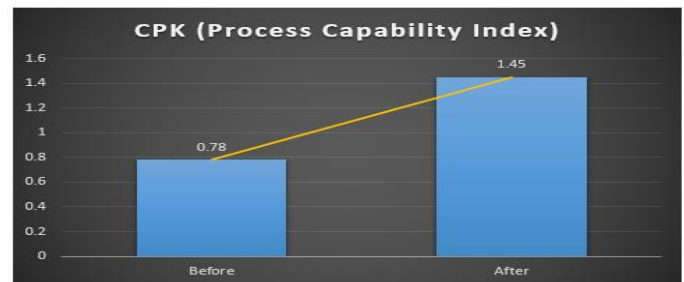
Fig. 11. Process Capability

After the implementation of the solution, CPK (Process Capability Index) has improved from an average of roughly 0.78 to 1.45

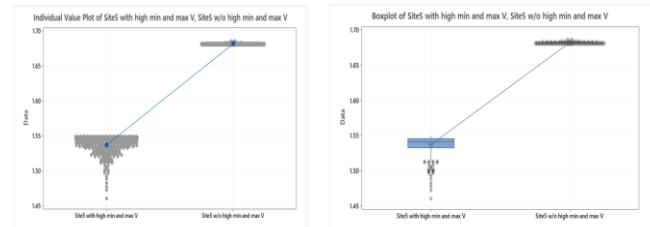
APPENDIX A.

The box plot above shows the spot check done with 500 samples of Test results reading. It was a comparison between the reading with high voltage spikes (minimum and maximum) versus the low voltage spikes. This was taken on single site only where “Failure X” was rampant or gross.

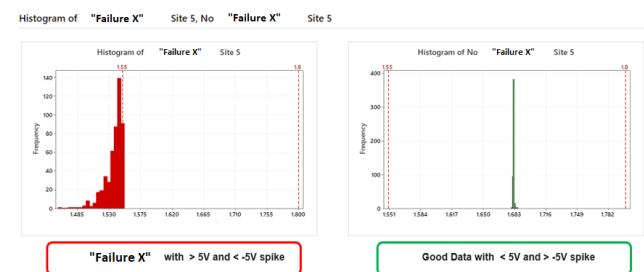
APPENDIX B.

The Histogram above shows the actual “Failure X” that is common to site 5 only. This happened in MXxx last October 28, 2021. After replacement of DIGHSB board, the set-up meets the specifications.

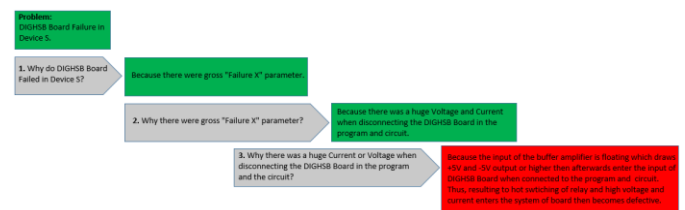
APPENDIX C.

The diagram shows the why why analysis for the identification of the root cause of the problem.

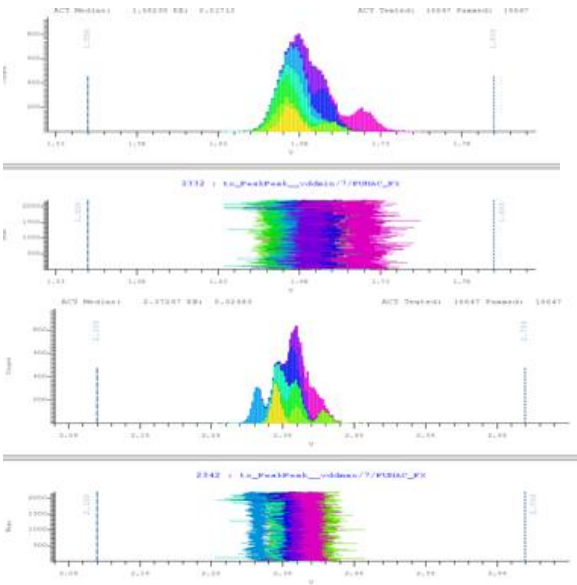
APPENDIX D.

Good Sample distribution of Data after the Test Program Revision.

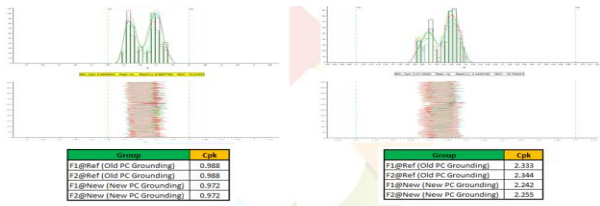
APPENDIX E.

After the implementation of grounding improvements, Distribution on Gross “Failure X” parameters are correlated (Before and After).
