Solder-induced HAST Failures

Package Research and Development
Nexperia Philippines, LISP 1, Diezmo, Cabuyao, Laguna

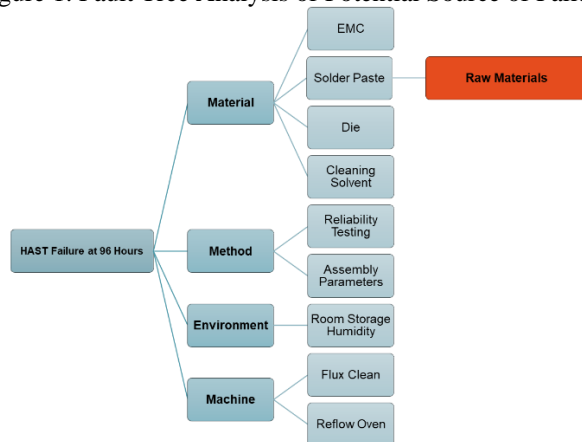
Figure 1. Fault Tree Analysis of Potential Source of Failures

All the potential sources of failure were considered, no gap found in the process as both lots run through the same parameters. The only distinct difference between the two assembly trials is the solder paste material used in the die attach process making it a valid potential root cause of the failure.

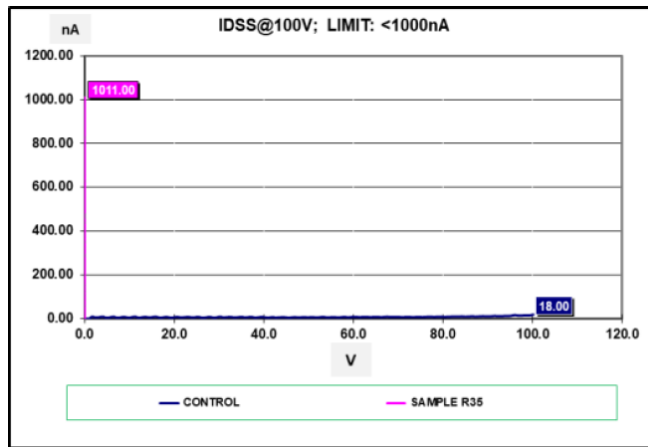
Figure 3. Electrical Curve Trace of HAST96 failed unit.

Failure Analysis of the HAST96 failed unit did not display any visual and x-ray anomalies. However, electrical verification from Figure 2 has shown that the failed unit has a current leakage on the on drain-source leakage current (I_{dss}) parameter at the level of 100uA, which is the maximum current that flows through a FET transistor when there is no bias being supplied on the gate.

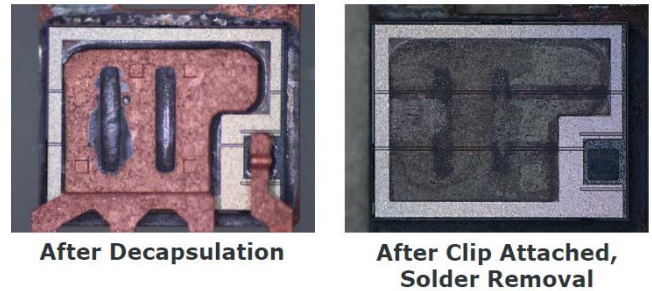
Figure 4. Decapsulation of the failed unit

Decapsulation was performed to observe if there was any damage inside the unit that can lead to failure. However, no visual anomaly was found on the failed unit. Hence, corrosion cannot be concluded as the reason of failure after HAST.

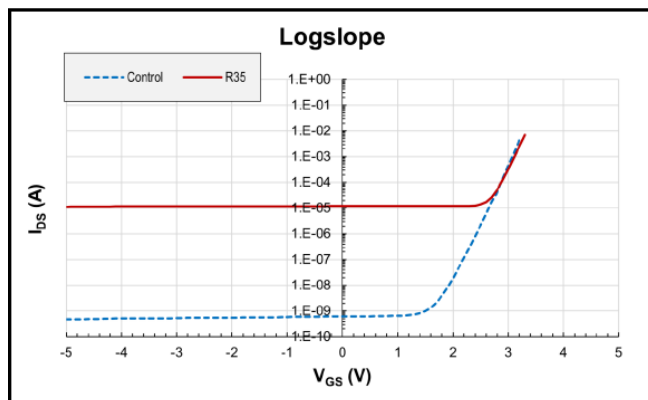
Figure 5. Logslope Analysis of the failed sample having “shifted” graphical representation.

Logslope analysis of failed units shown in Figure 5 exhibited a shift on the graph, which indicates that a moisture ingress during the process of HAST possibly triggered an electrochemical migration to occur inside the unit. This possibly took effect if the bromine content of the solder paste is deposited on the drain and source area, causing corrosion.

Thus, it is viable that the failure originated from the moisture obtained from the HAST process, which resulted in delamination that triggered the bromide to dissolve on the drain and the source causing an insulation breakdown.

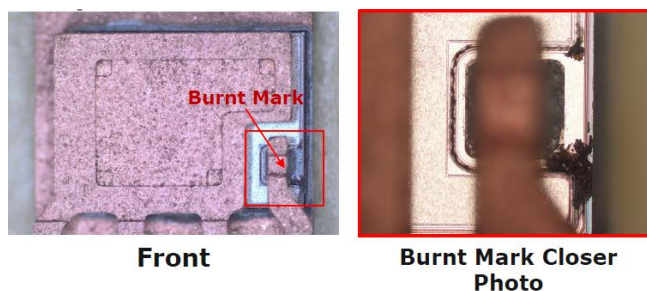
Figure 6. Burnt Mark on the failed unit after decapsulation.

For further analysis, chemical decapsulation was performed to verify if there is any anomaly on the hotspot found using a thermal emission microscope (TEM). Upon decapsulation, the burnt mark was observed on the failed unit indicating that a severe failure materialized on the unit.

Through the above analysis and study, there are no commonalities found in the failures encountered from assembly trials of the old and new formulations. The failure from the past trial encountered a current leakage on the drain to the source area and no corrosion was observed after decapsulation. Meanwhile, the failed unit on the latest trial could be a die-related failure as burnt marks are observed inside the unit.

Conduct further study using the new formulation by making more assembly trials to validate if similar failures will be encountered on other trials.
