OPTIMIZATION OF 2DID MARKING PROCESS THROUGH DUPLICATE ELIMINATION

Corina R. Urbina
Derick A. Quinto
Christian D. Tinsay

Final Test – Equipment Engineering Department
onsemi Tarlac, Luisita Industrial Park, SEPZ San Miguel, Tarlac City, Philippines
Corina.Urbina@onsemi.com
Derick.Quinto@onsemi.com
Christian.Tinsay@onsemi.com

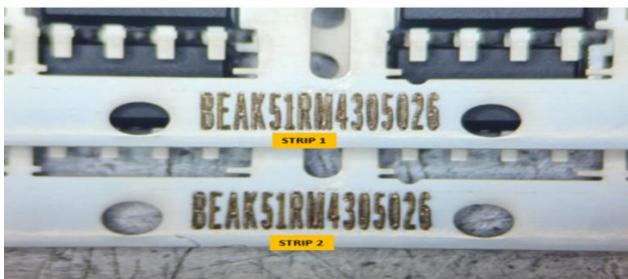
The analysis revealed that the primary root cause was a weakness in the program sequencing of the Laser marking machine – 2D01, leading to the assignment of identical 2DID codes to different lead frames. To address this software controlling the marking process was enhanced to incorporate validation checks ensuring each lead frame receives a unique 2DID. Additionally, process control improvements were implemented, including manual verification steps and training for operators and quality control personnel. Monitoring was instituted to track the effectiveness of these corrective actions.

Fig. 1. Identical 2DID codes to different Lead Frames

The software enhancement included the integration of a real-time verification logic that flags duplicate codes prior to marking. This system now checks the equipment's temporary registry and halts duplication by skipping codes already recorded during post-vision inspection.

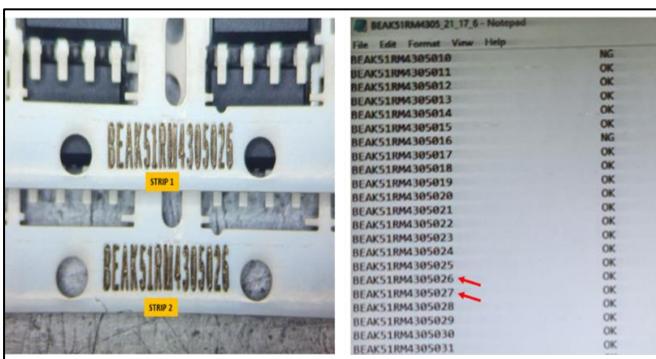
The duplicated code was physically found on two different strips, as shown in Figure 5. The mark history logs show two entries with the same 2DID, suggesting that the duplication was not detected by the system. Machine log records were reviewed, and no marking errors or hardware malfunctions were found.

Fig. 5. Actual Strips Marking vs Mark History at Machine PC

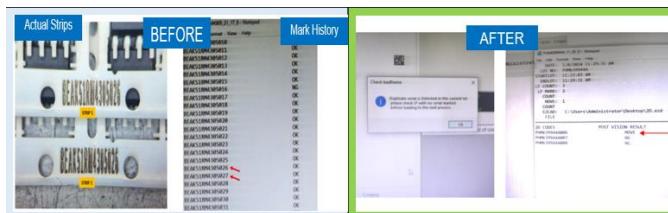
Fig. 7. Before Implementation of Corrective Actions vs After the Implementation
