RESOLVING THE METAL SPUTTERING ISSUE OF A HENE LASER

Process Engineering Department, QA FA/Reliability Department
Excelitas Technologies Philippines, Inc., LISP I, Diezmo, Cabuyao, Laguna
Maket.Lee@excelitas.com, Edgardo.Morales@excelitas.com, ChristianPaul.Maliksi@excelitas.com

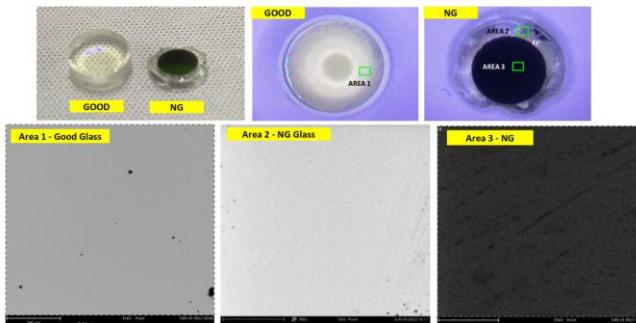
Fig. 2. Optical and SEM Images of a Good and NG lens. Images on top show the good lens (Area 1) as a transparent material while NG lens has a mirror-like deposit on the center (Area 3) and a transparent material around it (Area 2). The images on the bottom are SEM images of the 3 areas, with Area 1 and 2 having brighter image contrasts as compared to Area 3 with darker image contrast which may indicate another type of material deposited on the surface.

Table 1 showed that Area 1 from good sample and Area 2 from NG sample were found to be mainly composed of Silicon (Si) and Oxygen (O). Area 3 on the other hand, is found to be mainly composed of Nickel (Ni) and Iron (Fe) with Si and O as minor elements, confirming that another material was deposited on the center of the NG sample.

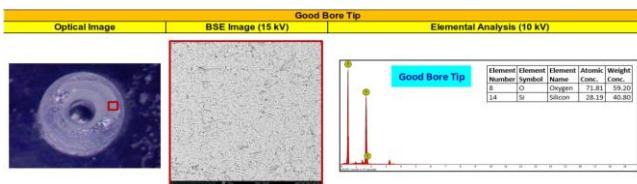
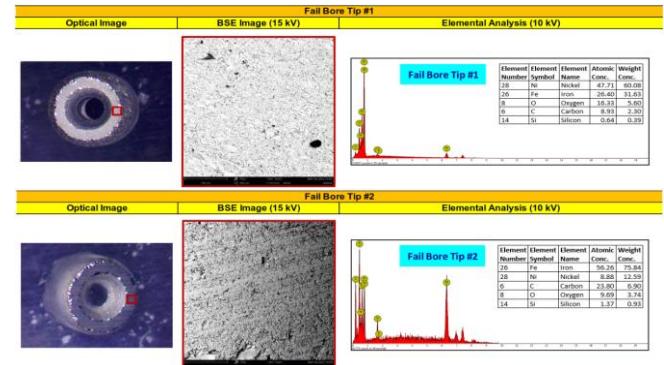
On the returned device Y (closed-cavity type), the tip of the glass bore was also analyzed using SEM-EDX. Samples for good and NG glass bore tips (sample #1 and #2) were investigated. Optical images (see Fig. 3) revealed that the good sample had a translucent, relatively even and dull tip surface while the NG samples had a translucent, relatively even and slightly reflective tip surface. SEM inspection revealed an irregular and rough surface with minimal dark spots for good samples, irregular and rough surface with few dark spots for NG sample #1 and irregular surface with indications of surface grinding with uneven topology and presence of streak lines for NG sample #2. Elemental analysis showed that the good sample was mainly composed of O and Si, while the NG samples were mainly composed of Ni and Fe, with O, Carbon (C), and Si as minor components.

Fig. 3. Optical, SEM Images and Elemental Analysis of a Good and two NG glass bore tips. Images on top show the good glass bore tip which has a translucent, relatively even and dull tip surface with elements mainly composed of O and Si. Images at the center and bottom show the NG glass bore tip samples which have translucent, relatively even and slightly reflective tip surface. SEM image of the 2nd NG sample reveals indications of surface grinding with uneven topology and presence of streak lines. Elemental analysis of the two NG samples shows that the surface is mainly composed of Ni and Fe, with O, C and Si as minor components.

Based on the results of SEM-EDX analysis on two different devices, the metal deposit found on both the AR lens and glass bore tip was mainly composed of Ni and Fe. The location of this lens and the glass bore tip were both on the cathode side of the laser. On this side, the material containing Ni and Fe was the cathode mirror-mount which was made up of alloy 4750, consisting of 48% Ni in Fe. This confirmed that the cathode mirror-mount became the target in the sputtering process that was happening inside the HeNe laser and the glass bore tip and the OC mirror or AR lens acted as the deposition substrates.

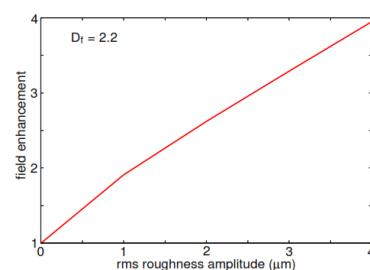
Fig 7 shows the electric field enhancement as a function of the root-mean-square surface roughness amplitude. The field enhancement refers to the ratio between the strongest electric field (typically occurring at sharp and high asperity tips) on the rough surface, divided by the electric field for flat surfaces with the same average surface charge⁶.

Fig. 7. The maximal electric field enhancement for random rough surfaces, as a function of the root-mean-square surface roughness amplitude⁶.

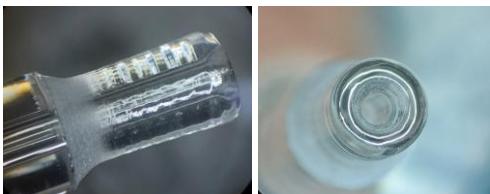
Fig. 8. Glass bore tip after fire polishing to eliminate the rough surface; left image shows the side view, and the right image is the edge of the tip.

An immediate correction developed by the team was to rework the inventory of glass bores by fire polishing the rough glass bore tip. Initially, there were 4 lasers out of 11 lots (133 lasers) which encountered metal sputtering and low power. The defect rate of metal sputtering was reduced from 7% to 3%. To fine tune the fire polishing process, a drop pin as well as microscope inspection at low magnification was added. The drop pin was to screen out potential glass bore tips which collapsed during fire polishing resulting in low power since the capillary became constricted. The microscope inspection was to screen out glass bore tips which still have some roughness on its surface to be subjected again to fire polishing (see Fig. 8). This mitigation had reduced the metal sputtering to 0%. This, however, was only effective for closed-cavity laser device Y. For devices X and Z, which were open-cavity devices, the alignment process was too difficult for the fire-polished glass bore tips.
