Utilizing Automated Manufacturing Execution System (MES) to Reduce Quality Issues due to Wrong Reel Labeling

Test Process Engineering / Quality Management & Engineering
Allegro MicroSystems Philippines, Inc.,

34th ASEMEP National Technical Symposium

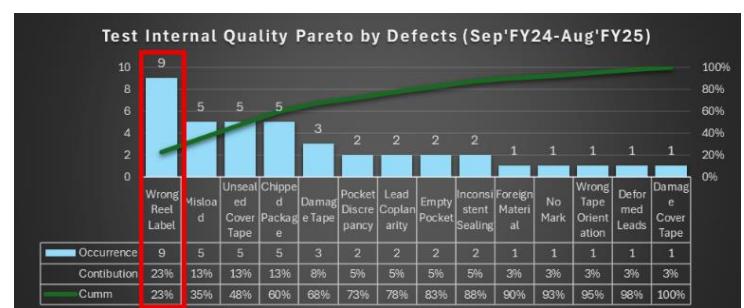
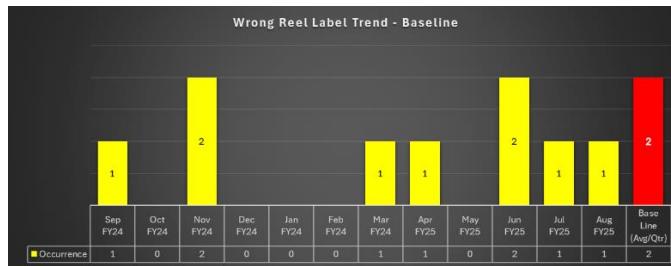
Using pareto diagram, the team used the Test Internal Quality data from the last 12 months (Sep'FY24 ~ Aug'FY25) to have more data population regarding defect contribution. With this, the team found out that “Wrong Reel Label” issue contributes 23% on the overall Test Internal Quality, averaging 2 occurrence per quarter. (see Figure 1)

Fig. 1. "Wrong Reel Label" issue contributed 23% on the overall Test Internal Quality occurrence, averaging 2 occurrence per quarter from Sep 'FY24 to Aug 'FY25.

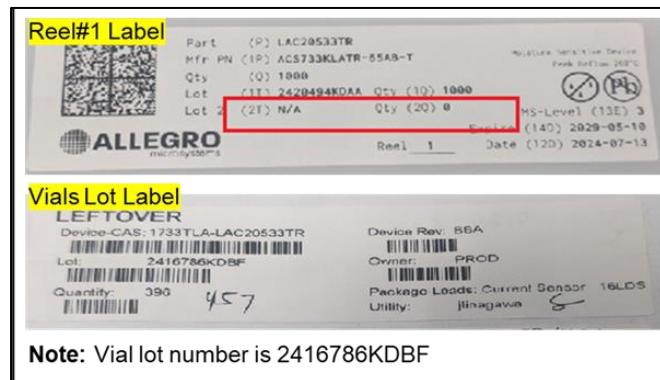
Fig. 2a. Wrong Reel Label scenario a) "No declaration of vials".

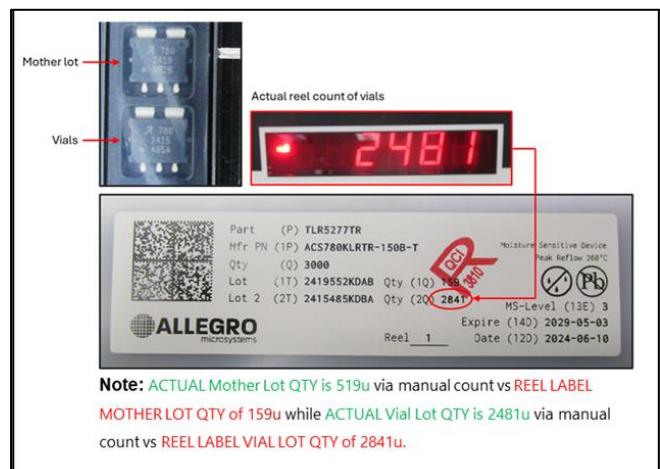
Fig. 2b. Wrong Reel Label scenario b) "Wrong declaration of Vials Quantity".

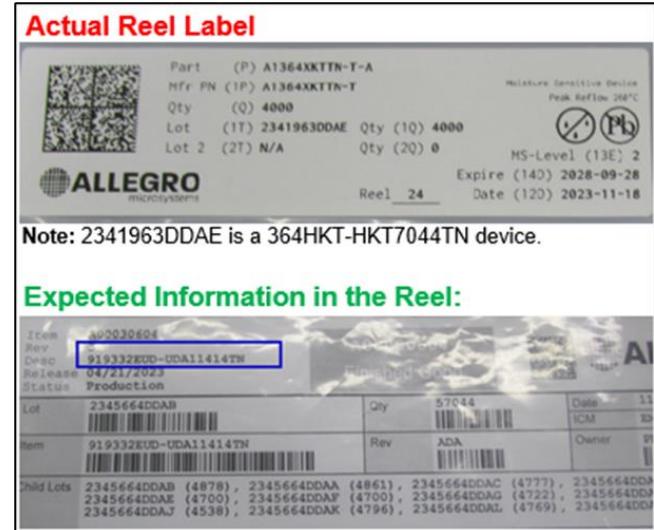
Fig. 2c. Wrong Reel Label scenario c) "Wrong part no./lot no. declared".

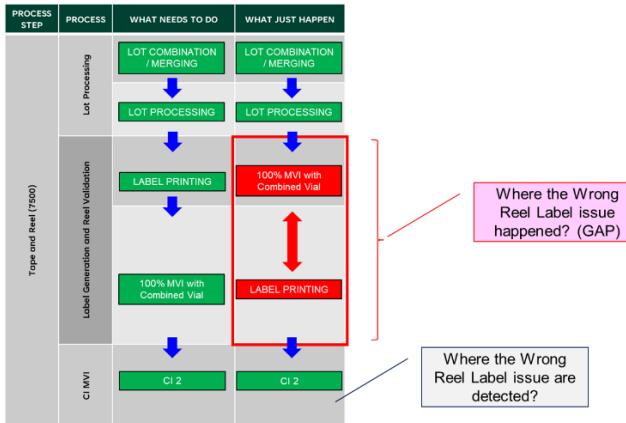
the issue comes from the Tape and Reel process across all packages, thus we used Process Mapping to further identify its cause. Its sub-process “Label Generation and Reel Validation” shows the gap we are looking for. (see Figure 3)

Fig. 3. Process Mapping tool shows that the occurrence happened during the “Label Generation and Reel Validation” sub-process of the Tape and Reel process.

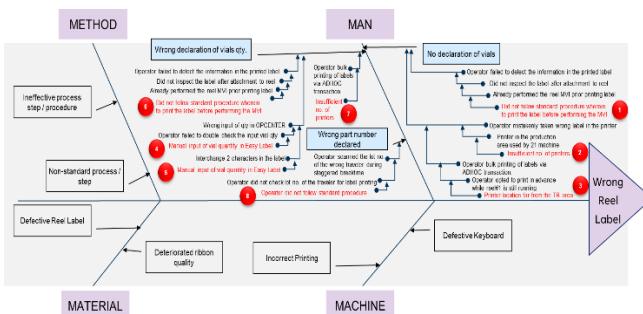
With this information, we re-group and sit-down for a brainstorming session and used the Ishikawa (Fishbone) Diagram to discuss further what we had observed during our Gemba Walk. Based on the brainstorming, we identified a total of 8 potential root causes mostly due to “Man” within the 3 Wrong Reel Label scenarios. For “No declaration of vials” scenario we found 3 (Did not follow standard procedure wherein to print the label before performing the MVI, Insufficient no. of printers and Printer location far from the TR area), for “Wrong declaration of vials quantity” scenario we found 4 (Manual input of vial quantity in label application – 2, Did not follow standard procedure wherein to print the label before performing the MVI and Insufficient no. of printers) and for “Wrong part number declared” we found 1 (Operator did not follow standard procedure). (see Figure 4)

Fig. 4. 8 potential root causes were identified using the Ishikawa (Fishbone) Diagram.

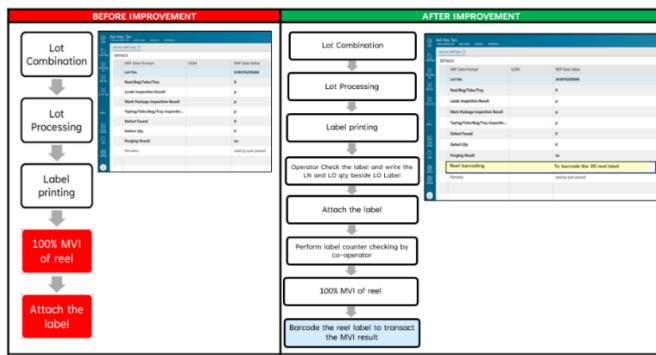
3.1 Operator did not follow standard procedure wherein to print the label before performing the MVI

To ensure that the implemented procedure will be mistake proofed, an enhancement of MES by Barcoding the reel label to transact the MVI result is added as countermeasure. (see Figure 6)

Fig. 6. To control the interchanging of process through Barcoding the reel label to transact the MVI result, an enhancement of MES by Barcoding the reel label to transact the MVI result is added as countermeasure.

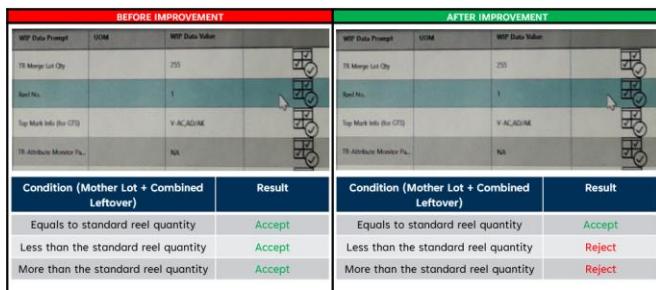
This root cause was potentially found in Wrong Reel Label scenario due to Wrong declaration of vials quantity and was validated as true root cause thru ‘Observing, Simulating and Checking in actual’, as observed and the result of simulation, it was found out that ‘Label Application default is to input vial quantity for lot with merged lot and also the system accepts anything inputted even discrepant to the quantity of vial’. The Team implemented an enhancement of control in MES to “Reject” condition with less/more than the standard reel quantity. (see Figure 7)

Fig. 7. An enhancement of control in MES to “Reject” condition with less/more than the standard reel quantity was implemented as countermeasure to ‘wrong declaration of vials quantity’.

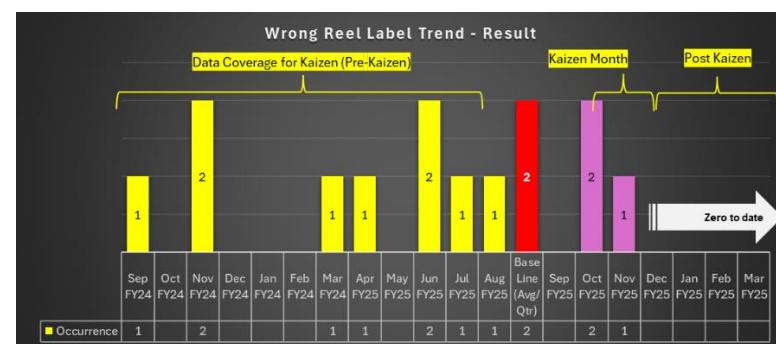
The Team aimed to reduce Wrong Reel Label issue occurrence from baseline (Sep’FY24~Aug’FY25 data) average of 2 per quarter to 1 per quarter, or 50% reduction by the end of Dec-Q3FY25. After the lean event conducted last Sep’FY25~Oct’FY25 with all the countermeasures implemented, the target reduction was achieved in Dec’FY25 and zeroed-out and sustained until Mar-Q4FY25. (see Figure 8).

Fig. 8. Target achieved by Dec-Q3FY25 and sustained zero occurrence by the end of Mar-Q4FY25.
