OPTIMIZING RETEST RATES IN TSSOP FOR SUSTAINABLE MANUFACTURING

Test Operations

Allegro MicroSystems Philippines, Inc. 4756 Sampaguita St., Marimar Village 1, Sun Valley, Parañaque City
jamanalo@allegromicro.com; mavelasco@allegromicro.com; fcarias@allegromicro.com

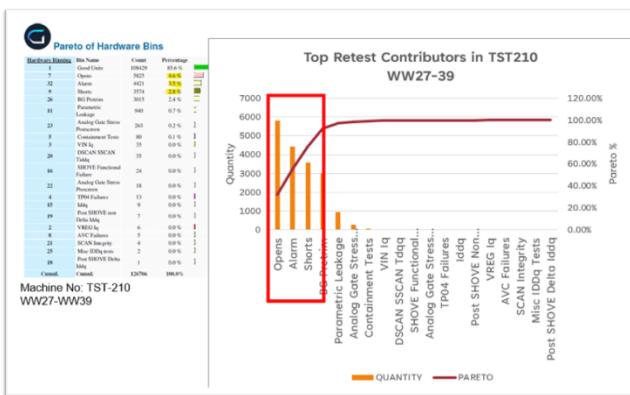
Figure# 1: Retest rate contributors

Preliminary data and root cause analyses indicate that open/short failures, alarm failures due to poor contact, and mechanical misalignments caused by plunger issues are the leading contributors to these retests. These issues often stem from factors such as test socket degradation, improper handler alignment, or insufficient maintenance routines.

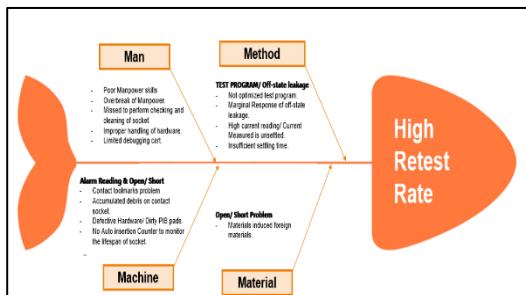
Figure# 2: Ishikawa diagram underlining potential sources of the problem

Based on the engineering expertise and experience of each team member, a structured brainstorming session was conducted to identify potential causes contributing to the High Retest rate observed in the TSSOP 814071TLV package. The outcomes of this collaborative analysis were captured in a fishbone (Ishikawa) diagram, and 5 why analysis, which was developed and finalized by the team as shown below:

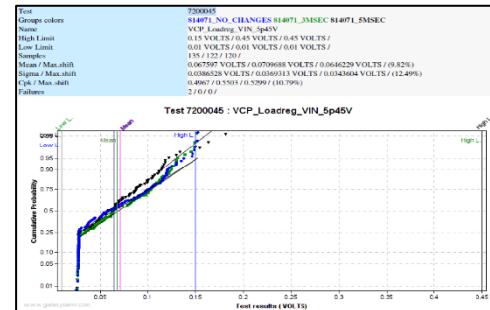
Figure# 4: VCP Loadreg VIN 5p45V Plot distribution

- **VCP_Loadreg_VIN_5p45V** – marginally failing at upper limits, the team optimize this parameter by adjusting the limits from 0.15 volts to 0.45 volts limits.

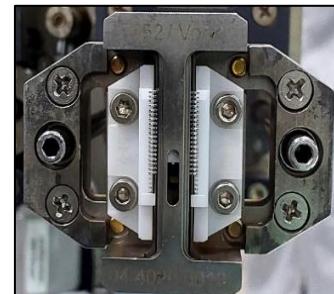
Figure# 5A: Plunger Head

Plunger Head lead support alignment in HSI, checking of contact marks alignment and plunger head condition prior production run.

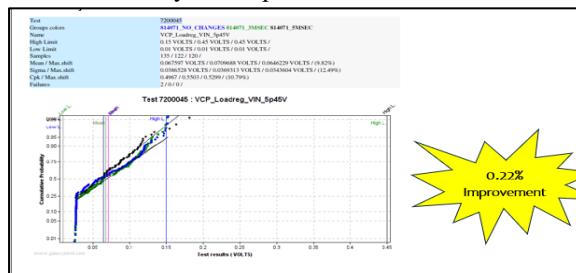
Figure# 6: VCP_Loadreg_VIN_5p45V Plot distribution

VCP_Loadreg_VIN_5p45V which has a marginal reading condition in upper limits was changed from 0.15V to 0.45V.

Results: 0.22% yield improvement from 5.71% to 5.49%

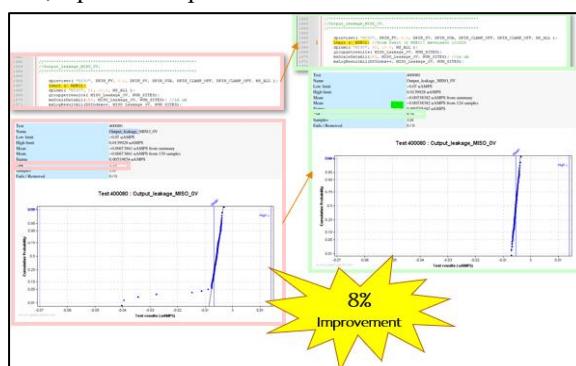
Figure# 7: Output_Leakage_MISO_0Volt settling time improvement

Characterization of settling time on forcing voltage condition of MISO pin from 2ms to 3ms.

Results: 8% yield improvement from 6.21% to 5.71% retest rate, Cpk also improved to 9.16.

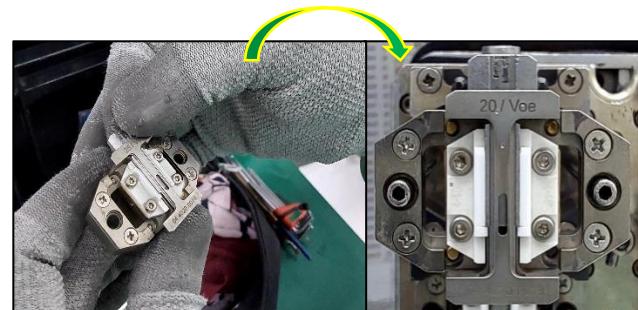
Figure# 9: Alignment Jig 5.5 mm

Introduced contact marks and alignment qualification through the usage of “lead support alignment jig” during Handler Set up Inspection process.

Results: Set up qualifications to determine the contact marks condition prior test

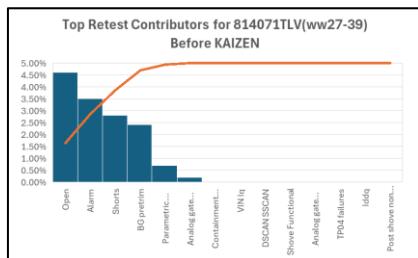
Figure# 12A: Failure Rate Kaizen

See below Failures Rates Before and After Kaizen
