ANALYSIS OF DAM CRACKS AT THE CERAMIC INTERFACE

Gilbert A. Diwa, Ricardo John D. Daluz, Rommel S. Bagarra

Analytical Testing and Calibration

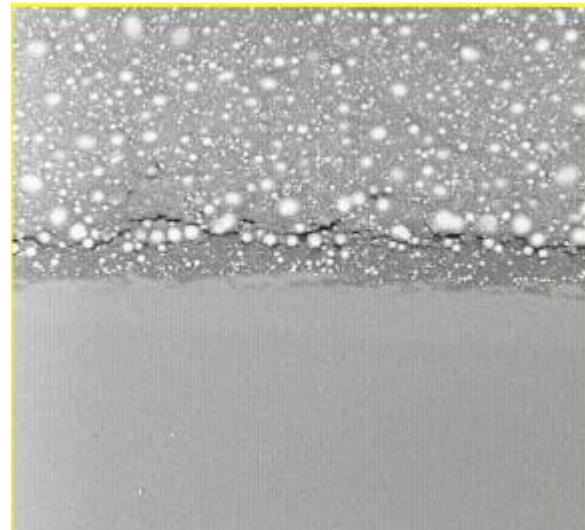
Representative SEM images of the dam-ceramic interface and dam-PCB interfaces are shown in Figures 6 and 7. The light rendered spots in the dam are the fillers.

Fig. 6. SEM image show dam crack. Dam at the upper part of the image while the lower part is the ceramic area³.

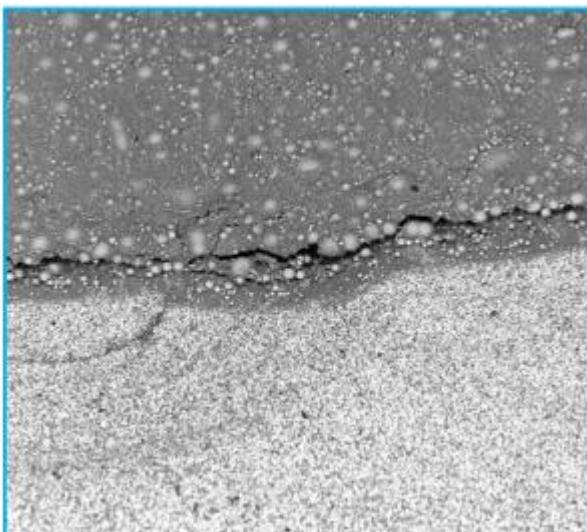
Fig. 7. SEM image show dam crack. Dam at upper part of the image while the lower part is the PCB area³.

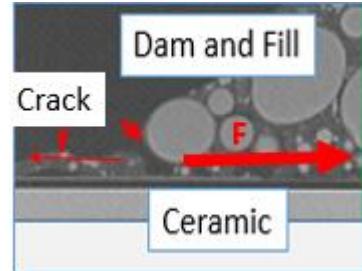
Referring to Fig. 8, the crack is observed at the fillet of the dam indicating the weakness at that point. Figure 9 shows shear forces F and f. Shear force F is attributed to the bulk

material while the shear force f is attributed to the fillet material

Fig. 9. Illustration of the interacting shear forces that resulted to the dam crack⁴.

As the composite solidifies, shrinking happens and the shear forces builds up. After reaching the solid state, the bulk material exerts larger shear force F than the fillet force f that resulted to the dam crack. The fillet's weak point is attributed to less epoxy material volume thus less mechanical strength. Moreover, the uneven distribution of the filler material in the adhesive causes mechanical weakness at the fillet area.

1. Reducing the fillet formation,
2. Reduce the shear force difference between the bulk and the fillet;
3. Reduce the filler sizes.

Gelation is first recommended to be done after dam dispense. Gelation increase the viscosity of the adhesive liquid thus reducing the fillet formation.

Second recommendation is to dispense the smallest dam volume. The small dam volume can reduce the opposing shear forces thus reducing the possibility of crack.

Third recommendation is to reduce the filler sizes to homogenize the distribution of filler thus strengthening the mechanical strength weakness at the fillet area.
