## GOLDEN LINE-DRIVEN DESIGN AND PROCESS SOLUTIONS FOR MOLD FLASH ELIMINATION IN HIGH-DENSITY WLF QFN MANUFACTURING

TI Clark Assembly Engineering Group

Texas Instruments Inc., Clark Freeport Zone, Gil Puyat Avenue, Angeles City, Philippines 2009

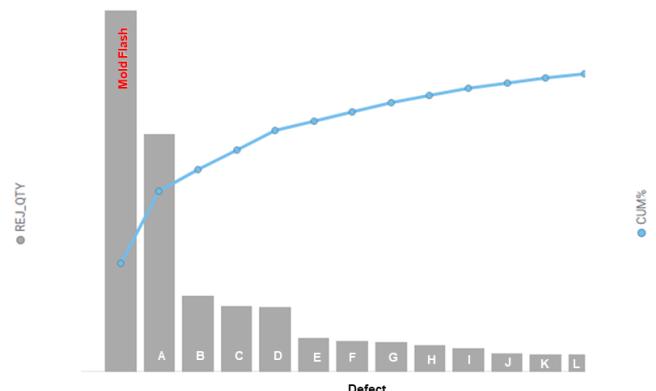
Figure 1. Wide Lead Frame Top Defect Pareto for 2024. Mold flash is seen to be one of the top defects impacting the WLF Yield.

In fact, mold flashing is the top defect contributing <5% loss to the WLF yield. Flashing occurs when mold compound flows through the gaps between the film and the lead frame during molding. These gaps may be caused by lead frame

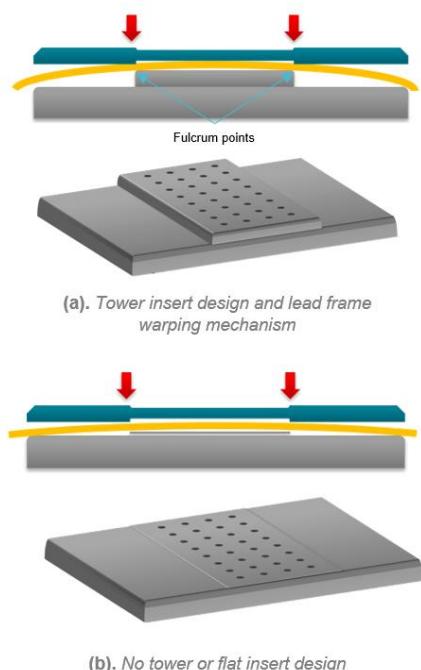
The results of the DOE on Signature A (See **Appendix 2**) revealed that the vertical flashing can be replicated through the combination of indexing and wire bonding of the Bad LF PN with dies on high tower insert. However, it is also worth noting that light flashing was also observed when the Bad LF PN was indexed through the wire bonder regardless of the heater block design; this reveals that there is some level of weakness on this particular lead frame design. Still, the use of the high tower insert aggravates the mold flashing and results in flashes that are irrecoverable even with chemical deflash.

The elevation or tower on the heater block insert instigates a fulcrum effect between the part of the lead frame that is staged during wire bonding and the parts that are “floating” on the lower parts of the insert. The edges of the tower touching the lead frame serves as the fulcrum point during indexing or clamping, resulting to buckling. This failure mechanism is illustrated in **Figure 7**.

**Figure 7.** Comparison between the clamping mechanism of (a) the high tower insert design, and (b) the flat or no tower insert design.

With this information, the interim action was to execute machine conversions to eliminate the high tower inserts installed in production. Through the exclusive use of low tower height inserts in the line in parallel with rework of high tower inserts, 25-35% DPPM reduction was already realized.

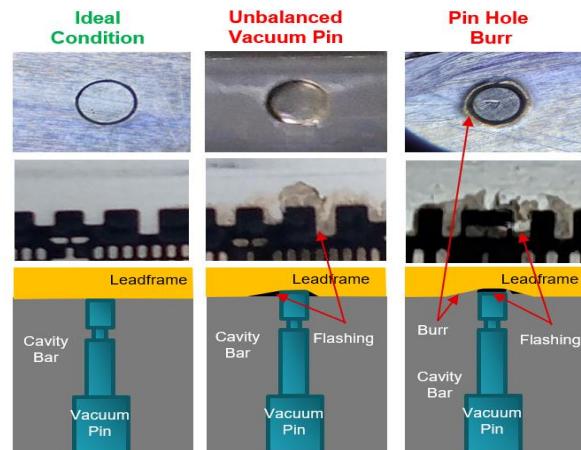
Results of the simulations showed that condition of the pin impacts the planarity of film causing mold flashing as summarized in **Figure 8**.

**Figure 8.** Pin conditions impacting film planarity.

Once the mold compound enters and clogs the vacuum pin holes, the pins may protrude and induce dents on the strip periphery, resulting to mold flashing and affecting live units as seen in Signature B.

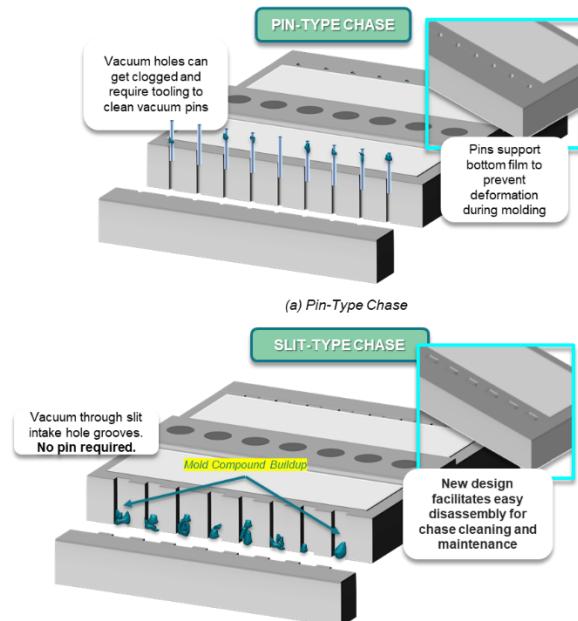
Figure 10. Comparing pin-type vs. slit-type mold chase designs.

To address the mold flash issue without compromising productivity and cycle time, slit-type mold bottom chase was designed. Instead of vacuum pin holes, intake hole grooves were used to create slits on the cavity bar. Through this design, there are no moving parts that may produce dents on the lead frame during molding. The new design also facilitates easy disassembly for chase cleaning and maintenance with the removable cavity bar. This also eliminates the risk of damaged vacuum pins which are normally induced during chase cleaning and maintenance.

The slit-type bottom mold chase design is also recommended for film-assisted molding processes. This improved design can eliminate periphery flashing caused by sinking or protruding vacuum pins and also features easy disassembly for accessibility and convenience during maintenance.

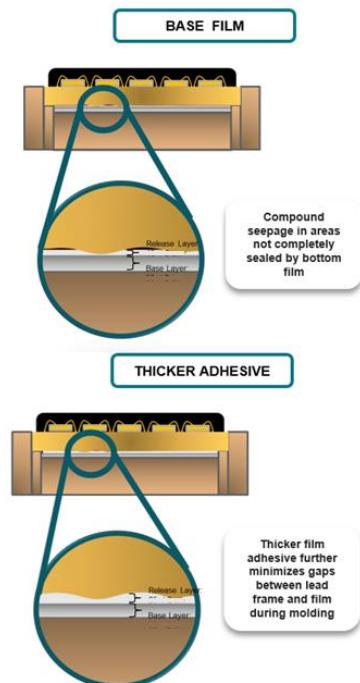
Through signature profiling and touch point mapping, the gross flashing on the leads (Signature C) was found to be mainly induced during wire bonding. Leads warping was observed due to the impact of the 2<sup>nd</sup> bond or tail-cutting at wire bond, especially with devices using large wire diameters. While the application of the specialized parameter and optimization of the stitch placement could help alleviate the warpage produced from wire bonding, additional measures can be performed to further contain and reduce its mold flashing impact.

Figure 11. Comparison between the base mold release film and mold release film with thicker adhesive.

To increase process robustness at mold, the bottom release film can be further improved. The existing bottom film has a

thin adhesive that makes it prone to slipping; however, this was resolved with the use of film holding system via bearing with one-way roller for consistent bottom film tension. Still, the thin adhesive of the base film could only offer minimal cushion for contours on the lead frame. Hence, the use of thicker adhesive release film during molding would better seal in gaps between lead frame and film to reduce risk of compound seepage.

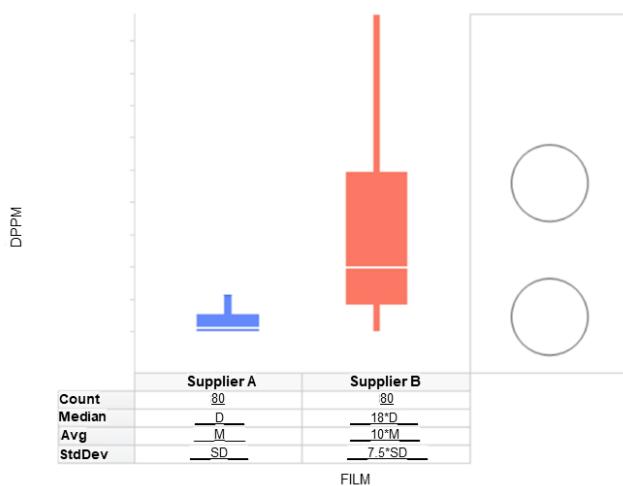
**Figure 12.** Comparison of mold flash DPPM between Supplier A Film and Supplier Film.

**Figure 12** shows the mean mold flash DPPM of M and 10\*M for Supplier A and Supplier B, respectively. Results were further analyzed statistically using the general factorial by one-way analysis of variance (ANOVA) at a significance level of 0.05.

One-way ANOVA results showed that there was a significant difference between the mold flash performance of Supplier A ( $M, SD$ ) and Supplier B ( $10*M, 7.5*SD$ ) with  $p=2.37E-006$ .

Thicker release layer can provide better support or proper holding onto lead finger to prevent mold compound sip into bottom lead and film, hence reduces mold flash.<sup>[1]</sup>

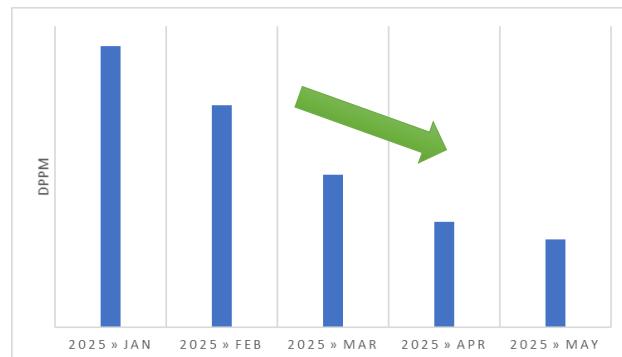
With all these key actions combined to form the golden line from Wire Bond to Mold, the mold flash DPPM dropped by 70-90% as of writing. These already translated to <5% increase in the WLF yield (see **Figure 13**).

**Figure 13.** Mold flash DPPM recovery from January 2025 to May 2025.

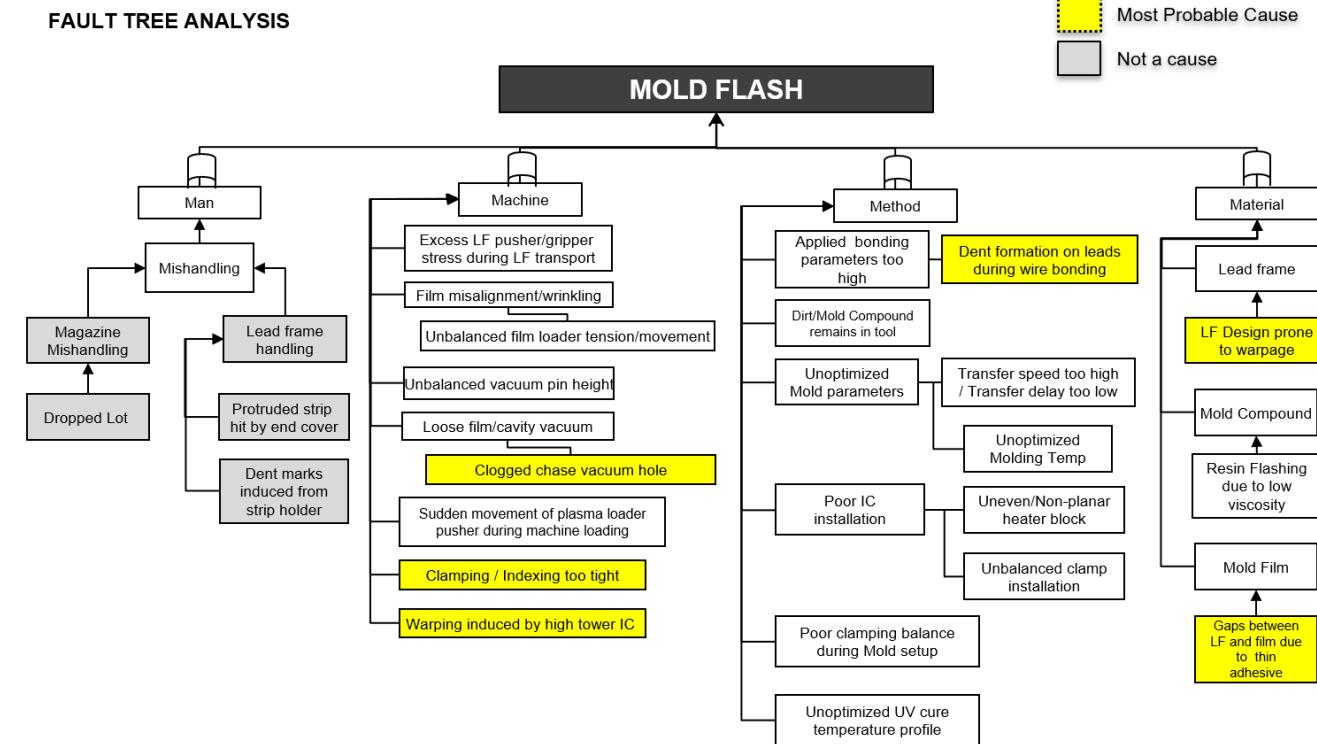
From the critical steps and factors noted from the three log points, a fault tree analysis (FTA) was built. The FTA was used as guide in the validation process to determine the most probable root causes of the top mold flashing signatures encountered, which were further categorized to be man-, machine-, method-, and material-related. (See **Appendix 1**)

**Appendix 1.** Fault Tree Analysis on man-, machine-, method-, and material-related causes of Mold Flashing.
