INVESTIGATING PACKAGE BACKSIDE SOLDER BUMPS INDUCED POST BURN-IN

Ampleon Manufacturing Philippines Inc.

ABSTRACT

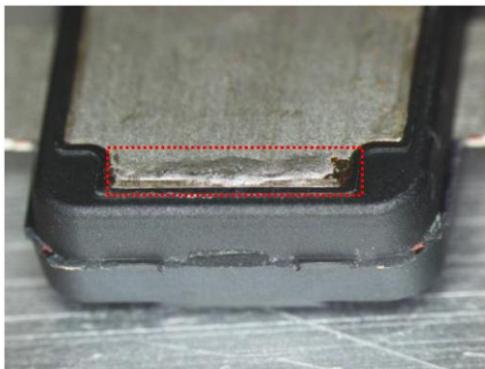
This could introduce defects that are not ideal on real-world applications. The defect seen below on Fig 1.1 shows that there is a bump seen concentrated on one of the short sides of the package. Investigating what caused the formation of this defect during burn-in is the objective of this study.

Fig 1.1 The defective sample showing unevenness on the tin plating on the backside. This was observed post-burn in.

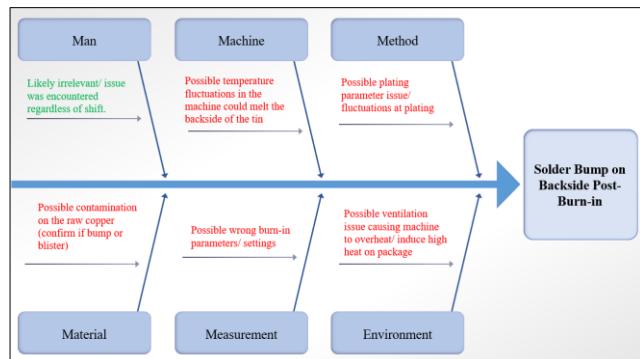
Upon encountering this issue, Defining the problem description was done using Ishikawa analysis. It was defined that the likely sources of the defect are machine (temperature fluctuation), method (plating process parameter defect), material (raw copper material defects), measurement (burn-in parameters) and environment (ventilation issues).

Fig 3.1 Ishikawa analysis done by the team for bump on backside issue.

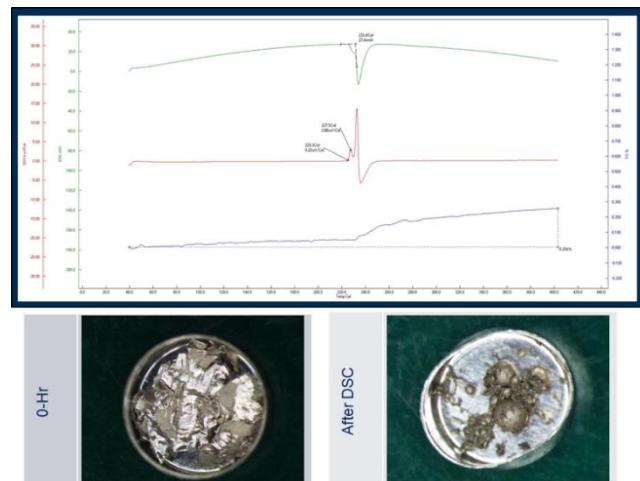
Fig 4.1 Differential scanning calorimetry curve (DSC) for the post plated tin.

For the material aspect validation. The first action was to characterize the melting point of post-plated tin via DSC. This will guide the investigation on what is the temperature limit that the tin is susceptible to deformation. The DSC (see Fig 4.1) indicated that the melting point of the plated tin is 231.6 °C. This is close to the theoretical value of pure tin. It is also noteworthy that 231.6 Celsius is a low temperature in terms of semiconductor manufacturing.

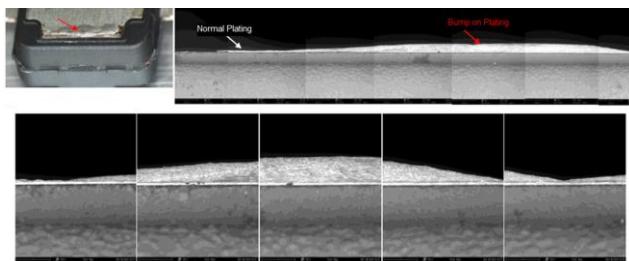
The defective sample underwent a mechanical cross section to look inside the bump on the backside. It was found to be dense and not hollow, meaning it is not a blister. This led the team to consider possible uneven plating or de-wetting due to hot temperatures.

Fig 4.2 Mechanical cross-section results done on the defect unit showing a dense bump.

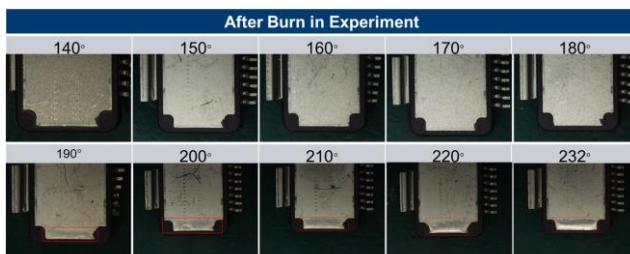
To investigate de-wetting, using the cube enclosure and hotplate setup on Fig 3.2, samples were loaded for 20 seconds for each temperature configuration. As seen below on Fig 4.3, no bumps were generated at temperatures up to 180 degrees. Bumps started appearing at 190 degrees onwards with the bump size increasing with higher temperatures. The amount of solder concentration at the bottom side increased as the temperature increased. This indicates that the amount solder deposition towards the bottom of the package increased. This formation aligns with tin deposit formations seen on the study from Kurtz et al.

This setup was able to replicate the defect seen on the burn-in load boards exactly.

Fig 4.3 Results of the heating experiment done on the heating setup. As shown, the bumps were induced with increasing temperature.

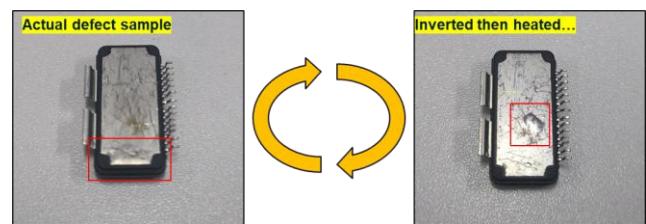
Upon replicating the defect, validation was done using the first defective unit. The sample underwent the same heat exposure at 232 °C but the bottom side with the bump is put on top. After the experiment on the actual defect sample, the solder bump moved downward which means that the defect was able to flow down at elevated temperatures.

Fig 4.4 The defect sample underwent the same heat exposure as the experimental samples.

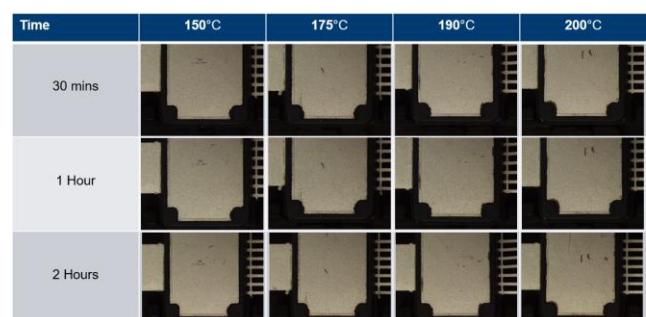
Using in-line settings on ovens, the max temperature used in Ampleon regardless of package is 200 °C. Samples placed upright (same orientation as the burn-in board) were placed in ovens to check if the tin will also de-wet. No de-wetting was observed as seen below on Fig 4.5, indicating no risk of de-wetting in ovens.

Fig 4.5 Samples that underwent over heating while placed in upright position.
