CACB RASCO JUPITER 2 COMMITTED MANUFACTURING CAPACITY (CMC) INSERTION IMPROVEMENT

ABSTRACT

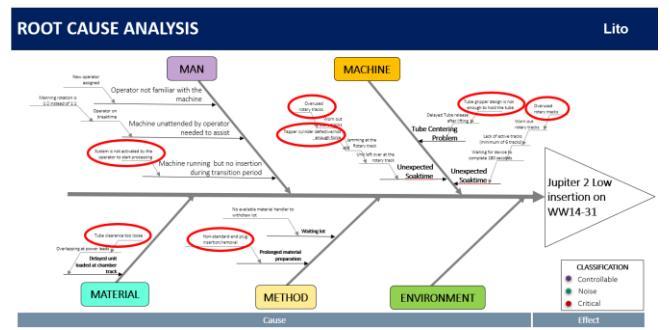
Using fishbone analysis (see Figure 4), the top contributors for low insertion at Jupiter 2 are: a) Undesired soaking time, b) insufficient impact in rotary track tapper, c) tube centering jamming at unloader, and d) shift transition of the operators.

Figure 4. Fishbone analysis showing the contributors of low insertion on Jupiter 2 hot set-up

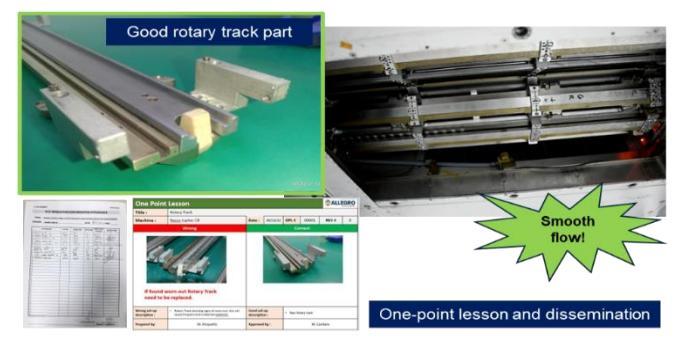
Based on the RCA, jamming is one of the contributors in terms of equipment related issue – specifically at Rasco Jupiter 2. The last machine related issue that was identified is the unusual soaking time during lot processing. Based on the investigation, it was found out that the rotary track is already worn-out that causes unit stuck up during unit flow. Statistics shows that the soak time incurred 1.09hrs/shift which was also verified as undocumented downtime.

Figure 5. Replacement of rotary track and one-point lesson

To address the issue, the rotary track was replaced to compensate with the current issue (see figure 5). Also, an OPL (One-Point Lesson) was also released stating that all rotary track tappers should be replaced to new design once found worn-out or causes unit jamming at track. This is documented under OPL#00001 Rev.0

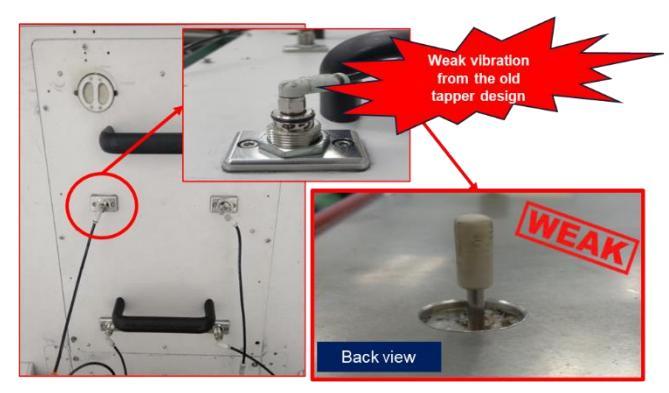
Another contributor related to soak time issue is the Tapper design by which it doesn't fully perform its intended purpose. Tapper should assist the units to smoothly pass through the track thru vibration. Current design of the tapper head is 7.5mm in diameter and 4 mm bore size of cylinder shaft (see Figure 6).

Figure 6. Old tapper design attached in Jupiter 2

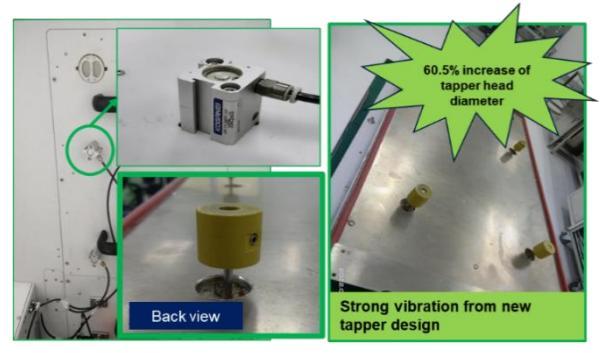
Figure 7. Improved tapper design

The team saw an opportunity to improve the design of the tapper to support the flow of units from the track during lot processing. The tapper head was modified to 19 mm diameter and 6 mm bore size of cylinder shaft (see Figure 7). Which resulted in a stronger vibration as seen during the actual verification.

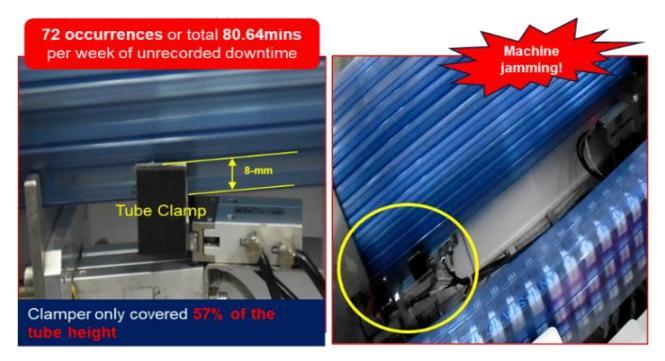
Another identified item on RCA is the tube centering problem. Current data shows that the Tube centering problem incurred 72 occurrences equivalent to 80.64 mins a week or 1.12 mins per occurrence that were not being recorded or considered as major downtime as this can be done or repaired easily by just re-aligning the tubes to the stacker. As observed, the design of the clamper greatly affects the alignment of tubes at the stacker (see Figure 8).

Figure 8. Old design of the clamper resulting to 80.64mins unrecorded downtime

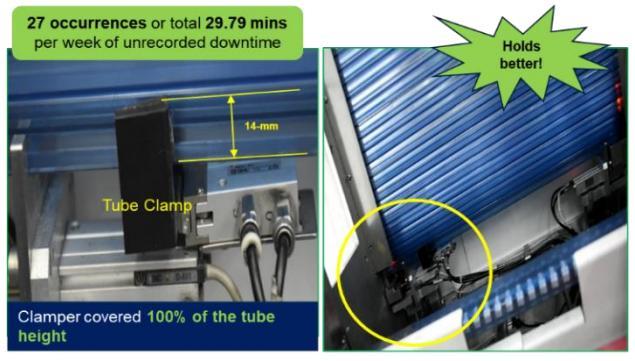
Figure 9. New design of the clamper resulting to 29.79mins unrecorded downtime or 50.85mins saved time from previous design

With this, issue was addressed by adjusting the tube clamp height from 8mm to 6mm to align with the tube height with respect to the clamp's clearance. The action was then monitored and resulted to the significant decrease in occurrences from 72 to 27 which is equivalent to 29.79 mins per week or 36% additional uptime to machine in terms for tube transport from stacker to shuttle (see Figure 9).

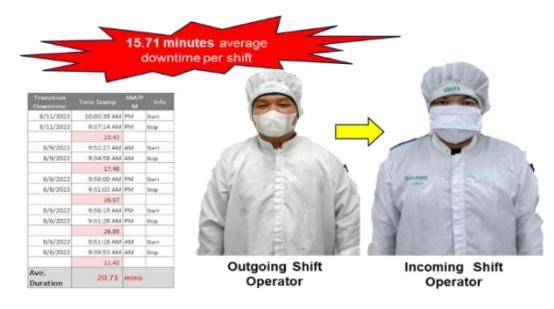
Last identified contributor was related to the method of endorsement/transition of operators from day to night shift and vice versa. It was found out that transition took 15.71 mins on the average per shift just for the endorsement itself (see Figure10). During the endorsement, machine is not in production mode thus resulting to loss of insertion.

Figure 10. Previous shift transition resulting to 15.71mins downtime per shift

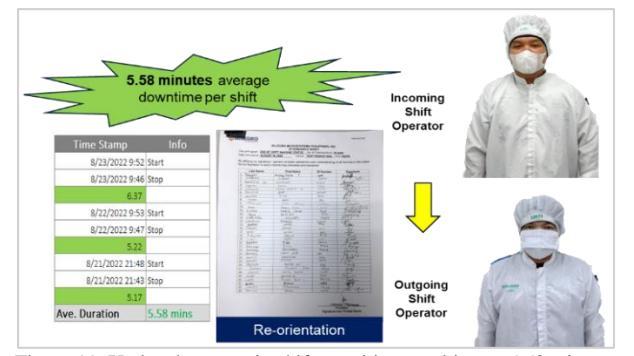
Figure 11. Updated process in shift transition resulting to 5.58 mins downtime per shift saving 10.13 mins per shift

A re-orientation was conducted to address this issue, all operators should ensure the machine is in production mode while being engaged in the endorsement. Correct machine status and the endorsement flow was also discussed by the trainers. As a result, from 15.71 minutes average downtime per shift was brought down to 5.58 minutes average per shift which is equivalent to an additional 35% uptime on the machine (see Figure 11).
