# DEEP-DIVE INVESTIGATION ON PAD DISCOLORATION ISSUE IN OPTICAL SENSING DEVICE

Assembly Manufacturing STMicrolectronics Inc., Calamba Philippines #9 Mountain Drive, Light Industry and Science Park II, Brgy La Mesa, Calamba City, Laguna Philippines 4027 rhodora.yu@st.com, jesse.jagape@st.com, emiliana.antonio@st.com

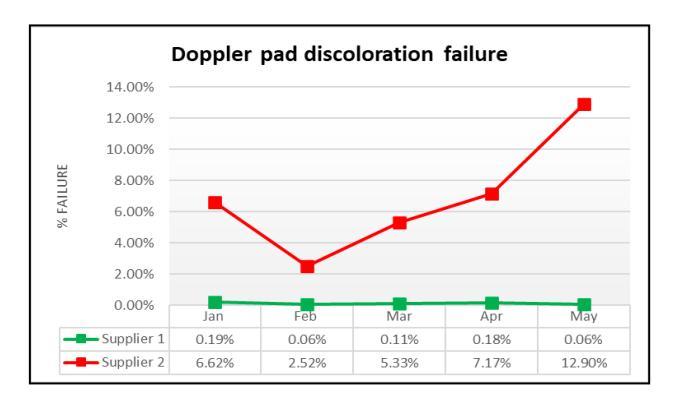
Fig 3. Doppler Pad Discoloration Monitoring

Further investigation showed that among the two substrate suppliers, only Supplier 2 contributed to low yielding lots which affected the yield target as per Fig 3.

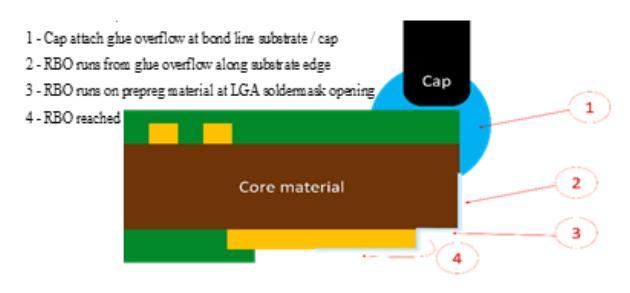
Fig 4. Resin Bleed Out mechanism

Figure 4 shows the resin bleed out mechanism that caused the pad discoloration. After epoxy dispense on the substrate, the cap will be attached causing the glue to overflow at the bond line & cap interface. After which, the epoxy resin will continue to flow along the substrate edge down to the prepreg material at LGA (Land Grid Array) solder mask opening until it reaches the gold pad.

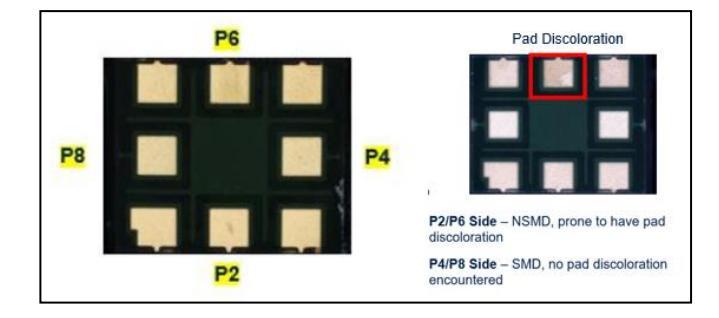
Fig 5. Doppler Pad Discoloration Monitoring

P2/P6 side of the substrate are NSMD (non-soldermask defined) which is known to have RBO during processing. P4/P8 side of the substrate are SMD (soldermask defined) which have zero occurrence of RBO on LGA pad.

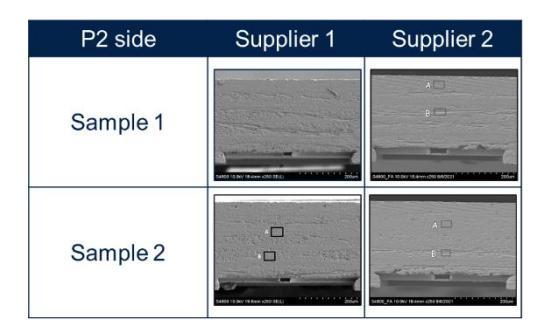
Fig. 7 shows the comparison of sidewall morphologies. Based on the SEM (Scanning Electron Microscope) images, the sidewall of Supplier 1 is relatively rougher than Supplier 2. To validate the condition of the layers, both Pad 2 (NSMD) and Pad 4 (SMD) sides were cross-sectioned. The sample SEM images of before and after cross-section are shown in Fig. 8.

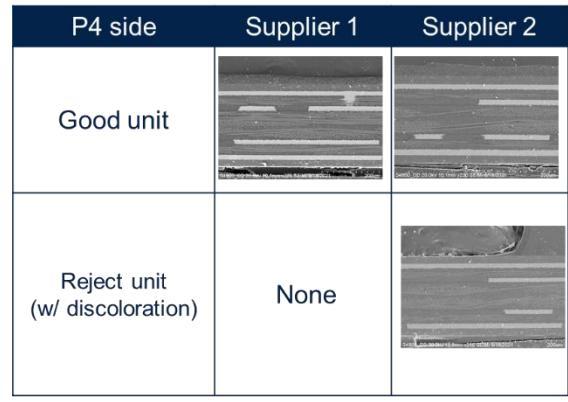
Fig 10. Cross-sectioned sidewall at P4 Side.

The SEM images of P4 side cross-section are presented in Fig 10. A change in glass fiber density was observed; Supplier 1 now has higher glass fiber density compared to Supplier 2 at P4 side. In addition, the horizontal fibers in Supplier 2 appeared to be wave like as compared to Supplier 1 in P4 side. This wave-like condition is present also in Supplier 1 P2 side.

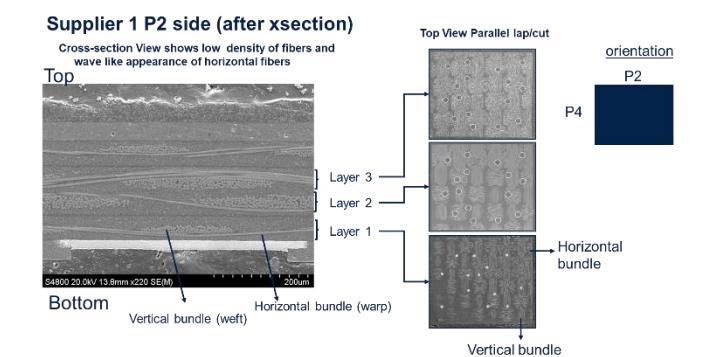
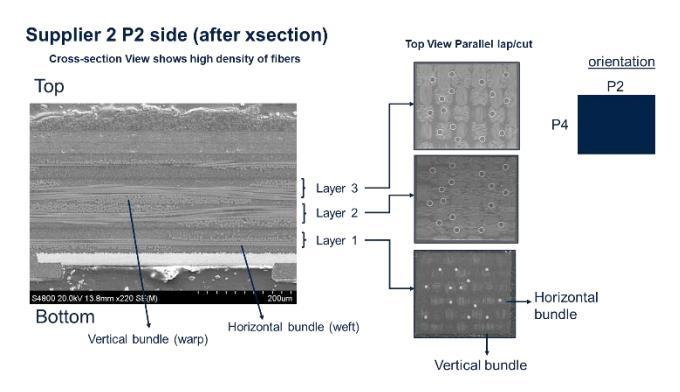
Fig 12. Glass fiber orientations for Supplier 1 and Supplier 2.

Based on the result, there is a significant difference between the glass cloth orientation of the substrates. Supplier 1 has narrower vertical bundles while Supplier 2 has narrower horizontal bundles. This was verified also on the bundle width measurement shown in Fig 15. This difference played a key role in the morphologies of both substrates. The narrow vertical bundle at Supplier 1 produced a lower density of fibers and wavy-like appearance on the side wall, which may have helped to make the sidewall rougher and slow down the resin bleed out at P2 and P6 sides.

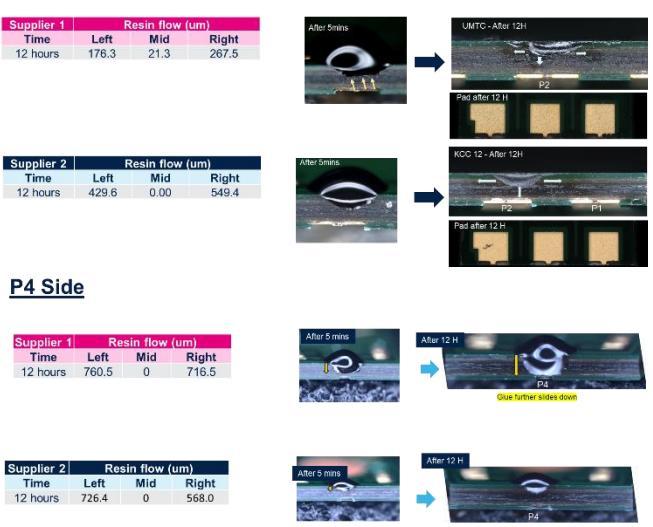
Fig 13. Simulation of RBO at P2 and P4 sides.

Based on the results below, resin bleed travels slower at Supplier 1 (wave like fiber) than Supplier 2 (high dense fiber) at P2 side.

At P4 side, resin bleed travels faster at Supplier 1 (high dense fiber side) compared to Supplier 2 (wave like fiber side).

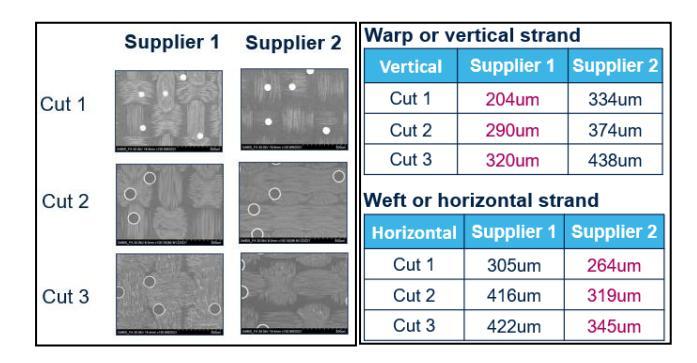
The parallel cut was done in several samples from both Supplier 1 and Supplier 2 to be able to measure and compare the bundle width with respect to orientation. Based on the results:

- Supplier 2 have relatively wider warp bundle width compared to Supplier 1.
- Supplier 2 have smaller weft bundle width compared to Supplier 1.
- Based on this data, considering they have the same source of fiber cloth, we can deduce that Supplier 1 is 90 degree rotated. This rotation determined the difference in morphology of the side wall.

The authors recommend to consider this learning in the design of the substrate's LGA pad (SMD and NSMD) with respect to PP construction.

Fiber cloth orientation must be considered, likewise, during substrate process design when doing the device qualification.

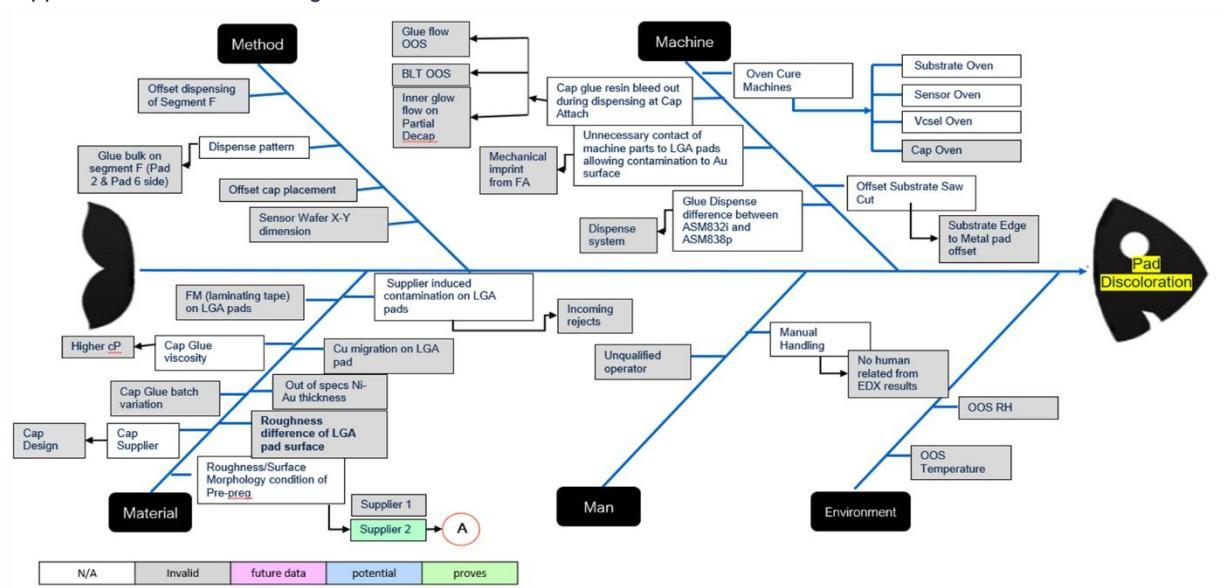
### Appendix A- Fish Bone Diagram

From the fishbone diagram (Appendix A), the potential root cause identified is related to the substrate material that needs further investigation. Table 1 shows the validations made for the substrate material. Based on assessment, glue flow is influenced by sidewall morphology.
