LEADFRAME TAPE DE-REEL PREVENTION AT WIREBOND MACHINE THROUGH SENSOR INTEGRATION

Integrated Lines Operations 1 STMicroelectronics, Inc. 9 Mountain Drive, LISP 2, Calamba 4027 Laguna, Philippines, bernard.zamora1@st.com, eric.espino@st.com, julius.andal@st.com

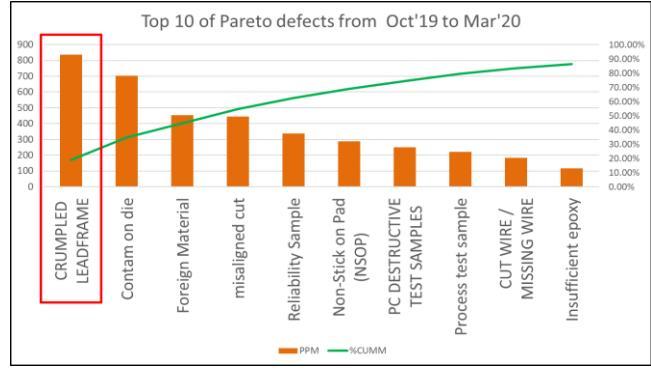
Analyzing the Yield detractor, it shows that crumpled Lead frame tape due to de-reeled lead frame at Wirebond process is the top defect in pareto chart as shown in Fig.2

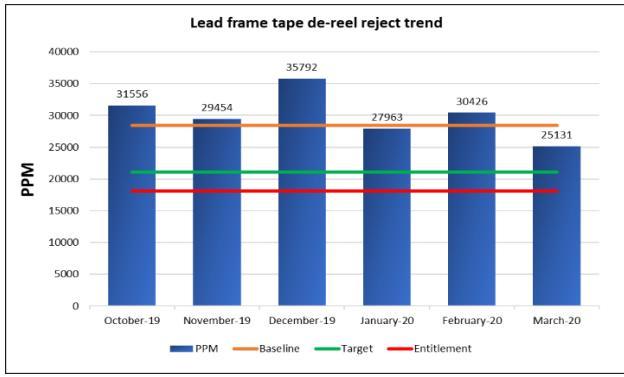
Fig. 3. Lead frame tape de-reel PPM from Oct 2019 to Mar 2020

Figure 3 shows PPM trend of lead frame De-reel at Wirebond averaging 21038 PPM for Micromodule devices from October 2019 to March 2020. The target is to reduce the crumpled leadframe PPM level to 19892 PPM.

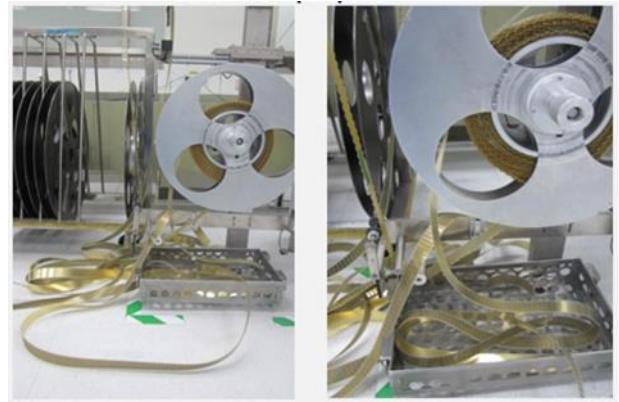
Fig. 7. De-reel Lead Frame tape event at Wirebond

Fig. 7 shows the event of de-reel lead frame tape at Wirebond. This scenario happens at input/output of spooler, where the sensor encounters malfunctioning resulting to continues stepper motor movement. This machine malfunction will cause the lead frame tape to slide into the floor where bonded and unbonded units hit the hard surface.

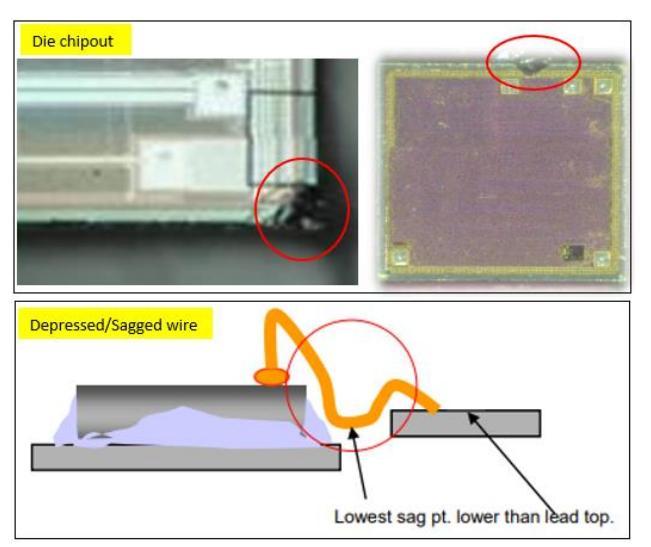
Fig. 8. Lead frame tape de-reel defects.

The assembly defect manifestation was encountered after dereel at Wirebond which is failed at Final test and potential customer complaint as shown in Fig.8

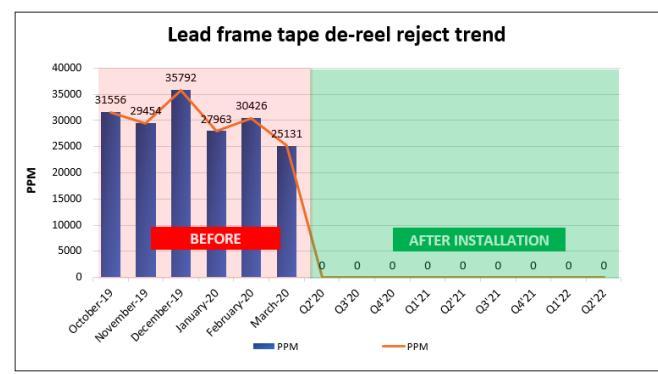
Fig. 16. De-reel event trend after installation

Graph shows at fig 16 that after the implementation of best solution, the lead frame tape de-reel event at Wirebond was eliminated starting April 2020 to June 2022.
