# REDUCTION OF OVER REJECTION AT 5 SIDES VISION OF TEST & TAPE MACHINES

Jiannina Zocor B. Manalo

Test Process Engineering Onsemi, Tarlac, Luisita Industrial Park, SEPZ, San Miguel, Tarlac City Jiannina.Manalo@onsemi.com

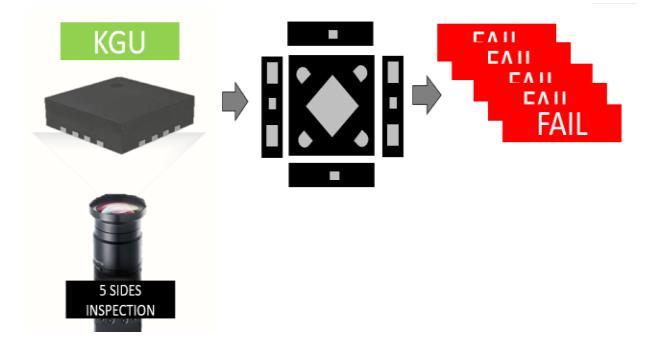
Fig 3 Illustration of 5Sides vision over rejection showing repetitive inspection conducted on a KGU with a consistent Fail judgement.

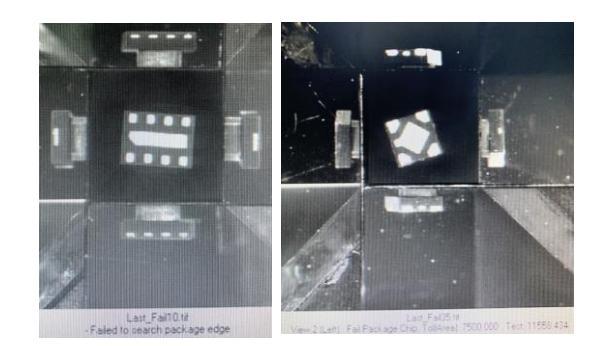
Fig 4 Actual KGU that were rejected under 5Side Vision inspection.

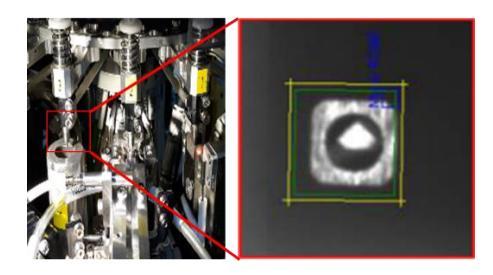
PUH (Pick up head) is the arm of an integrated machine that picks up each unit and transport it to each part of the machine sequentially until test and tape sequence is finished. A Clogged pickup head condition during lot processing results to a misaligned unit due to insufficient and ineffective suction to unit in place. The clogging occurs when there is dirt accumulation inside the Pick up head. Any misaligned unit during vision inspection is automatically declared as reject. Thus over rejection occurs.

Through actual machine checking and performing ON/OFF test, it was confirmed that clogged pick up head resulted to over rejection of units on 5Sides inspection.

Fig 7 Bottom view of a clogged pick up head with dirt blocking the vacuum from the machine that holds up the unit.

4.2 Clogged Pick Up Head: Activation of Automatic checking and cleaning of Pick up heads.

Machine automatically stops when Purge due cycle limit was reached prompting an error message shown in Fig 17. The lot processing will not resume unless cleaning of PUH was conducted. Also, this feature was already hardcoded and can not be disabled.

The implementation of the action was effective in eliminating clogged pickup heads resulting to 5Sides over rejection. No recorded case of low yield after action implementation.

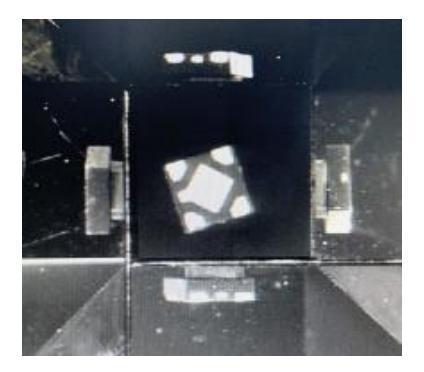
Fig 9 Misaligned unit during 5Sides vision inspection held by a clogged pick up head.

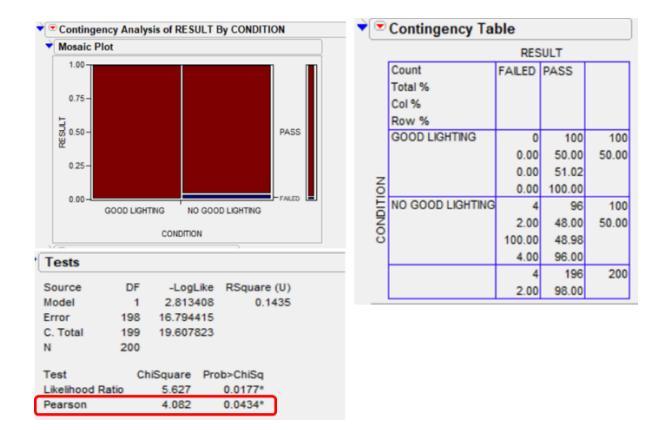
Light setting plays a vital role in any automatic vision inspection. No good light setting results to over rejection

since appearance of unit subjected to inspection is affected, thus impacting vision judgement.

Fig 10 Hypothesis Testing using Chi-square test shows that there was a significant difference on vision judgement during No good lighting and good lighting.

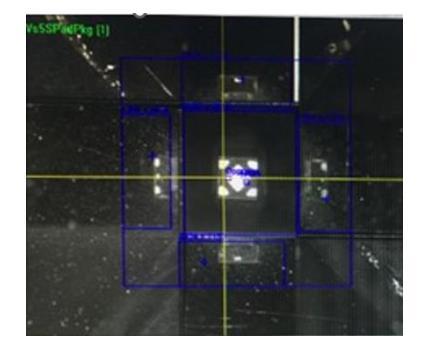
Historically, low yield on 5Sides inspection encountered due to camera misalignment. By performing an ON/OFF Test, it was also proven that misalignment, uneven camera focus resulted to improper centering of unit ROI (region of inspection) vs FOV (field of view).

Fig 13 The appearance of unit under inspection with uncentered Region of inspection (ROI) vs Field of View (FOV)

The ROIs (region of inspection) was centered and secured as shown on Fig 20 thus eliminating over rejection due to improper centering. Access on this part of vision settings was also limited to engineering level only.

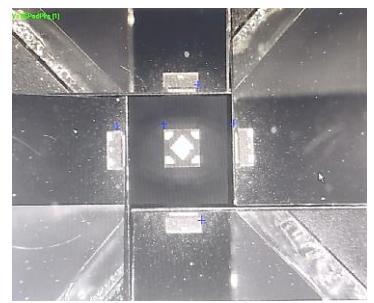
Foreign materials appearing along with the unit during inspection results to fail judgement. This is due to some foreign materials appear as added leads/pads and some appears to be white defects on package. Thus another reason of over rejection.

Reviewing the historical machine record, frequent occurrence of 5Sides over rejection was noted due to dust particles observed during inspection. Also, during ON/OFF test, it was proven that dirty Prism or 5D mirror automatically results to a rejection. The activity on cleaning the 5D was also human dependent and should conducted periodically to prevent accumulation.

Fig 14 Dirty 5D mirror due to dust accumulation

Cotton swab shown on Fig 21 was identified as a proper cleaning tool of 5D mirror / prism. This activity was integrated as part of Standard operating procedure of FLA (First Level Analysis) group and performs 5D mirror cleaning and physical condition check once a week.

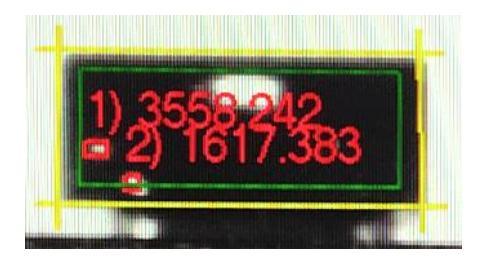
Fig 16 Rejection on Top side of the device package due to the detected foreign material which are physically attached to the Prism and not to the unit being inspected

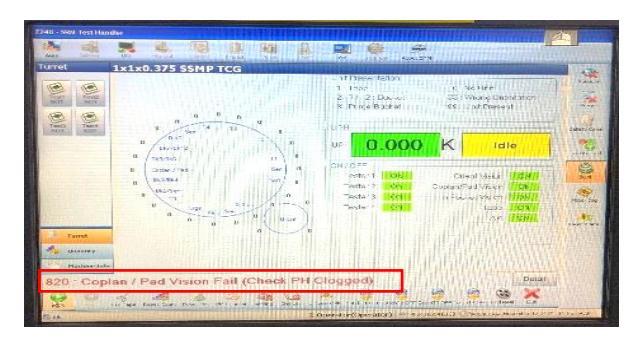
Fig 17 Actual machine alarm message during Pick up head purging and auto-cleaning.

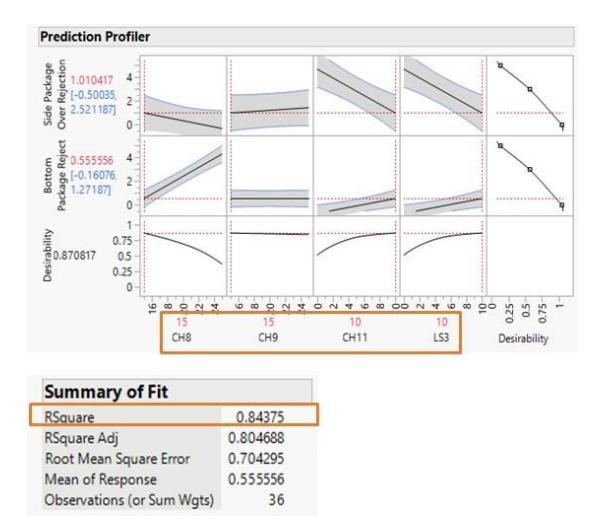
Fig 19 Optimized light setting for CH8, CH9, CH11 and LS3 saved on inspection recipe.

Recommended light setting for optimum 5Sides Vision inspection performance as shown in Fig after parameter characterization thru DOE was identified and reflected on recipe. Take note that in every lot number barcoding, the recipe will automatically be applied, and no human adjustment is needed on the setting.

The result of evaluation lots revealed that the set values for four (4) light sources, CH8 = 15, CH9 = 15, CH11=10 and LS3=10 were effective since the overall result of over rejection was 0 PPM.

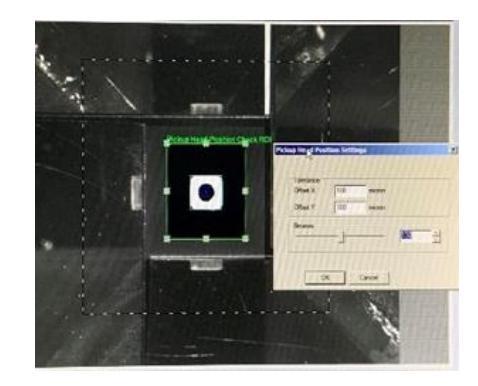
Fig 20 Properly centered pickup head vs device ROI vs FOV

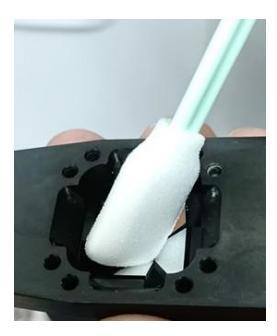
Fig 21 cotton swab for 5d mirror cleaning

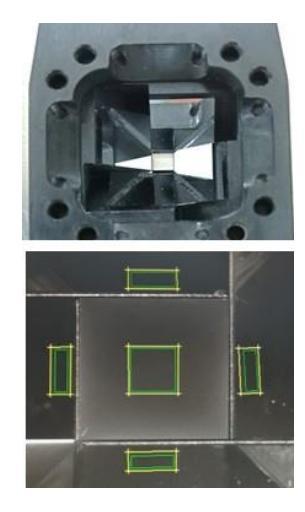
Fig 22 A dust-free 5D mirror and its appearance on vision.

Action implemented prevented the over rejection caused by accumulated foreign materials on 5D mirror surface.
