REDUCTION OF OVER REJECTION AT MARKING, ORIENTATION, AND PACKAGE (MOP) VISION INSPECTION OF DEVICE X

Test Process Engineering onsemi Tarlac, Luisita Industrial Park, SEPZ San Miguel, Tarlac City, Philippines Einna. Tadeja@onsemi.com

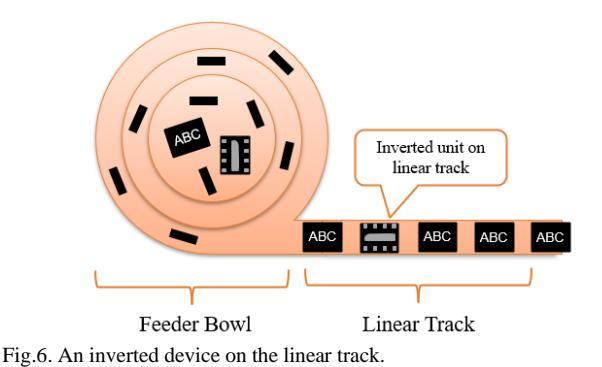
The feeder bowl is where untested units are poured before it is picked up and placed on the MOP Vision Table for inspection. Before the device is picked up, it passes through the linear track, but it should already be on the correct position where the marking is facing upward (see Figure 6).

By using ON/OFF test, different speed rotation of feeder bowl was set during operation. Through this, it was validated that high speed rotation of feeder bowl can cause Over Rejection at MOP inspection.

The validated speed rotation of the feeder bowl for Device X was documented on the machine setup checklist. This is, to imply that Device X has a certain speed rotation to be followed compared to other devices processed on the machine.

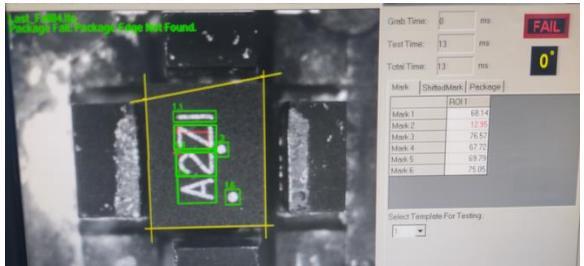
Vision system parameters play a vital role during inspection. Unoptimized parameters result to unreliable data of judgement of good and no good units. Over rejection due to vision system failing to detect the package edge was experienced. To validate that vision settings are the root cause of the issue, Characterization DOE (Design of Experiment) was performed. Appendix B presents the data collected during DOE. KPIV that Unoptimized Vision Settings are found to be valid based on the different test from the DOE.

Fig.7. A known good unit (KGU) that failed MOP Vision Inspection. Failure was that the vision system failed to detect the package edges.

Optimization DOE was performed to determine the optimized Vision settings that will result to less/no Over Rejection. Figure 11 presents that at View 2 lighting of 255 and all sides package thresholding of 55 is the optimal vision setting for Device X.

Fig. 11. View 2 lighting of 255 and all sides package thresholding of 55 is the optimal vision setting for Device X.

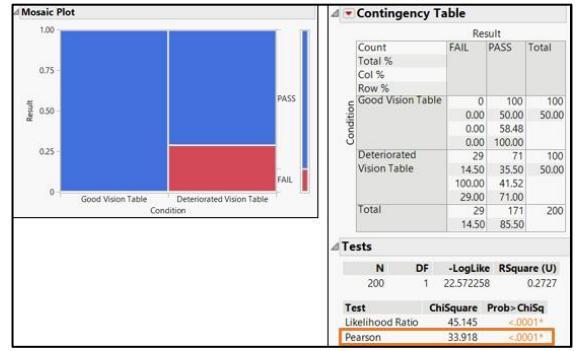
The result of the Chi-Square test is presented on Figure 8. P Value is at <0.0001 meaning that there is a significant difference between Good vs Deteriorated Vision Table on occurrence of Over Rejection.

Fig. 8. Chi Square test resulted to a p-value of <0.0001 proving that Deteriorated Vision Table causes Over Rejection at MOP inspection

From the Chi-Square test conducted during validation, the corrective action was to replace the deteriorated vision table to a new one.

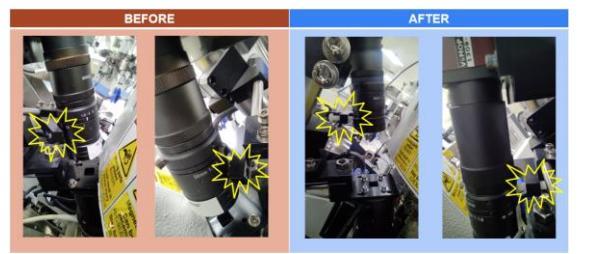
Historically, there were reports that low yield issues were encountered due to blurred marking captured by the MOP inspection camera. Upon checking of actual units, no blurred marking was observed. The root cause of the blurred marking was found out to be due to uneven camera alignment/focus. Thus, validating our claim that Un-even camera alignment/ focus can cause Over rejection at MOP inspection.

Fig. 9. Before (left photos) implantation of Corrective action, MOP camera supports are missing. After (right photos) shows marking camera with the 3D printed supports.

To address the uneven camera alignment of MOP inspection camera, a 3D print of the MOP camera support was made. A sample illustration of the Before and After implementation is shown on Figure 9.

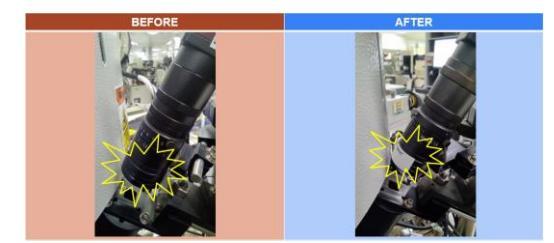
Fig.10. Seal is attached on MOP camera to prevent tampering/adjustment during operation.

Another Corrective Action was implemented to address the uneven camera focus causing over rejection. This is to attach a seal on the MOP camera lens to avoid tampering/ adjustment during operation (see Fig.10).

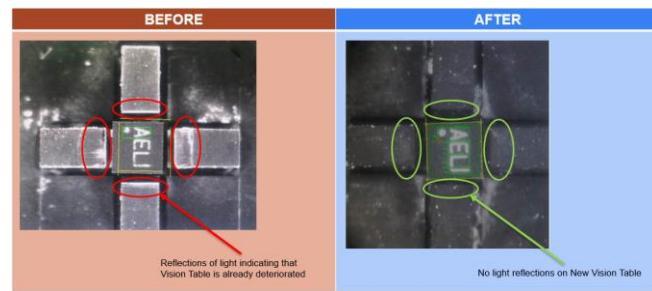
Fig. 12. On the left is the image captured with Deteriorated Vision Table where package edge was not correctly detected by vision system. While on the right is the one using a new vision table. The package edge is detected correctly.
