REDUCTION OF 3RD OPTICAL INSPECTION YIELD OFF AND FALLEN UNITS AT GTS FRONT OF LINE

ABSTRACT

32nd ASEMEP National Technical Symposium

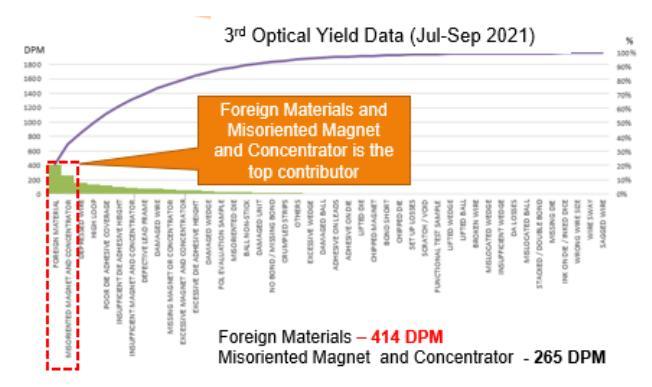
Fig. 3. - 3rd Optical Yield Data Pareto Diagram

Based on Pareto Diagram (Fig 3) of 3rd Optical Inspection, Foreign Materials (21%) and Misoriented magnet with concentrator (14%) are the top contributors that cause from not hitting the target yield.

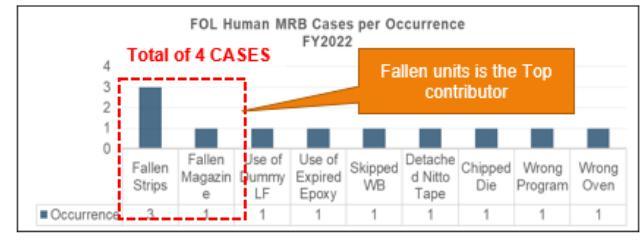
Fig. 4. - Human Related MRB Pareto Diagram

For Human Related MRB Pareto Diagram (Fig 4) shows that Fallen Units are the top contributor.

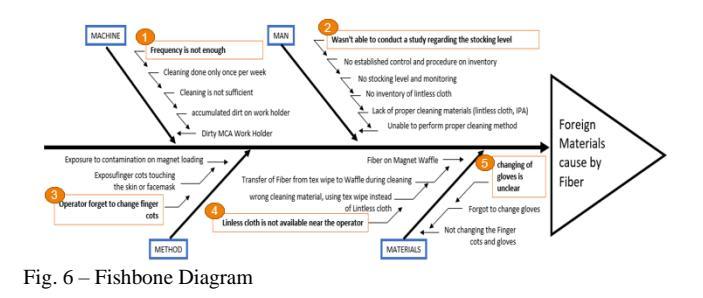
Using Fishbone Diagram (Fig 6) the team identified five possible causes of foreign materials which falls under Machine, Man, Method and Materials. Under Machine (1) Frequency of cleaning of work holder was not determine, under Man No stocking level for Lint Less Wipes that why operators tend to (2) use the Wrong Wipes, under Method Operator forgot to change gloves because there is (3) no clear rules for changing, and under materials (4) Lint Less Wipes is not available near the operator and (5) changing of Gloves is unclear.

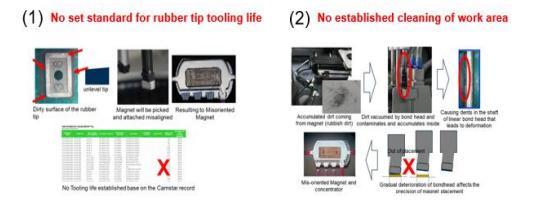
Fig. 8 - Root Causes of the problem misoriented magnet and concentrator

As the team dig more into our investigation of misoriented magnet and concentrator, the team identified the causes of the problem which is worn out rubber tip because the frequency of rubber tip change was not determined and accumulated dirt at work area. The team concluded that Misoriented Magnet (1) no set standard for rubber tip tooling life and (2) no established cleaning of work area.

No.	Problem	Improvement	
1	Worn out Rubber Tip Bond head	Establish Rubber Tip Tooling Life	
2	Accumulated Dirt inside MCA machine	Establish MCA Work Area Cleaning	
3	No checking of actual Strips during Post Bond Error	Check actual strip every post bond error

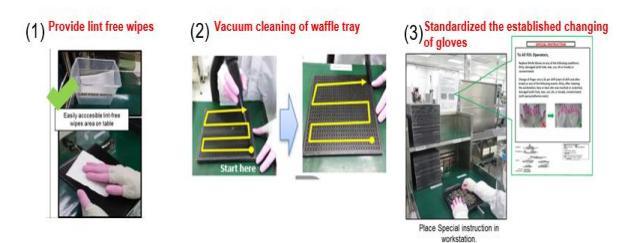
Fig. 10 - Kaizen actions for foreign materials

After the Root Cause Analysis (RCA), the team have confirmed the root causes of the problem foreign materials on which occurs at Magnet and Concentrator Attach process and caused by (1) wrong cleaning materials and no available lint less wipes, (2) established system of cleaning of waffle trays was not enough to remove fiber inside tray and (3) changing of gloves was not clear.

No.	Problem	Improvement	
1	Wrong cleaning materials and no available lint less wipes	Placed Lint Less Wipes at the working station	
2	Fiber Inside Waffle	Install Vacuum for Magnet Waffle cleaning	
3	No Clear frequency of changing of gloves and finger cots	Provide Clear rules of changing of Gloves and Finger Cots

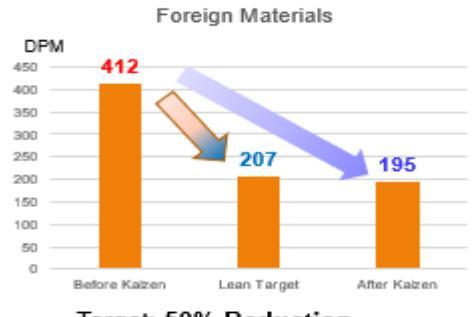
Target: 50% Reduction After Kaizen: 53% Reduction Fig. 13 – Foreign Materials Reduction after Kaizen Result

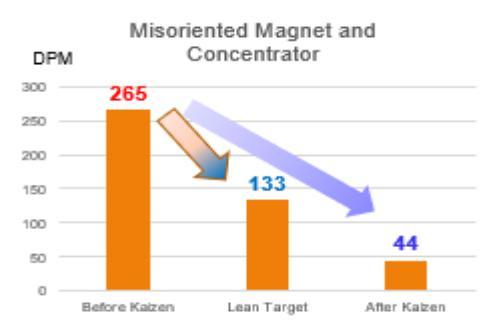
Fig 14 – Misoriented Magnet and Concentrator after Kaizen Result

Target: 50% Reduction After Kaizen: 83% Reduction

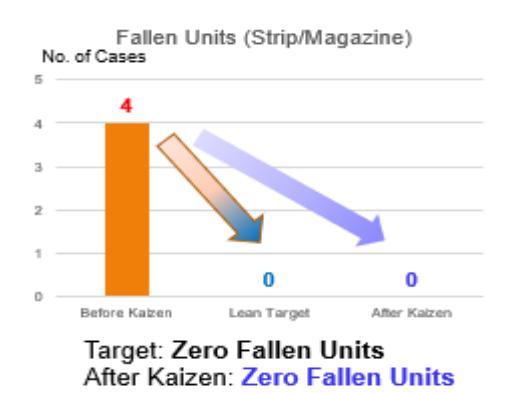
Fig. 15. - Fallen units Result after Kaizen Results

For Fallen Units, during Gemba, the team observed 2 problems that caused incidents at Wire Bond Attach process where there are 2 cases of fallen units occurred: (1) not supporting the bottom portion of the magazine during product handling and (2) no designated location for magazine stopper.

No.	Problem	Improvement		
1	Proper handling was not followed	Install visualization for Proper Handling at the Magazine		
2	Operator is carrying one magazine during transportation	Provide small pushcart good for single magazine

(1) Install visualization as reminder Provide pushcart for single magazine transportation

(2) Provide proper location for magazine stopper, near operator
