## SYSTEMIC APPROACH ON ROOT CAUSE ANALYSIS OF BANDGAP FAILURE FOR YIELD IMPROVEMENT OF QFN DEVICES

Mariane A. Mendoza Argie M. Manansala Gospel T. Marino

Microchip QFN Department Microchip Technology Philippines, Calamba City, Laguna, Philippines Mariane.Mendoza@microchip.com, Argie.Manansala@microchip.com, Gospel.Marino@microchip.com

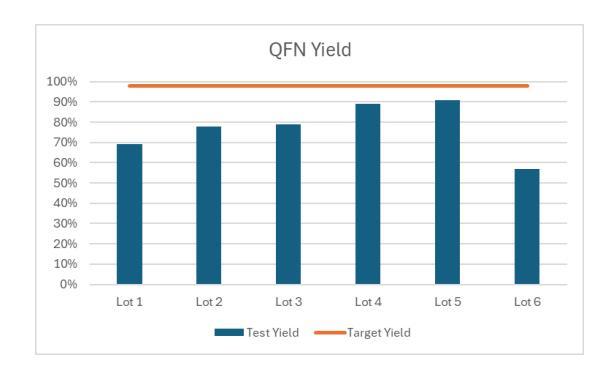
Various QFN devices have started the qualification with the 5x5mm and 7x7mm package size. During the initial stages of qualification, a yield target of 98% was not met which fails the qualification criteria, and the highest rejection was accounted with bandgap failure.

Fig. 1. Graphical representation of the yield gap between the target yield of 98% vs the Actual Yield Average of 77%.

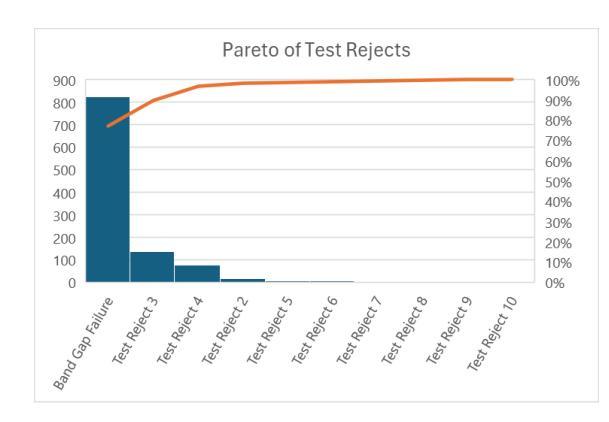
Fig. 2. Graphical representation of the test reject distribution for QFN 5x5mm and 7x7mm Package. Band Gap Failure is the top defect compared to the other test rejects from the qualification lots.

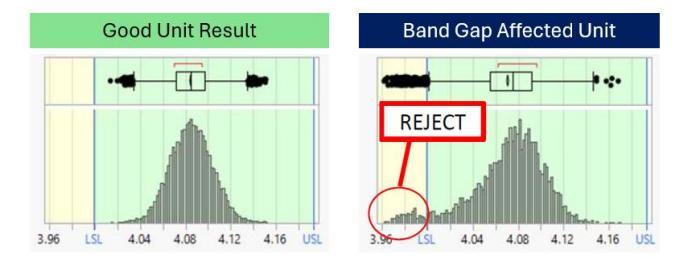
Fig. 4. Band gap failure lies on the out-of-specification range of the voltage reading of a unit.

Good units possess voltage reading within the specified Upper Specification Limit (USL) and Lower Specification Limit (LSL). However, band gap failure displays reading beyond the LSL. Failure to meet the voltage requirements results in parametric failure and may further result to Open/Short (O/S) rejection as an open unit. Units with open failure have a disconnection with the circuitry.

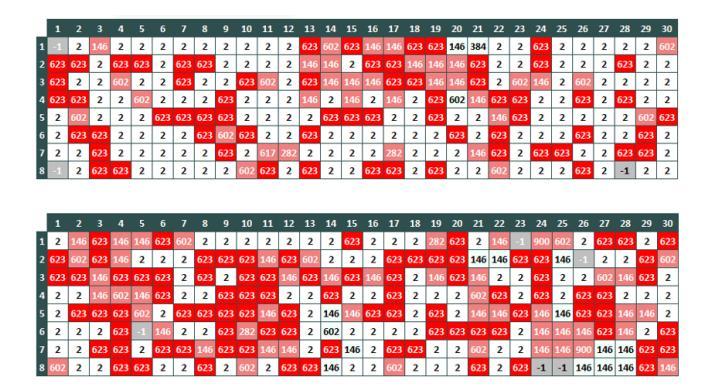
Fig. 5. Reject mapping of band gap rejection represented by red and dark red units on the strip mapping. There is no unit localization on the rejected units as per strip test results.

The unit traceability was worked out to be traced back on the wafer level. However, data from qualification lots shows that there is no commonality from the wafers where the rejected units came from.

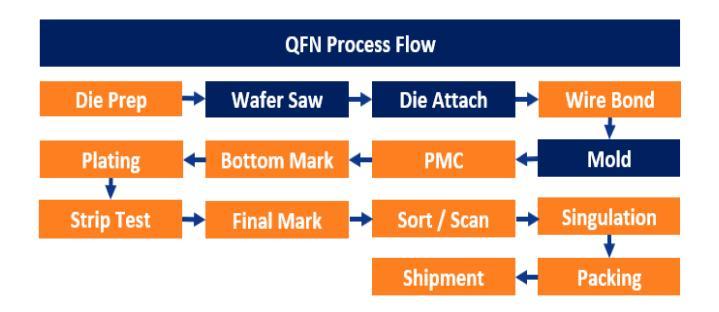
Fig. 6. QFN Process Flow with significant discrepancies found for investigation and commonality analysis.

The first identified discrepancy is the used water resistivity parameter range on Wafer Saw process. Other Microchip plants use 0.25 to 0.35 MOhm of resistivity while MPHIL3 uses 0.55 to 0.60 MOhm. It has been suspected that the resistivity of water used at wafer saw process is high which results with the band gap after the unit assembly.

Another identified discrepancy is the subjection of the strips at X-Ray exposure on die attach and mold. Normal production procedure of the QFN devices do not require X-Ray after die attach, and mold has sampling inspection only. However, due to the tight inspection and verification, X-Ray was conducted to verify the occurrence of epoxy voids and wire related issue after mold application.

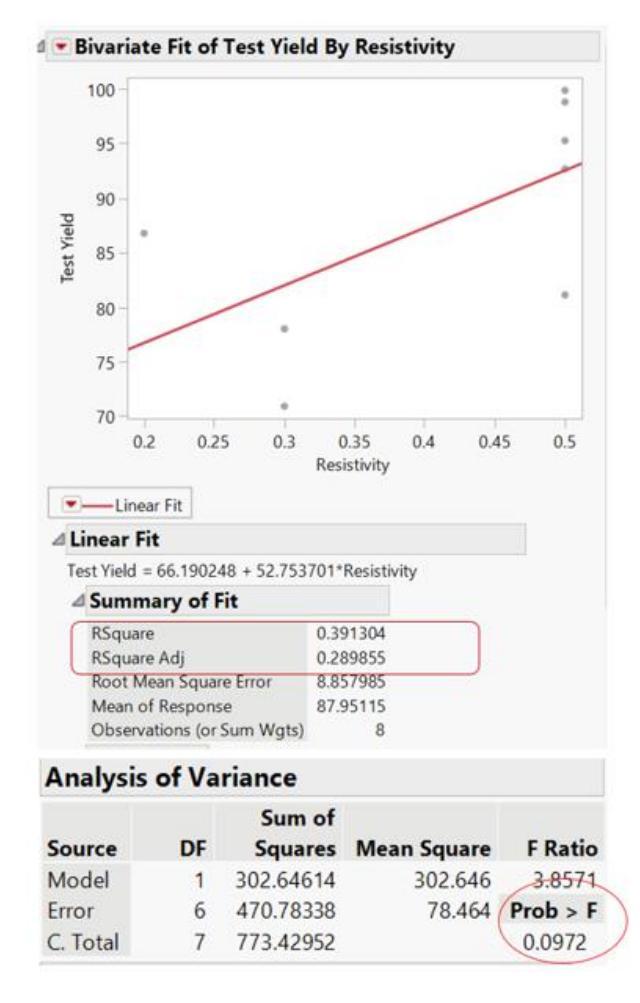
Fig. 7. Statistical analysis shows that there is no significant difference between the water resistivity set-ups regarding the band gap failure occurrences.

Based on the statistical results with P-Value >0.05, water resistivity has no significant effects on the band gap failure occurrences and thus is not a valid root cause of the problem. Correlation was not found between the water resistivity and the band gap occurrences with low attribution of 39% based on the statistical analysis results.

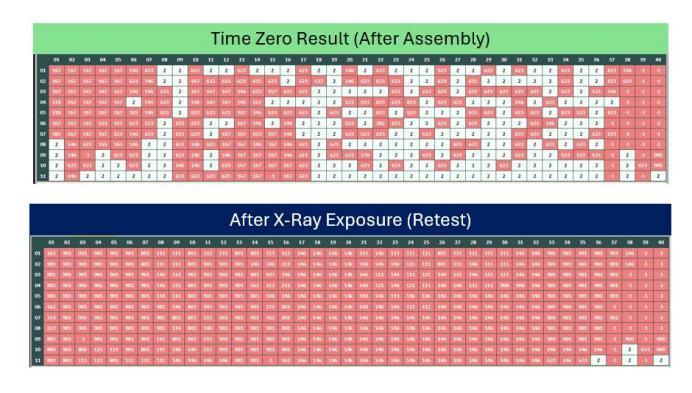
Fig. 8. Comparison of a single strip before and after further subjection to X-Ray exposure.

Initially, the strip garnered 45.2% yield after Time Zero (T0) assembly process. The strip has undergone X-Ray at Die Attach and Mold as part of verification. However, after further subjecting to X-Ray, the yield dropped down to 0.98% where the additional rejection was attributed to band gap failure. It has also been observed that the band gap failure was developed into O/S Failure upon further X-Ray exposure.

The validation has proven that the X-Ray contributes highly to the occurrence of band gap failure. The next step of the authors is to validate the identifies root cause.

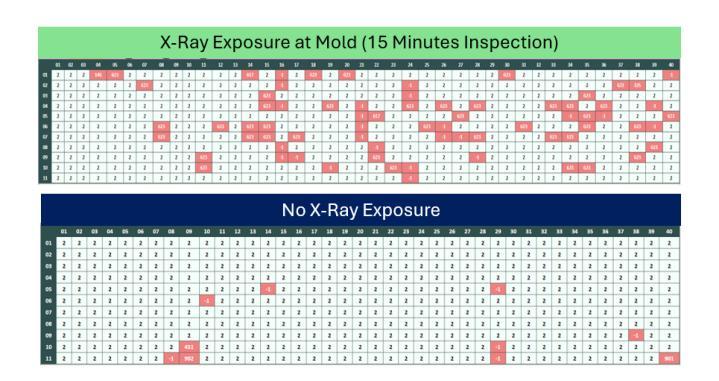
Fig. 9. Validation results of X-Ray Exposure at 15 minutes and No X-Ray Exposure.

X-ray exposure of 15 minutes after mold has been proven to have few units affected of band gap failure. On the other hand, the strip that was not exposed at x-ray has a cleaned test result without any band gap failure occurrence.

No exposure at x-ray is the best option that can be considered according to the result of x-ray exposure evaluation. X-ray exposure completely puts the units on risk for band gap failure. However, x-ray inspection is required to ensure the good quality of the units produced.

The results of validation have driven the process experts and the management to implement no x-ray inspection on the good lots. Verification and inspection of strips are managed on a built dummy strip to avoid exposure of good lots at xray while ensuring the quality of the produced products.

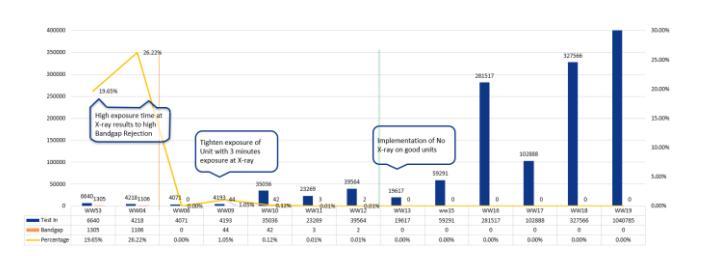
Fig. 10. Validation results of X-Ray Exposure at 3 minutes and No X-Ray Exposure.

The monitoring of band gap failure has proven that x-ray exposure is the root cause of the problem, and the yield can be improved through the implementation of no x-ray inspection on good lot run.
