ETCHED TO STAMPED LEADFRAMES AS A COST-EFFECTIVE SOLUTION TO COPPER LEADFRAME SUPPLY

Materials Engineering – Quality Department^{1,2,3}
Ampleon Manufacturing Philippines Inc.
rommel.obed@ampleon.com¹; julius.patalen@ampleon.com²; rodjie.ortiguerra@ampleon.com³

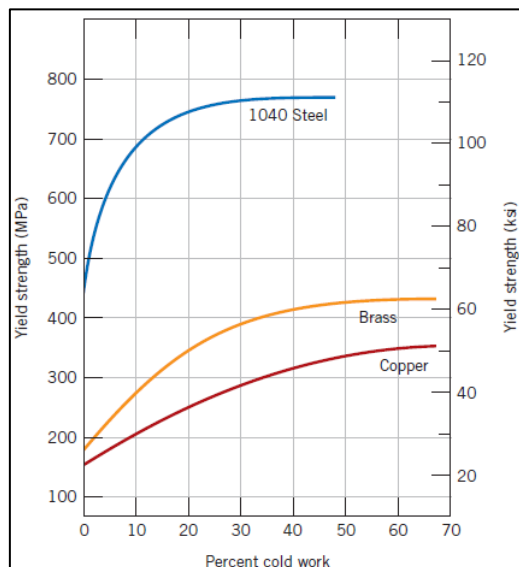
Fig 2.2 A sample plot of the effect of cold work to common metals, 1040 Steel, Brass and Copper (Callister)

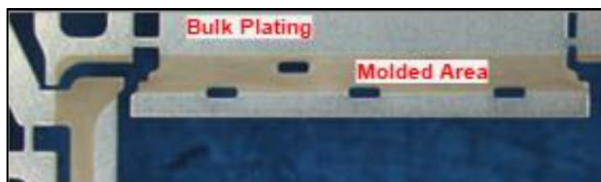
Fig 4.2 The two primary surface finishes of the leadframe, the bulk plated area and the mold plated area

Figure 4.2 shows the surface finishes of the leadframe. The bulk plated part is an electro plated layer while the molded area is another etched area designed to improve the adherence of a mold compound during successive processes. This is a different etching process and is not the etching forming

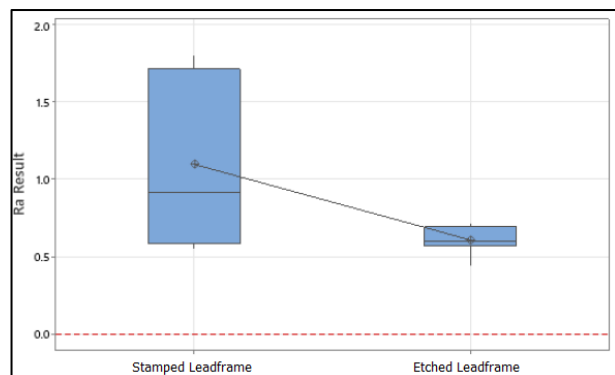
Fig 4.5 Boxplot showing the Roughness (Ra) delta needed on the molded area to compensate for the removal of the Etching leadframe forming process.

The rationale for this difference is that the replacement of the etching process on the stamped leadframes produced a surface finish with a lower activation energy. When producing these samples, the supplier encountered mold adhesion issue that was not present in the initial etched variant despite achieving the same roughness target. They

opted to increase their roughening parameters to compensate for this. Overall, this is what caused noticeable roughening difference on the stamped leadframe.

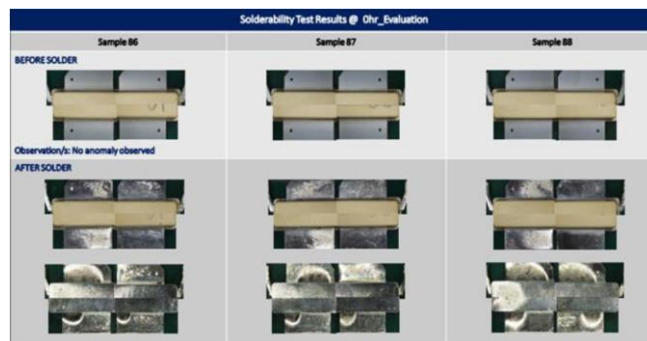
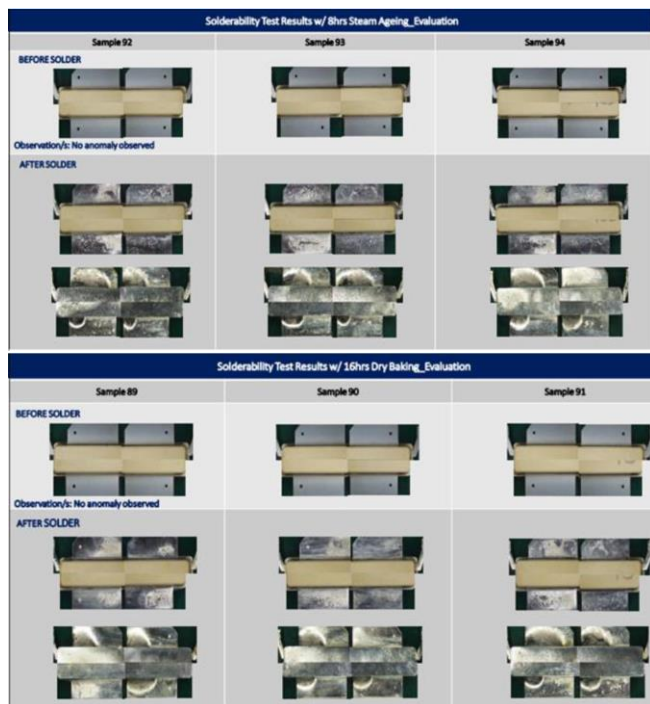
Fig 4.8 Solderability tests results for 0Hr dip and look, post dry-bake and post steam-age.

Results shown on figure 4.8 show that the leads formed from the stamped leadframe pass solderability at 0Hr, post Dry baking and post steam-ageing. 100% solder coverage was observed for all samples.

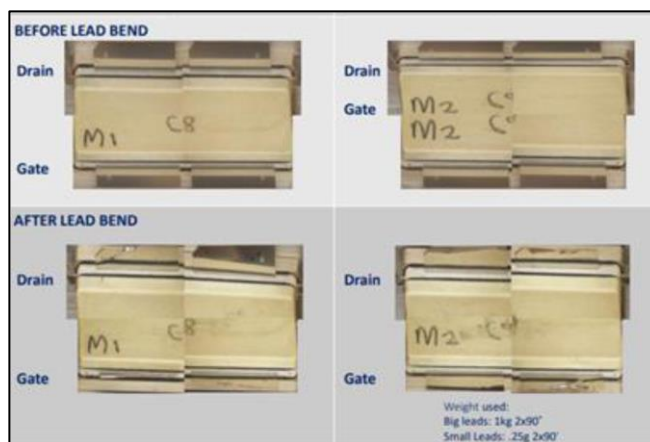
Fig 4.10 Lead bend integrity test results.

Lead integrity tests through lead pull and lead bending results show no package crack nor broken leads for stamped leadframes.
