## HARD STAIN PPM REDUCTION IN POTTING STATION THROUGH EFFECTIVE AND ROBUST DESIGN OF TAPE TRACK COVER

Assembly Operations 1  
STMicroelectronics, Inc.  
9 Mountain Drive, LISP 2, Calamba 4027 Laguna, Philippines,  
[irish-jan.beltran@st.com](mailto:irish-jan.beltran@st.com), [eric.espino@st.com](mailto:eric.espino@st.com), [bernard.zamora1@st.com](mailto:bernard.zamora1@st.com)

In today's ever-changing technology, in an industry where competition is neck and neck among companies, Cost saving serves an important role in staying competitive in the industry. This technical paper will discuss how cost savings were achieved through elimination of one of the top defect contributors during manufacturing. Hard Stain was solved using DMAIC approach.

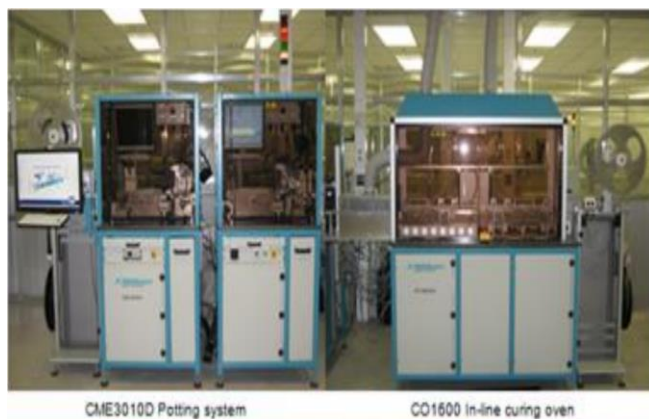
Fig. 1. CME3010D Potting System and Inline Curing Oven

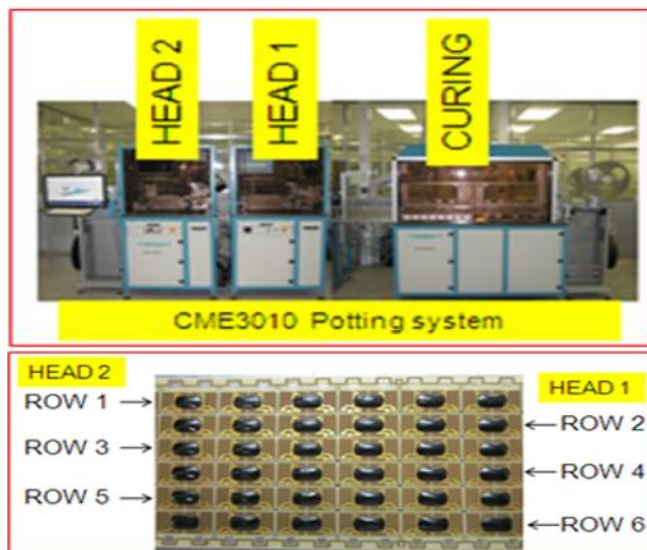
Fig. 4. Head 1 encapsulates the even rows while Head 2 encapsulates the odd rows.

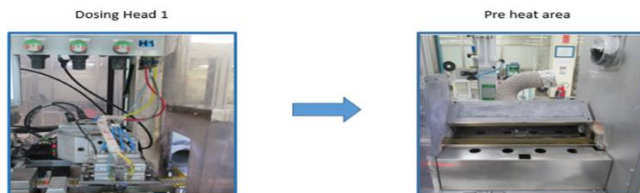
Fig. 9. Dosing Head 1 to Pre-heat process step validation

Validation result shows that there is no occurrence of Hard Stain while simulating the leadframe tape transfer from Dosing Head 1 to Pre-Heat Area. Therefore, the team concluded that this is not a valid root cause.

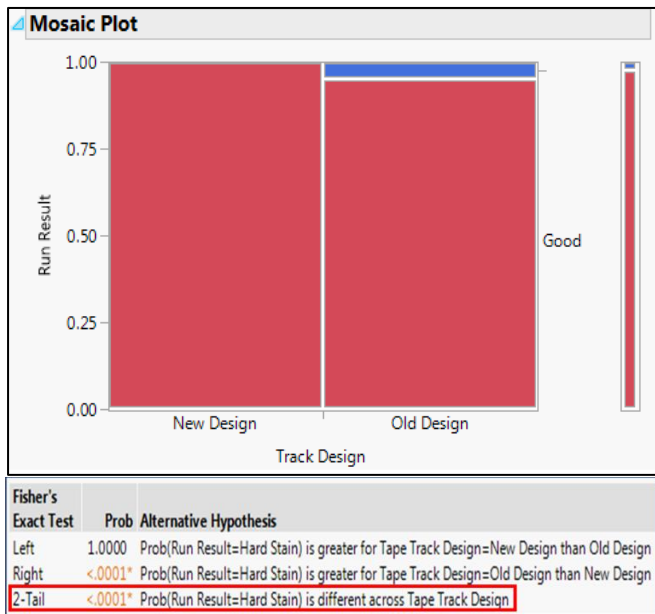
Table 10. Statistical Analysis

Practical Conclusion:

- ✓ Run Results are different between the designs.
- ✓ At better than 95% confidence level, Old tape track design will result to higher hard stain occurrence for micromodule devices.
