## LEADING INDICATOR DETECTION THROUGH SPC INPUT VARIABLES

Central Plating Sustaining Engineering Department

Nexperia Philippines Inc., Philips Avenue, LISP 1

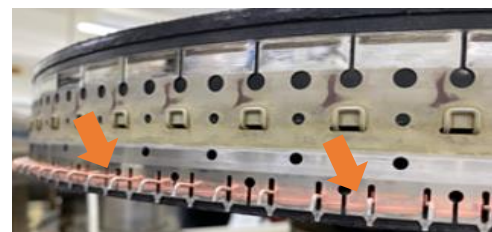
Figure9. Discolored belt due to Galvanic Corrosion

The conveyor belt of a plating line is the major part affected with galvanic corrosion. Corrosion (Fig. 9) on the belt thickness reduces its thickness overtime.

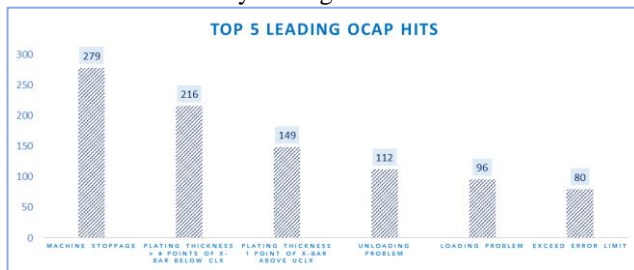
Figure11. Leading OCAP Hits

Whenever abnormalities are detected in the machine, an investigation is conducted to analyze the problem and to provide corrective actions. Based on the OCAP trend (see Fig. 11), machine stoppage is the leading contributor to OCAP hits followed by Plating Thickness OOS.

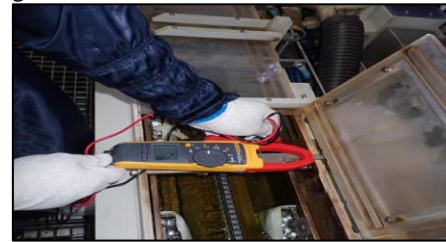
Figure 12. Measurement of rectifier output

The rectifier supplies the voltage and distributes the current to multiple electrolytic process cells from the pre-treatment to the electroplating process. Disturbances in the rectifier electrical output could result in several defects in the products like flakes, peel-off, or thick/thin plating thickness. One of the top defects caused by an abnormal rectifier output is Peel-off Plating (POPL). Fig. 12 demonstrates rectifier output monitoring.

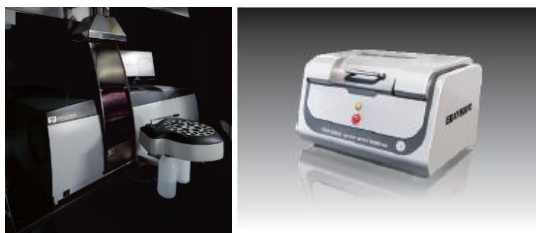
Figure 25. PG-500 AAS(Left); RoHS XRF (Right).

Current ATCB capability is to control that Pb content of the Plating bath via Atomic Absorption Spectrometer (AAS).

Second step of our Pb contamination control will be the implementation of the use of our RoHS X-Ray Fluorescence Spectrometer (XRF) (see Fig. 25). RoHS X-Ray can measure the Pb co-deposition on the product. RoHS limit on co-deposited Pb is < 1000 ppm.
