FROM CRACKS TO MARKET: A JOURNEY TO ELIMINATE DIE CRACK ON TURRET HANDLER

Process Development and Equipment Engineering
Analog Device Inc. Gateway Business Park Barangay. Javaleria General Trias Cavite | 4107
JoanaMarie.Kintao@Analog.Com | Lorenzo.Melgazo@Analog.com | Ruel.Mijares@Analog.com

Product qualification is vital for validating semiconductor device performance and ensuring regulatory compliance. This study examines a $2.5 \times 2 \times 0.55$ mm package that initially had a 65% defect rate due to leakage failures caused by microcracks on the silicon die.

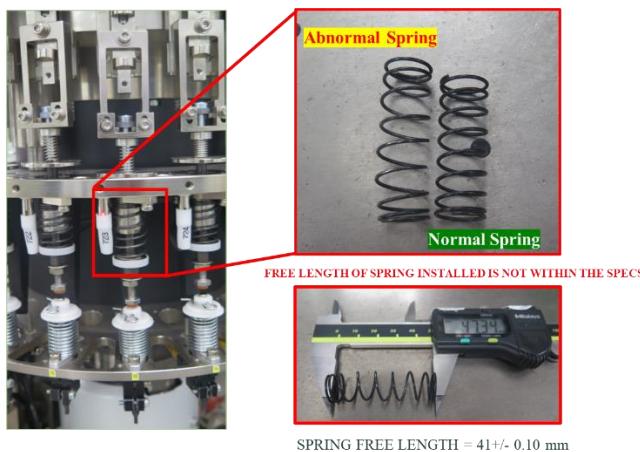
Figure 11. Force Testing Preparation

Spring under observation will be elongated with actual measurement of 47.34mm and out of specs vs. Spring free length of 41+/- 0.10mm.

Transferred the conversion kit from Turret Handler B. Perform fine tuning and Jam rate (10k), Set up index time to 200ms (10k UPH). Peel Back Force Test (PBFT) passed during requalification. Accomplished Defect Material Review Board (DMRB) checklist. Replaced Press Turret Springs for Test Site 1 and Test Site 5 due to >43mm of free length see in Table 4.

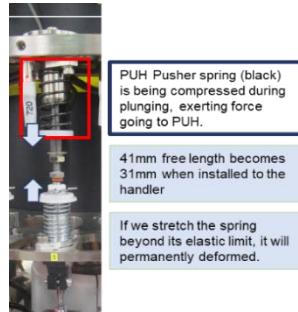
If a spring is compressed, then a force with magnitude proportional to the **decrease** in length from the equilibrium length is pushing each end away from the other

Figure 15. Hooke's Law Model, when a spring is compressed, it employs a force that is proportional to the decrease in its length from the equilibrium state, pushing both ends apart.
