**ENABLING CONTINUOUS IMPROVEMENT THROUGH POWER BI: POST-TEST YIELD ANALYTICS FOR SUSTAINABLE SEMICONDUCTOR MANUFACTURING IN THE AI AND INDUSTRY 4.0 ERA**

**Marlon A. Recuelo**

Process Development Engineering  
Analog Devices Inc., General Trias, Cavite  
[Marlon.Recuelo@analog.com](mailto:Marlon.Recuelo@analog.com)

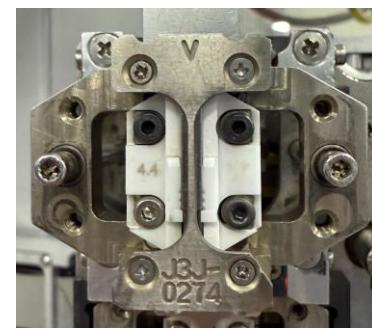
Figure 5b. A properly aligned lead support

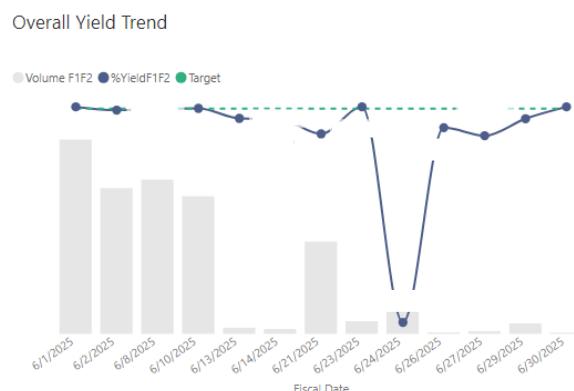
Upon implementation of fixes on the affected machine, its performance gradually returned to the normal level (Figure 7).

**Figure 7.** Daily Yield Trend of Affected Machine in PTY dashboard after implementation of fixes
