Damaged Package Elimination: A Study and Adaptation of Top Package Unit Stopper in FT-2026 Handler Onload Singulation Process

Final Test, Engineering Department

Nexperia Philippines Inc., Philips Avenue Light Industry and Science Park 1,
Cabuyao, Laguna, 4025 Philippines
DeanErian.Arago@nexperia.com
Angelo.D.Catamco@nexperia.com
Victor.Partolan@nexperia.com

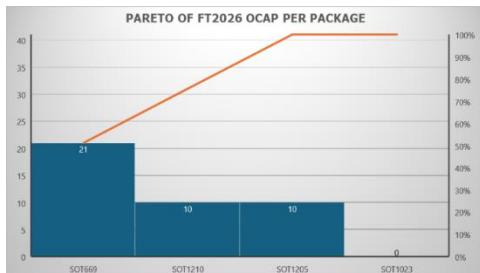
Figure 9. Pareto of OCAP Hits

SOT669 package is the top contributor on Unit Separator OCAP hits for FT2026 Handler with an average of 4 hits on each set up, as shown in figure 9. Indicating that SOT669 set up is the top priority to check for abnormality in set up.

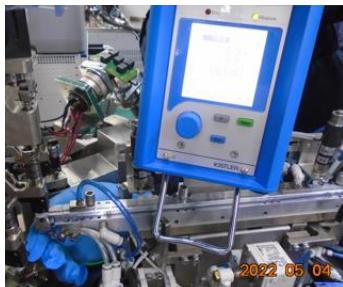
Figure 12. Unit Force Measurement

The force applied by the movement of unit is determined using force measuring tool. The separator assembly is removed and is replaced by the force measuring tool at the end of the outlet track. The machine performs a jog run and then every set of units that was blown into the track was measured. The max force used is 25.7 N.

A. Force Applied by Unit Movement

Force	Number of units in tube					
	10	20	40	60	80	100
Min	1.5	3.5	5	8.2	16.6	12
Max	4.3	5.9	8.7	10.7	25.7	15.7
Average	3.17	4.63	6.37	9.63	20.22	13.55

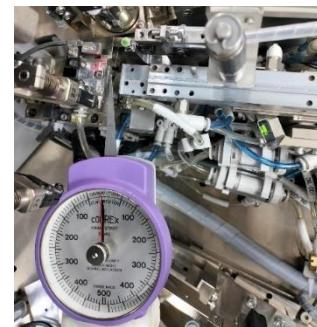
Figure 13. Separator Force Measurement

The force exerted by the separator is measured using a Gram Force Meter. The meter is placed at the position where the extended unit will be during its defect inducing event. This is about one unit in length were the force exerted is 3.465 N.

C. Force Applied by Separator

Separator Force		
Trial	Half Unit Distance	Full Unit Distance
1	145	450
2	120	400
3	170	340
4	150	340
5	140	260
6	145	200
7	145	450
8	160	375
9	140	300
10	145	350
Average	146	346.5
Force (N)	1.46	3.465
