Innovative Quartz Cassette Design for Minimizing Wafer Breakage and Quartz Cassette Damage

Probe Department – Process Maintenance and Equipment Engineering

Allegro Microsystems Philippines Inc.

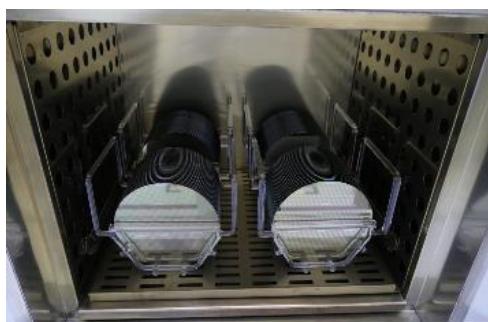
Figure 5. New quartz cassette design inside the oven chamber.

Phase 2: The final design was modified to feature vertically positioned handles on both sides. This adjustment was made to enhance ergonomic handling while maintaining the full loading capacity of the oven chamber, ensuring that operational efficiency was not compromised. (See Figure 5)

- Assessment of the redesigned quartz cassette within the chamber to verify its effectiveness in maximizing capacity. (See Figure 5)
- A comparative analysis of post-bake yield outcomes using the original versus the redesigned quartz cassette design. (See Figure 6)
