ENHANCING DIE CLEANING EFFICIENCY WITH AUTONOMOUS VACUUM TRIGGER IN TRIM & FORM MACHINES

EOL-MTF Engineering Department
onsemi, Luisita Industrial Park, SEPZ San Miguel, Tarlac City
JeromeJay.Mayo@onsemi.com, Allan.Samaniego@onsemi.com, ShaneMark.Sarmiento@onsemi.com

34th ASEMEP National Technical Symposium

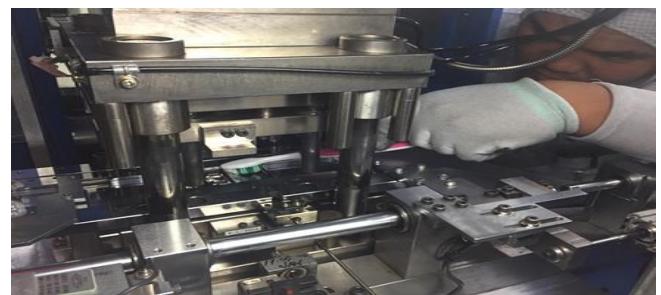
Die cleaning is very important in Trim and Form because this log point is one contributor of dust and resin debris due to its cutting and trimming process. It is a combination of lead frame and mold compound debris where when not properly removed will result to various problems. Improper cleaning or without performing cleaning at all will result to catastrophe that will lose thousands of dollars due to low productivity output, die breakage and worst customer claim due to bent leads, stand-off and the like affecting factory's KPI (see Fig. 2).

Fig. 2. Actual Presentation of Die Tool Cleaning Performed by Production Specialist.

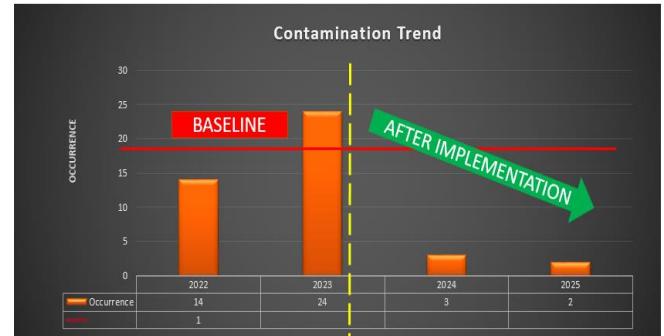
After implementation of project 1 contamination and die tool repair was decreased from average of 19 cases in year 2022 and 2023 down to 2.5 cases in year 2024 and 2025 year to date, 2 eliminated add on activity of operators in finding external vacuum cleaner whenever need to perform die cleaning, 3 removed the common reason of operator why they cannot perform their job satisfactory due to unavailability of vacuum cleaner, 4 increased productivity more than 2 hours stoppage down to 5 minutes, 5 cost avoidance of more or less

Fig. 8. Contamination Occurrence from the Baseline in Year 2022 and 2023 Compared to Year 2024 and 2025 after Implementation of Project has Significantly Decreased by 91.67%.
