MEMS MV8P WIRE PROXIMITY PPM REDUCTION

MEMS Operations 3
STMicroelectronics, Inc.
9 Mountain Drive, LISP 2, Calamba 4027 Laguna, Philippines,
emmanuelle.cadag@st.com, teresita.suple@st.com, renie.fegason@st.com

As one of the critical parts of the wire bonding process, loop formation will be discussed in this technical paper, focusing on how the optimization of loop formation reduces the wire proximity PPM for the MEMS MV8P device. Using problem-solving methodology, the team was able to identify and analyze the root causes of wire proximity rejects during the wire bonding process through DMAIC approach.

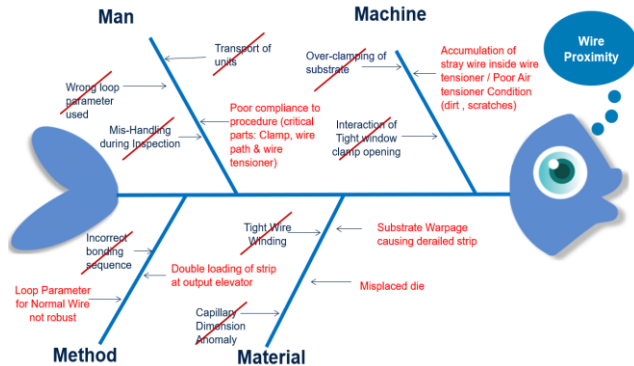
Shown below is the fishbone diagram of wire proximity at wirebond. The team identified 14 potential root causes, as shown in Figure 12.

Fig. 12. Fishbone diagram.

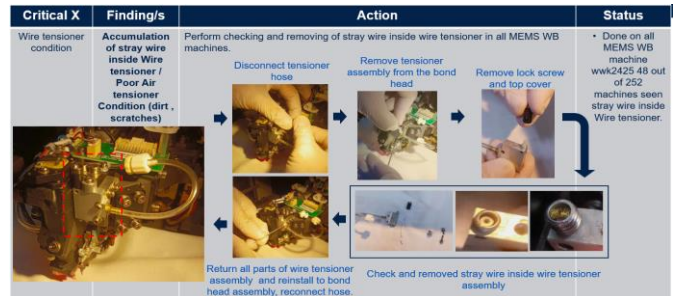
There are 5 activities that help address 5 potential causes and contribute to the current wire proximity PPM performance, as, shown in Fig. 13 –17.

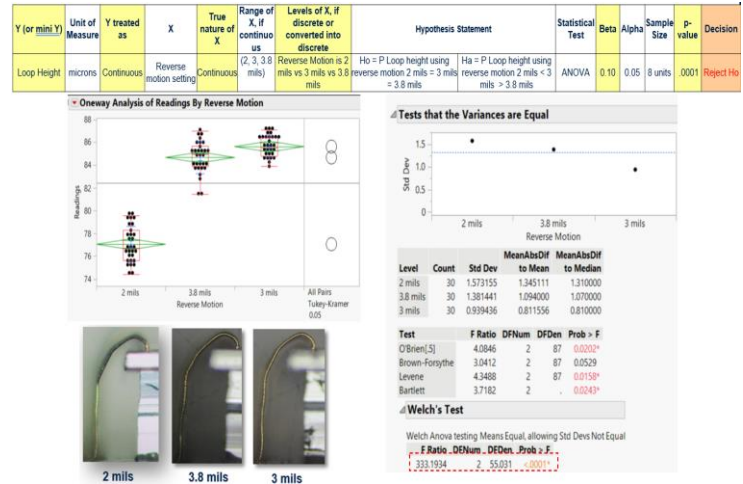
Fig. 21 Statistical testing of three reverse motion setting.

At 95% confidence level, loop height of 2 mils reverse motion is significantly lower than 3 mils and 3.8 mils reverse motion. Thus, reject Null Hypothesis, as shown in Fig 21.

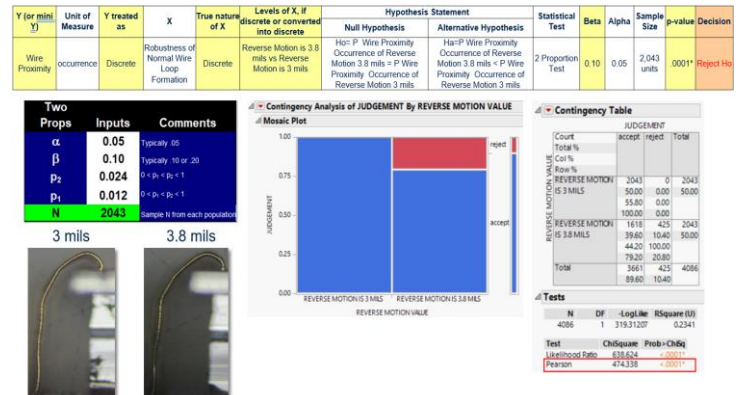
Fig. 22 Statistical testing of robustness of loop formation.

At 95% confidence level, there is a significant difference in wire proximity occurrence if the Reverse Motion is 3.8 mils and if the Reverse Motion is 3 mils. Thus, reject Null Hypothesis, as shown in Fig. 22.
