PREDICTIVE TESTING FOR LONGEVITY: EXTENDING SHELF LIFE OF PROTECTIVE LINERS THROUGH ACCELERATED AGING

WT & TNF Process Engineering – Operations 2

STMicroelectronics Incorporated

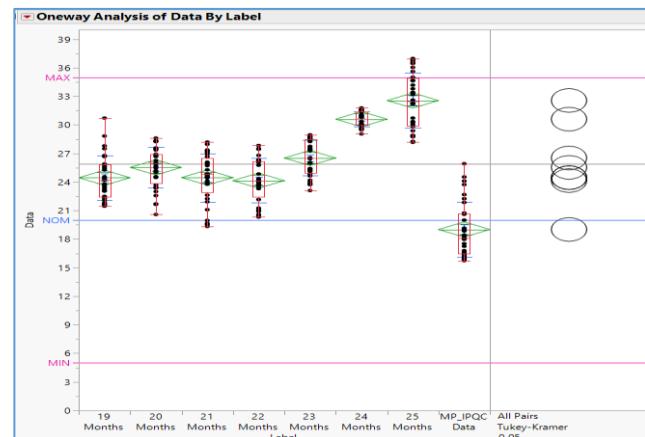
Figure. 2. Anova plot for B201 Expired Liner Materials more than 24 months

Over time, expired liners may lose their structural integrity, leading to compromised performance. Using expired materials can result in product defects or failures, impacting customer satisfaction. Managing expired materials can incur additional costs, including disposal, replacement, and potential production delays.

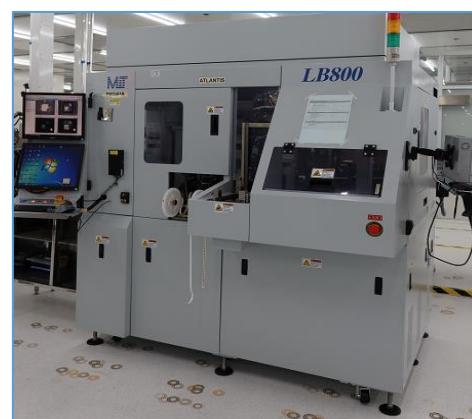
Figure. 3. MIT LB800 Final Liner Attach Machine

A liner attach machine is a specialized piece of equipment designed to automate the process of attaching liners to various surfaces or products. These machines are commonly used in manufacturing and packaging industries to improve efficiency, consistency, and precision in liner application.

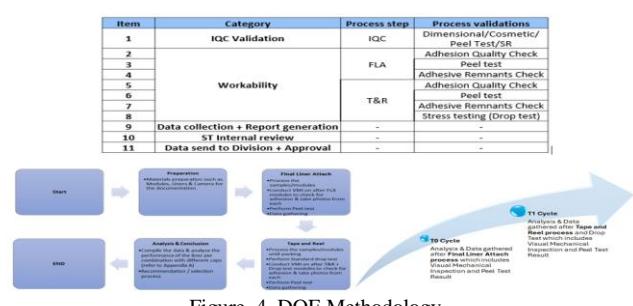
Figure. 4. DOE Methodology

Perform Liner shelf-life extension study using ST Material Engineering Plan. Conducting a linear shelf-life extension study using the ST Material Engineering Plan involves systematically evaluating the longevity and stability of a product under specific conditions. The process begins with defining the study's objectives, such as extending the shelf life by a certain period. Key materials are selected to ensure they represent typical production batches. See Figure 4.

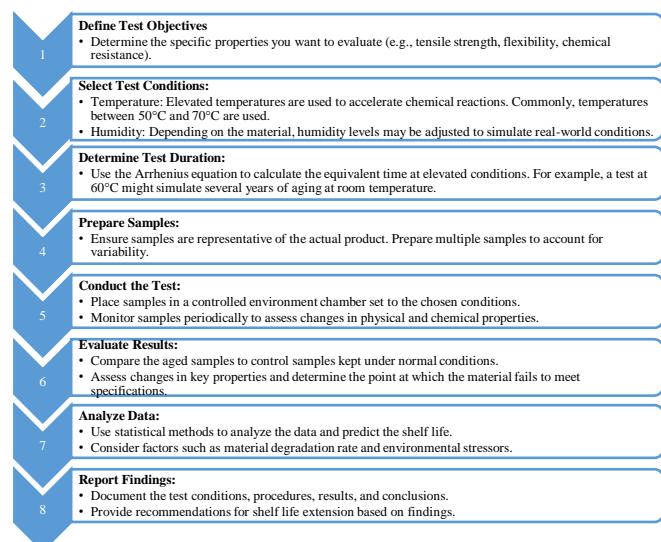
Figure. 5. Procedure on Accelerated Aging Tests

Accelerated aging tests are a powerful tool for predicting the shelf life of protective liners. By carefully designing and conducting these tests, manufacturers can ensure product reliability and extend shelf life, ultimately leading to cost savings and improved customer satisfaction. Here's a comprehensive guide on how to conduct accelerated aging tests to extend the shelf life of protective liners. See Fig. 5.

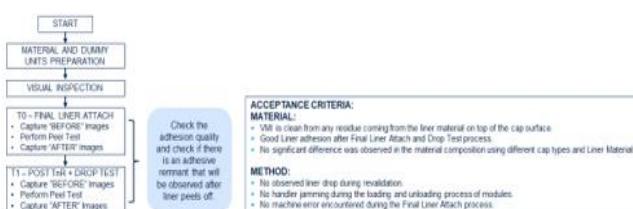
• No machine error encountered during the P1

Materials and methods for the evaluation plan and qualification criteria from T0 cycle – Final Liner Attach process up to T2 cycle – Tape and Reel + Drop Test.

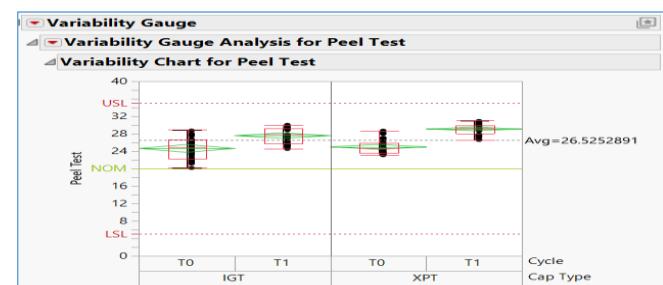
Figure. 8. Variability Chart for Peel Force (gF):

- Both Cap (IGT and XPT) using 3M7418E Liner shows stable readings at different cycles and PASSED on defined specification limits from 5 to 35 gF but slightly above nominal target of 20gf (Avg=26.52gf).
- Liner material 3M7418E on both IGT and XPT cap shows stable performance and normal adhesion response from T0 to T1 cycles.

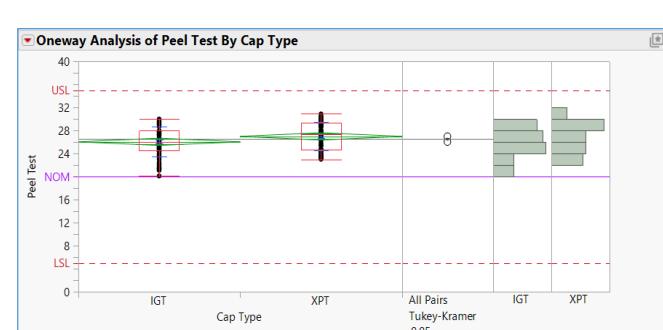
Figure. 9. One way analysis for Peel Force (gF):

Correlation data from interaction plots showed that mean from liner material 3M7418E on both cap (IGT and XPT) is BOTH within Peel Test specs limit and almost have the same performance. Both CAP type is correlated based on Tukey-Kramer analysis.

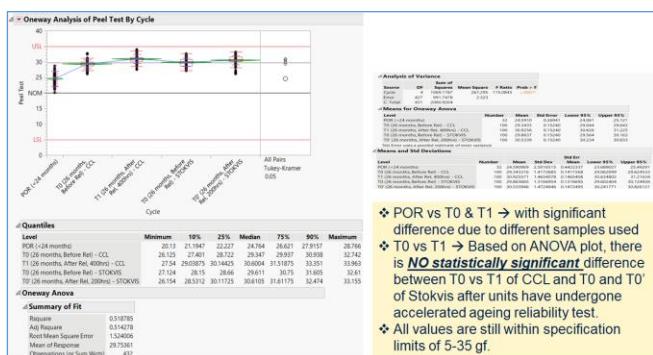
Figure. 10. REL Test Peel Test Results

- T0 vs T1, based on ANOVA plot, there is NO statistically significant difference between T0 vs T1 of CCL and T0 and T1 of Stokvis after units have undergone accelerated ageing reliability test.
- All values are still within specification limit of 5-35gf.

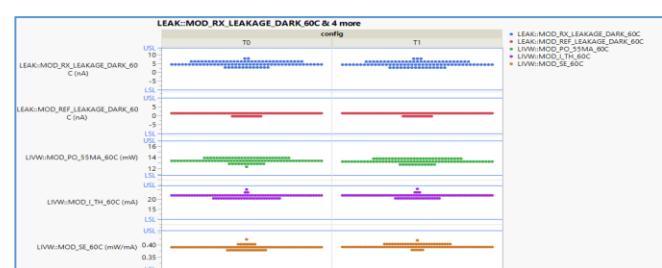
Figure. 11. LIV Test Plot

- All units passed (BIN 1) at Electrical/Functional/Optical Test at LIV Test stage.
- Statistical plot shows all units passed (BIN 1) after SPEA Drift test and no drift from T0 to T1 After Rel

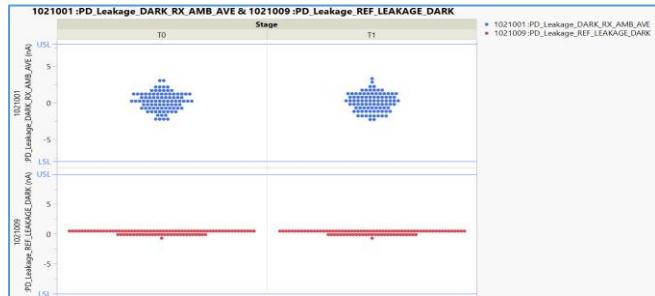
Figure. 12. SPEA Test Plot

- All units passed (BIN 1) at Electrical/Functional/Optical Test at SPEA Final Module Test stage.
- Statistical plot shows all units passed (BIN 1) after SPEA Drift test and no drift from T0 to T1 After Rel

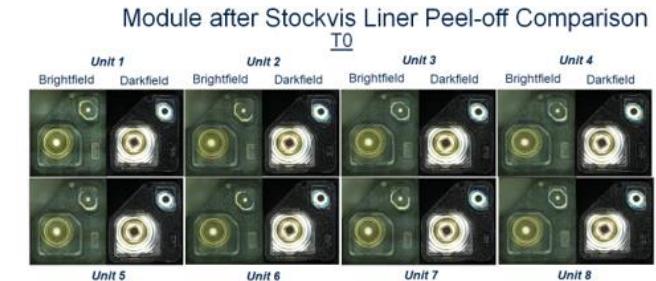
Figure. 13. Manual Liner Removal FA Result (100% Optical Inspection)

1. Sample preparation: Place samples with liner on adhesive tape to simulate condition with FATP or Final Assembly and Test Package (module is already soldered within the system).
2. using an ESD plastic tweezer, manually peel-off liner on B201 modules starting from the tab toward the opposite side.
3. Conduct visual inspection for adhesive residue (magnification: 30X).

No adhesive residue observed on the cap surface on all inspected samples during 100% VMI.

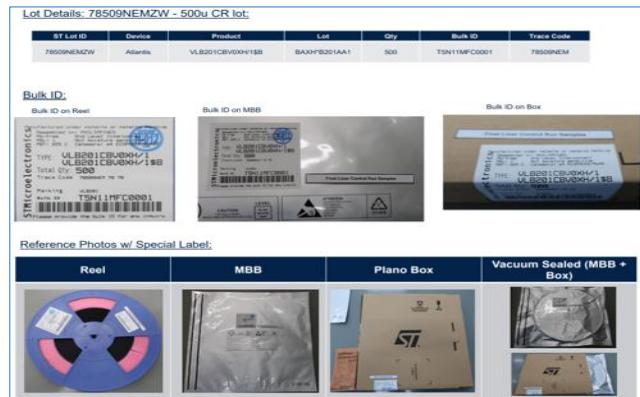
Figure. 14. Control Run Samples

ST Calamba to prepare Control run samples to FATP (1 Reel/500 units) using the aged Stokvis/CCL material to check the response during manual liner removal process at customer side.
