CACB RASCO JUPITER 2 COMMITTED MANUFACTURING CAPACITY (CMC) INSERTION IMPROVEMENT

ABSTRACT

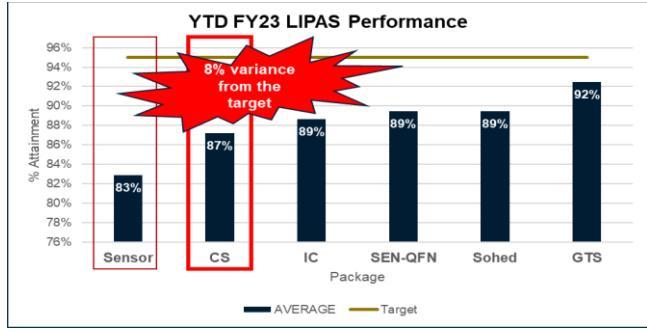
Last FY23 from WW14 to WW31, the package with highest variance of LIPAS performance is Sensor with 12% variance, but due to limited scope of the study, the team focused on the Current Sensor (CS) package with 8% variance from the target (see Figure 1). contributor of Finished Goods Risk is SEN CB resulting to 9 FG Risks including 1 High Risk. Upon assessment, 9 out of 9 risks is due to the handler related issue resulting to low insertion (see Figure 2).

Figure 1. Sensor being highest variance in LIPAS performance and CS being the top 2

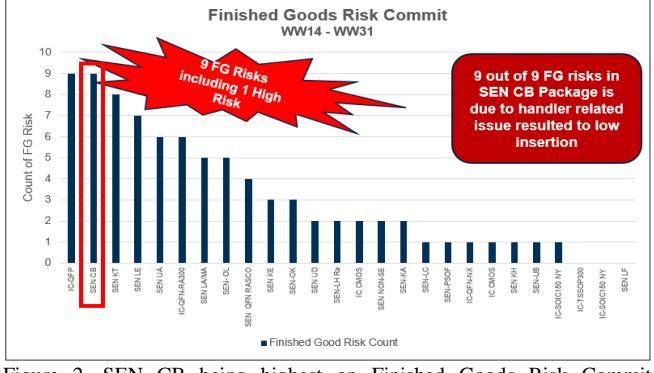
Figure 2. SEN CB being highest on Finished Goods Risk Commit Monitoring

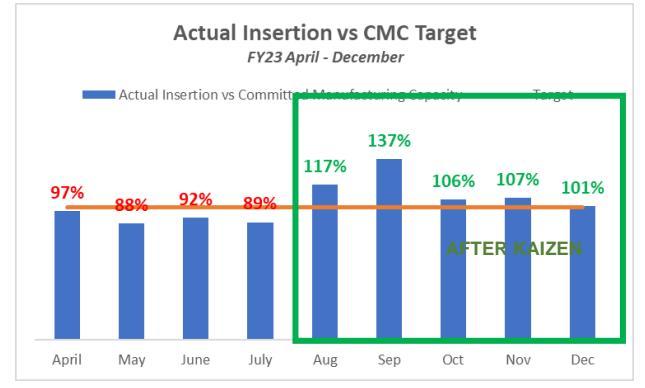
This project aims to improve the CMC insertion of Rasco Jupiter 2 from 92% to 100% or 8% increase which will add up to the Current Sensor (CS) LIPAS to meet the 100% target. After the Kaizen, we are able to sustain all the counter measures implemented with improvement on Insertion from 92% to 114% with reference to weekly CMC target output with Zero LIPAS missed cause by Jupiter 2 with Zero Medium/High risk assessment by manufacturing of weekly FG commit starting from the week after kaizen (see Figure 12 & 13).

Figure 12. FY23 April - December Actual Insertion vs CMC Target

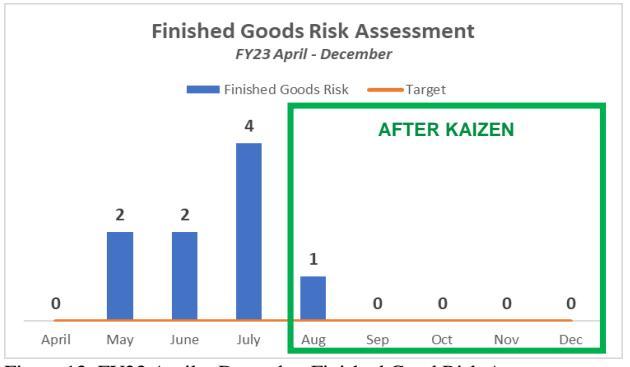
Figure 13. FY23 April - December Finished Good Risk Assessment
