# DEEP-DIVE INVESTIGATION ON PAD DISCOLORATION ISSUE IN OPTICAL SENSING DEVICE

Assembly Manufacturing STMicrolectronics Inc., Calamba Philippines #9 Mountain Drive, Light Industry and Science Park II, Brgy La Mesa, Calamba City, Laguna Philippines 4027 rhodora.yu@st.com, jesse.jagape@st.com, emiliana.antonio@st.com

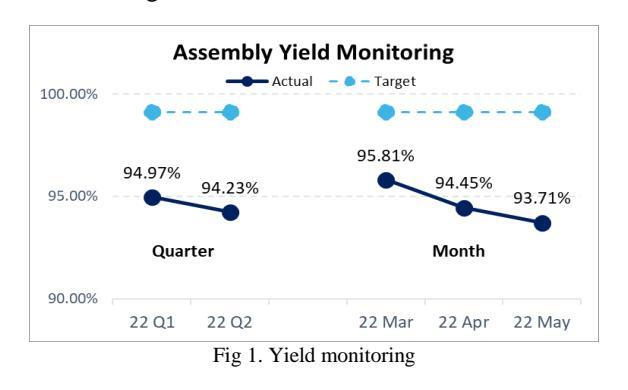
Addressing the Voice of Customer (VOC) as one of the top priorities of STMicroelectronics Inc., the need to focus on detractors to meet yield target must be given attention. Based on the yield performance in Fig 1, the yield remained below the 99.12% target.

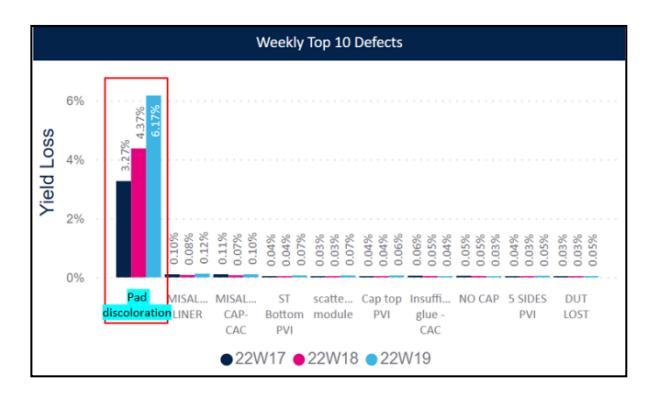
Among the top 10 detractors, the highest contributor is the pad discoloration due to RBO as shown in Fig. 2. It has been the major issue encountered in one device in OPS2. It started to manifest during Engineering phase and continued until mass production.

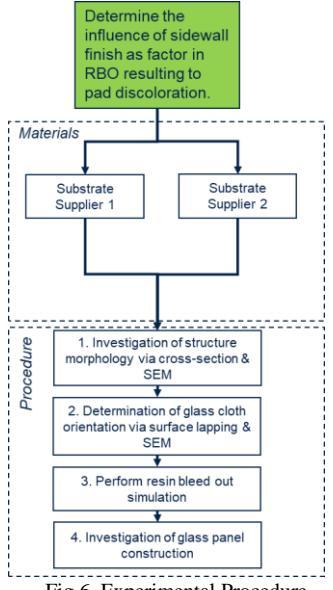
Fig 6. Experimental Procedure.

Using fishbone diagram, several potential causes on man, machine, method, material, and environment were identified and validated one by one.

From the fishbone diagram (Appendix A), the potential root cause identified is related to the substrate material that needs further investigation. Table 1 shows the validations made for the substrate material. Based on assessment, glue flow is influenced by sidewall morphology.
