Effective Failure Analysis Approach in Uncovering Gate-to-Drain/Source Tungsten Spur Fabrication Defect

Global Failure Analysis, Analog Devices Inc.,
Gateway Business Park, Brgy. Javalera, Gen. Trias, Cavite, Philippines 4107
Email: alex.delcastillo@analog.com; alfredjay.rafael@analog.com; jae.saladar@analog.com

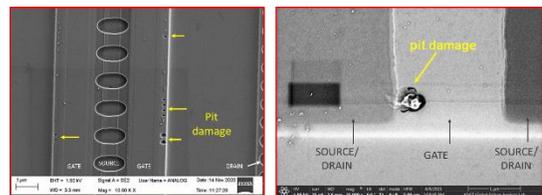
One (1) unit was subjected to chemical deprocessing to expose the transistors in the silicon substrate. Pit damage sites on the edge of the gate channel was observed, see Fig. 10.1. From the initial observation, the damage looks similar to an ESD damage. A typical ESD damage is shown in Fig. 10.2. However, the damage shown in Fig. 10.1 is not an indication of an ESD damage, but a result of the tungsten spur defect. The tungsten spur has been etched away by the chemical etchant leaving pits or damage at the defect site. Chemical deprocessing was not the preferred physical failure analysis approach for this type of defect, but rather FIB cross sectioning approach to keep the defect intact.

Fig. 10.2. Typical silicon pit damage on the edge and along the channel indicative of gate oxide rupture due to ESD as seen on other devices
