ELIMINATION OF PEEL OFF UV ADHESIVE ON UV SHOULDER RMA DEFECT IN CATHETER ASSEMBLY

Lyka Mae D. Quillosa
Jaime Miguel C. Agustin

Medical Device Assembly Business Unit- Engineering Department
P.IMES Corp., Block 16 Phase 4, CEZ Rosario , Cavite
quillosa@pimes.com.ph, jagustin@pimes.com.ph

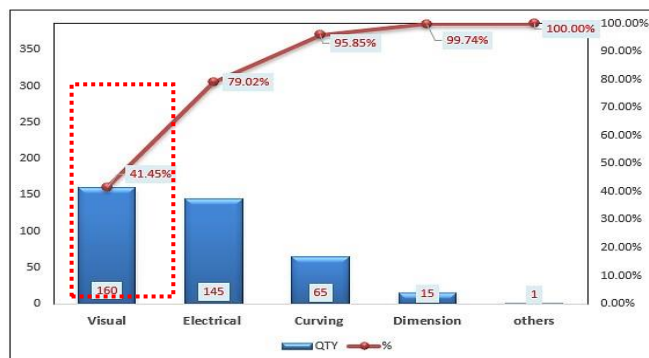
Figure 2. Visual Related Defect Trend

In regards to the above company's target, shown in Figure 2, Visual Related Defect has the highest RMA defect occurrence feedback by customer JLL (Japan Lifeline), with **41.45%**.

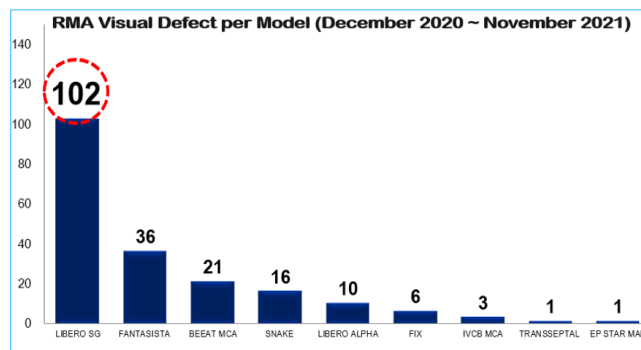
Figure 3. Visual Related Defect per model

With the graph being presented, Based on the Visual defect per model (shown in Figure 3), **Libero SG** model has the highest visual defect quantity with **102 pieces** from **December 2020 to November 2021**.

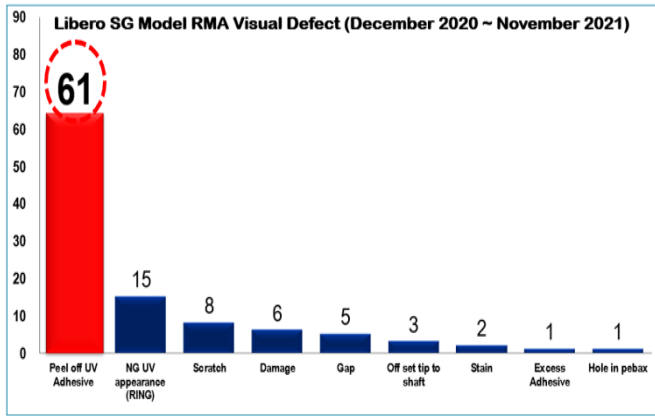
Figure 4. Libero SG Visual Related Defect

Upon presenting above graph's, all the visual related defect in model Libero SG in RMA, Peel off UV Adhesive on UV Shoulder has the highest defect rate with **61 out of 102 pieces - (0.61%)** being feedbacked.

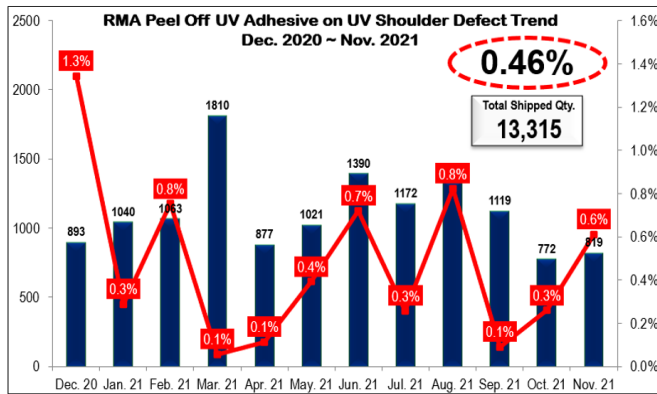
Figure 5. RMA Peel Off UV Adhesive on UV Shoulder Defect Trend (Dec. 2020 ~ Nov. 2021)

Upon identifying the highest RMA Defect for FY2021, Figure 5 shows, the Peel Off UV Adhesive on UV Shoulder Monthly Trend with varying defect rate of 0.1% to 1.3% defect rate with an overall rate of **0.46%**.

Therefore, RMA defect rate of **0.46%** of Peel-off UV Adhesive on UV shoulder of Libero SG encountered in FY2021 from Dec. 2020 to Nov. 2021.

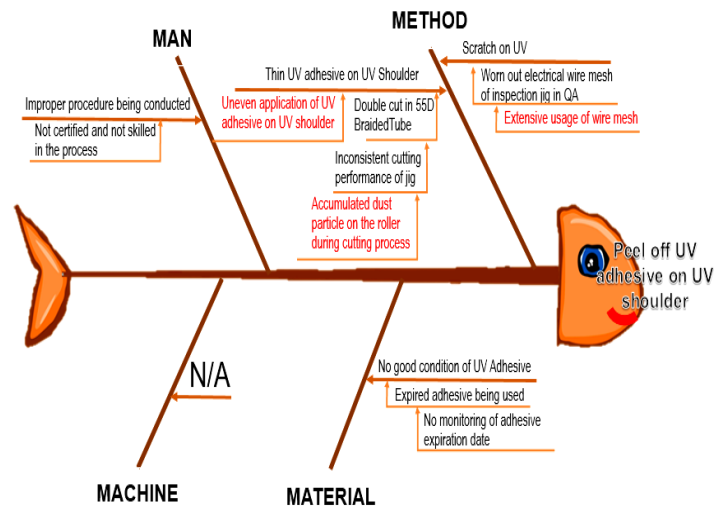
Figure 7. Ishikawa Diagram for Peel Off UV Adhesive on UV Shoulder

Ishikawa diagram in Figure 7 was used to identify the potential root cause of **Peel Off UV Adhesive on UV Shoulder**.

After the verification of the potential root causes it is found that the possible cause of Peel Off UV Adhesive on UV Shoulder has a relation with **UV application, electrical jig and a jig used in cutting the 55D Braided Tube**. (See Figure 8 for the 4M Analysis).

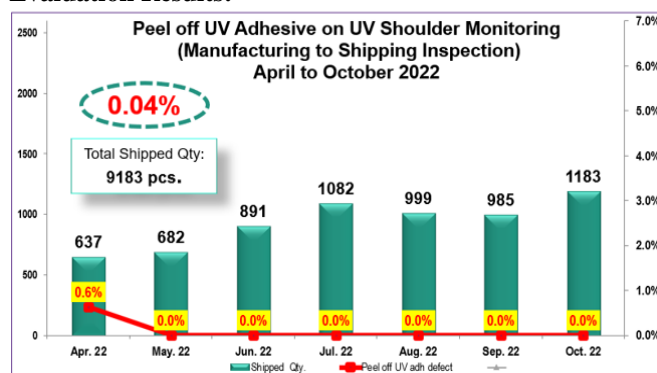
Figure 19. Peel Off UV Adhesive on UV Shoulder Monitoring

Based on the graph given in Figure 19, it shows that we have only found **0.04%** Average defect rate from April to October 2022 after the implementation of controlled UV Application on the shoulder part.

ACTION PLAN: Evenly spread UV adhesive on UV shoulder to 55D braided tube

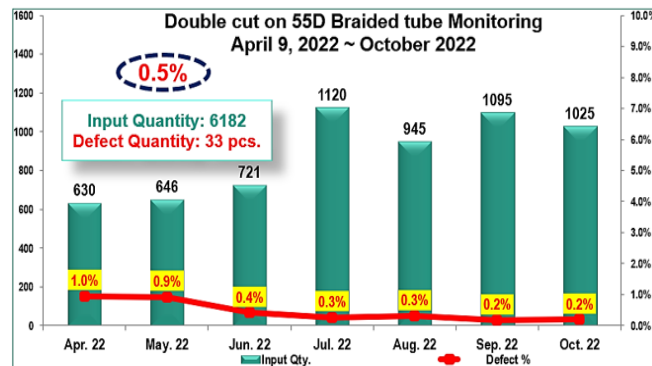
Figure 20. Double cut on 55D Braided tube Monitoring

As observed, by cleaning of roller part of Cutting jig, the double cut **decreased** after the action implementation

ACTION PLAN: Cleaning of roller part using air gun and cotton swab before and after use

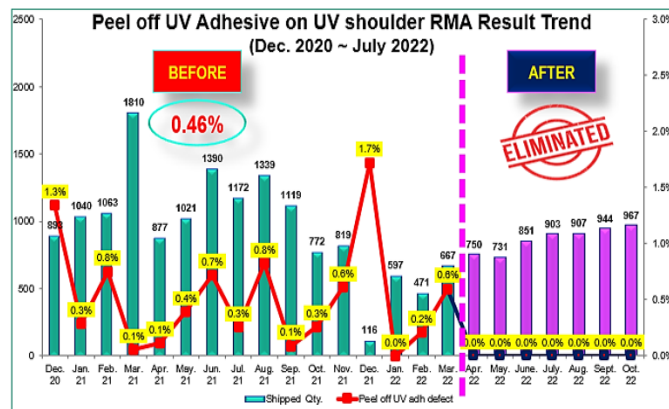
Figure 21. Peel off UV Adhesive on UV Shoulder RMA Trend Before and After Implementation of Actions

Overall, Figure 21 shows Peel off UV Adhesive occurrence was **eliminated** after the implementation of actions

BEFORE ACTIONS: 0.46%
AFTER ACTIONS: ZERO (0)

Based on the results, implementation of action plan of evenly applying the UV on UV Shoulder, cleaning the accumulated dust particles on the roller part of jig during cutting and changing variant of mesh from Extra Fine to Super Fine Wire mesh helped to eliminate the defect of Peel Off UV Adhesive on UV Shoulder from its original defect rate of 0.46% from April ~ October 2022 can gain a high quality and cost efficient catheter products not just for customer's satisfaction, but also for P.IMES credibility and integrity.
