## IMPROVED MOLD TOOL DESIGN ROBUSTNESS THROUGH THE DMAIC PROCESS

Walfredo Z. Peña  
Arnel S. Berlon  
Erikson J. Mapote

ATCB Central Engineering  
Nexperia Philippines Inc, LISP I, Cabuyao City, Laguna  
walfredo.pena@nexperia.com, arnel.berlon @nexperia.com, erikson.mapote@nexperia.com

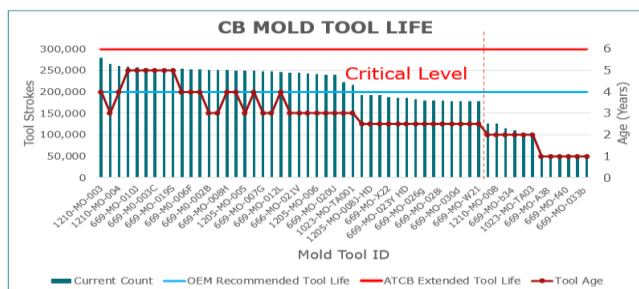
Figure 6: Mold Tool Life Status.

The 43 out of 54 mold tools of Nexperia Philippines were already at the critical level of its 300,000 strokes defined life, therefore replacement is necessary to maintain the quality of the products. If not, there will be quality risks to the customers, or the molding capacity will be reduced by 80%. Figure 6 shows the tool life status and age of mold tooling for the Clip Bonded line.

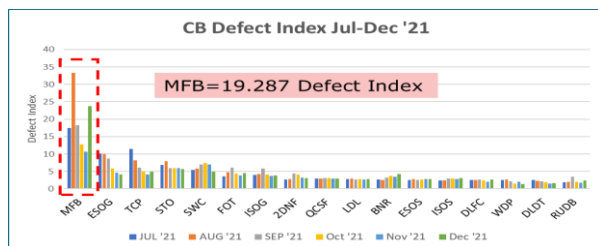
Figure 7: Top defect yield loss from June to December 2021.

Yield is one of the Key Performance Indices of Nexperia. Any yield loss means financial loss, which is why this is the top priority. Figure 7 shows the historical yield loss from Q3 to Q4 2021. The MFB was on top with an average of 19.287 defect index.

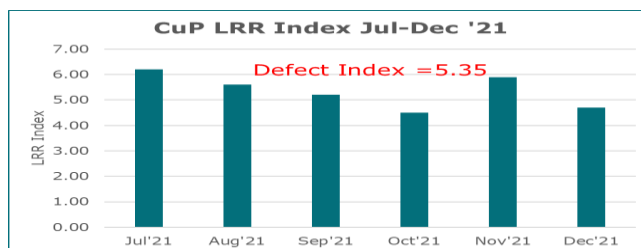
Figure 9: CuP LRR defect Index from July to December 2021.

The LRR is computed as the number of rejected lots over the total of lots produced. Figure 9 shows the LRR defect Index from July to December (Q3 to Q4) of 2021 with an average of 5.35.

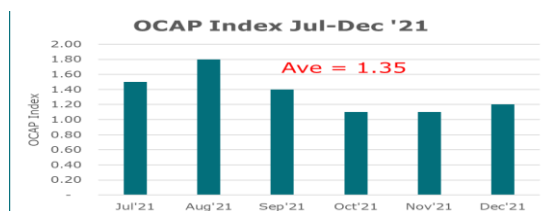
Figure 10: OCAP Index for CuP from July to December 2021.

The OCAP is triggered when a certain lot was found with CuP during the inline monitoring by quality personnel or by the operator at Mold, TF, or test. It is a critical defect because it requires an X-ray to see the embedded copper inside the package which is a risk for potential electrical shorting. Figure 10 shows the OCAP defect index from July to December 2021 with an average of 1.35.

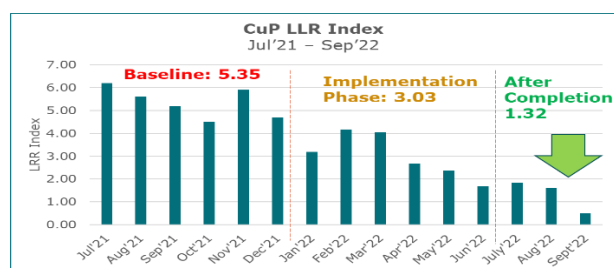
Figure 21: LRR Index Reduction for CuP from Jul '21 to Sep '22.

Figure 21 shows that the LRR defect index was reduced from 5.35 of the baseline periods (Jul – Dec '21) to 1.32 in Q3 (Jul-Sep) of 2022. This was a 75% reduction which was higher than the set target for this project.

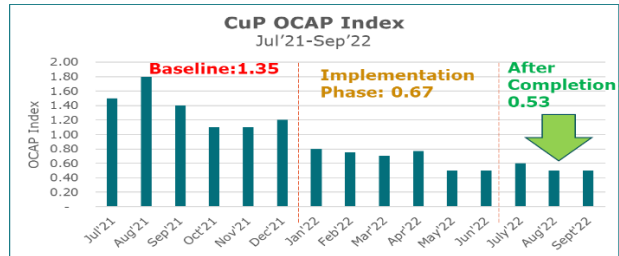
Figure 22: OCAP Index Reduction for CuP from Jul '21 to Sep '22.

Figure 22 shows the reduction of OCAP or line-detected CuP defect. The OCAP was reduced from 1.35 defect index baseline from July to December 2021 using the old tools down to 0.53 defect index in using new tools from July to September 2022. This was a 60% reduction, which is above the set target.
