**INNOVATION AND INCLUSION OF POU DESICCANT DRYER TECHNOLOGY TO  
ELIMINATE PAD DISCOLORATION CAUSED BY INTERACTION OF CDA  
MOISTURE TO METALLIC LGA PADS**

**Reinadd Jan B. Abad  
Judioz M. Manejero  
Ivan B. Veridiano**

**WT & TNF Process Engineering – B2F2 Operations  
STMicroelectronics Incorporated  
#9 Mt. Drive, LISP2, Brgy. La Mesa, Calamba City, Laguna 4027  
[reinaddjan.abad@st.com](mailto:reinaddjan.abad@st.com), [jude.manejero@st.com](mailto:jude.manejero@st.com), [ivan.veridiano@st.com](mailto:ivan.veridiano@st.com)**

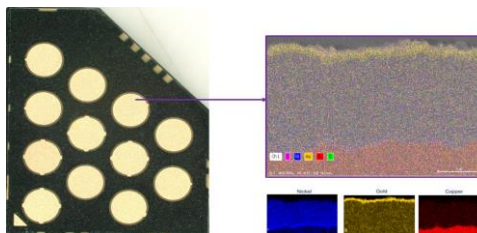
Figure. 2. LGA Pad Composition

The LGA Pads on the Bottom Substrate of the module are composed of Copper Base metal, Nickel (5um min Electrolytic) and Gold (0.3um to 0.8um 99.99%) as finishing layer.

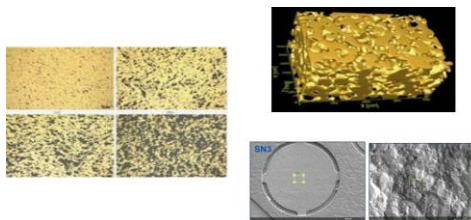
Figure. 3. Metal Gold Pads

Metal Gold Pads are naturally porous material and has high permeability where minute spaces or holes are present and oil, water or air may penetrate.

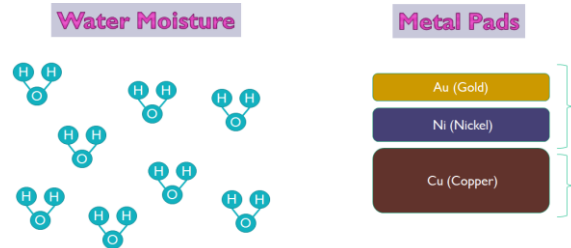
Figure. 4. Water Moisture Interaction to Metals Pads

When metal is exposed to moisture which contains oxygen, this causes reaction where the metal ions bond with the oxygen atoms and creates an oxidation. This can manifest in the Printed Circuit Boards (PCB) or Metallic pads which is usually composed of Au (Gold).

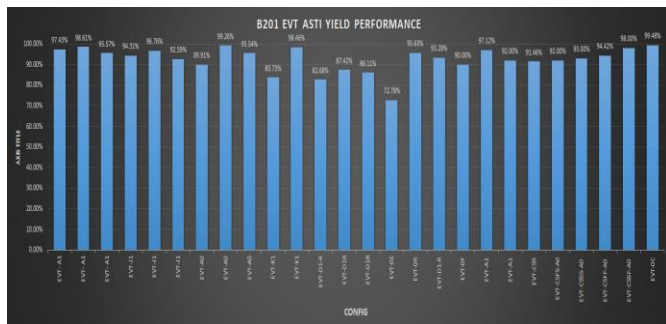
Figure 8. ASTI Tape and Reel Yield Performance

Pad Discoloration was the Top detractor during the EVT phase of the new Proximity device (BXXX) with an impact of 5.36% yield loss at ASTI Tape and Reel process. Other cosmetic rejects are within process capability PPM. This

significantly affects the overall target yield performance of the product.

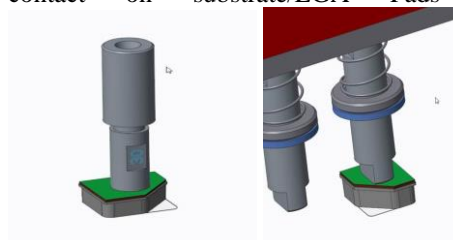
Figure. 18. Turret and Gang Pick Overlay

Overlay photo of the Turret PnP Tip/Gang Pick which is contact on substrate/LGA Pads (Middle part)

Superimposed image of the Turret tip and Gang pick shows that the defect location of Pad discoloration is coinciding with the contact points of the pick-up tool head.

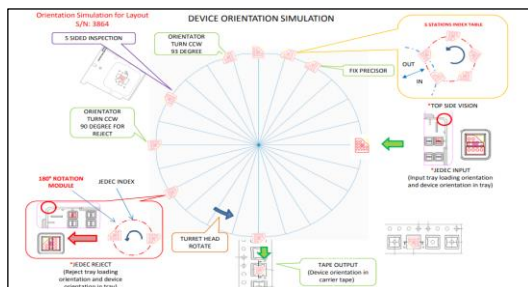
Figure. 21. ASTI Machine Sequence

Possible Contact points on ASTI TnR machine is during Turret Pick up on bottom substrate (LGA Pads). Figure 21 below shows the processing sequence of modules from machine input to output.

Contact points on ASTI TnR machine is during Gang pick-up and Turret Pick head on bottom substrate (LGA Pads) which is the possible source of CDA moisture and resulting to Pad discoloration. The machine is equipped with 24 nozzle turret tips which are in contact with the module during production mode.
