LEADFRAME TAPE DE-REEL PREVENTION AT WIREBOND MACHINE THROUGH SENSOR INTEGRATION

Integrated Lines Operations 1 STMicroelectronics, Inc. 9 Mountain Drive, LISP 2, Calamba 4027 Laguna, Philippines, bernard.zamora1@st.com, eric.espino@st.com, julius.andal@st.com

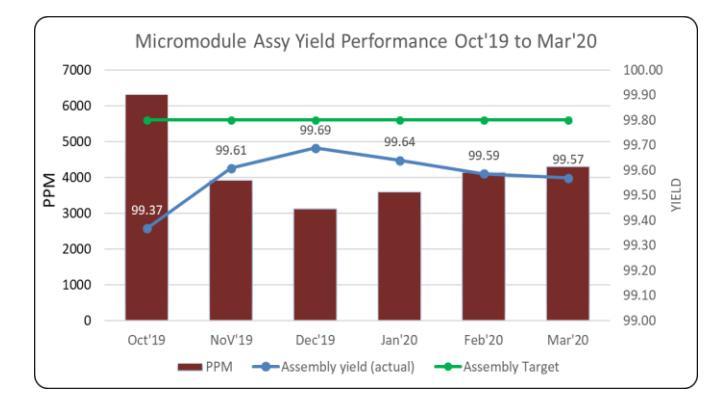
Fig. 1. Micromodule Assy Yield from Oct 2019 to Mar 2020

Yield graph shows that it's not consistently meeting the target of 99.80% versus actual yield from Oct'19 to Mar'20 as shown in Fig.1

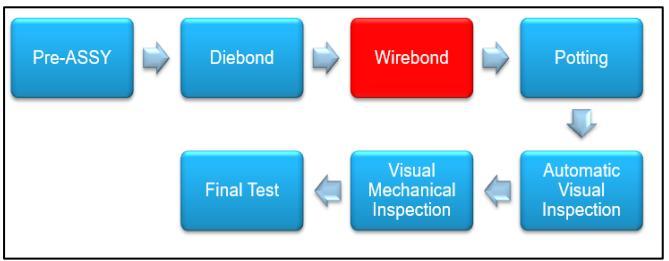
Fig. 4. Micromodule Process Macro Map

Fig. 4 is the Process macro map of Micromodule device from Assembly to Final test where Wirebond is the focus of this project and the main source of Yield top defect.

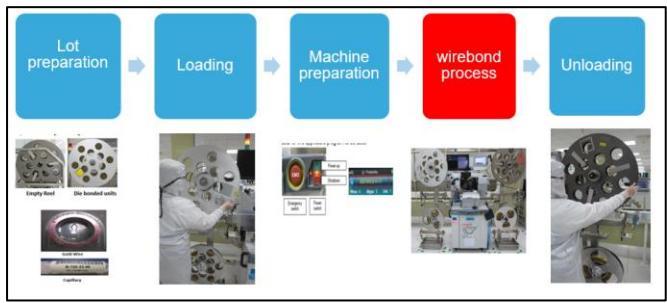
Fig. 5. Detailed Reel to Reel Process Flow

Fig. 5 is the process flow of Wirebond Reel-to-Reel from lot preparation to unloading of wirebonded units at metal reel where de-reel happened during wirebond process.

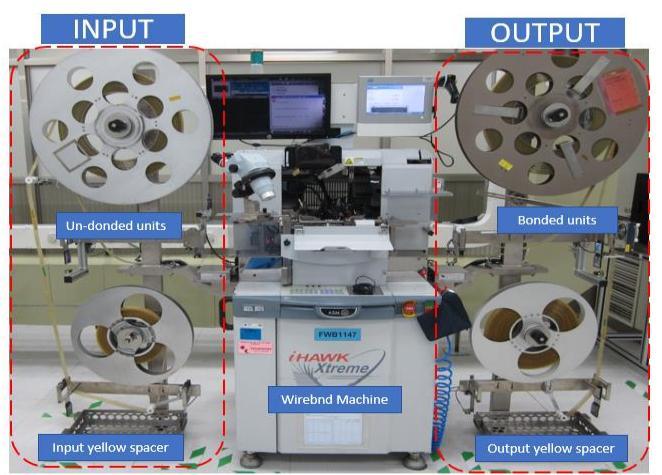
Fig. 6. Reel to Reel iHawk Xtreme Wirebond Machine

Reel to Reel wirebond machine with Input and Output spooler. Lead frame tape with un-bonded units is connected to input yellow spacer, while the bonded units is connected to output yellow space as shown in Fig.6

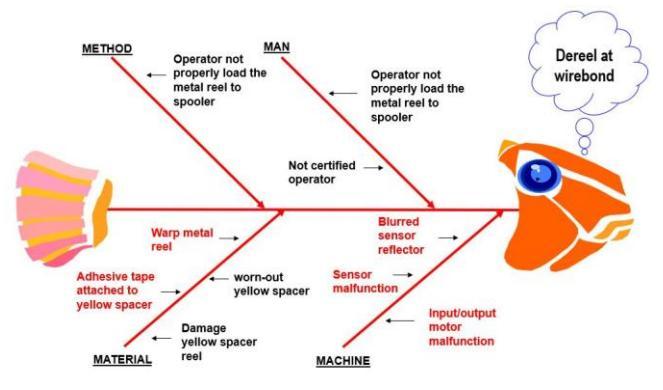
Fig. 9. Cause and Effect diagram.

Fig.9 is the Cause-and-Effect diagram of De-reel Lead frame tape at Wirebond. Team identified 9x potential root causes that contribute to the problem or defect.

Table 1 shows the validation of potential root causes which identified at cause-and-effect diagram. The team identified 5 potential root causes namely blurred sensor reflector, sensor malfunction, input/output motor malfunction, adhesive tape attached to yellow spacer and warp metal reel which are all true cause and within control.

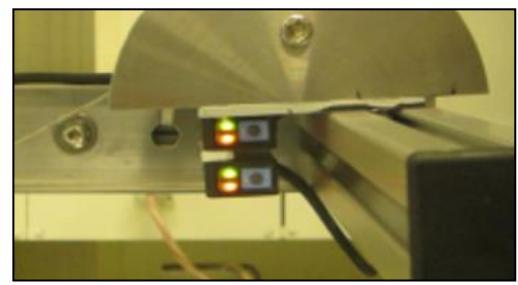
Fig. 12. De-reel Lead frame Sensor

When light from the Emitter strikes the sensing object, the object reflects the light, and it enters the Receiver where the intensity of light is increased. This increase in light intensity is used to detect the object. Sensing distance ranging from several centimeters to several meters as shown on Fig 12.
