REDUCTION OF CRUMPLED STRIPS OCCURRENCE FOR SOHED AT MECO-01

Assembly Process Engineering Department
Allegro MicroSystems Philippines, Inc. 4756 Sampaguita St., Marimar Village 1, Sun Valley, Parañaque City
vcaragayan@allegromicro.com, rrodriguez@allegromicro.com, ipalomo@allegromicro.com

32nd ASEMEP National Technical Symposium

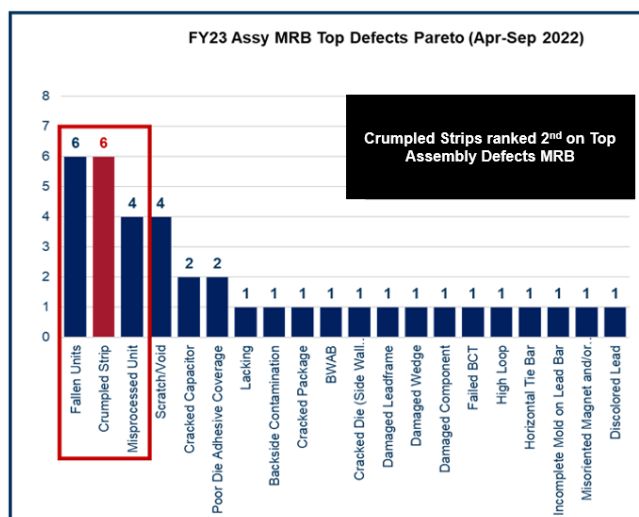
Figure 1. FY23 Assy MRB Top Defects Pareto.

Fiscal Year (FY23) highlighted the increase in Crumpled Strips MRB. Based on Apr-Dec 2022 data, it topped all Assembly defects with 6 MRBs, four of which were from Tin Plate (TP) station (see Figure 1-2).

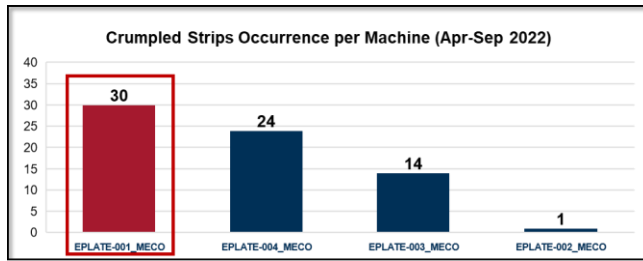
Figure 4. Crumpled Strips Occurrence per Machine.

In terms of number of cases per machine, 30 of 69 cases (43.48%) were from MECO-01 (Figure 3). Of these 30 cases, 15 cases (50%) were incurred on SOHED package (see Figure 4). The crumpled strips DPM on average for

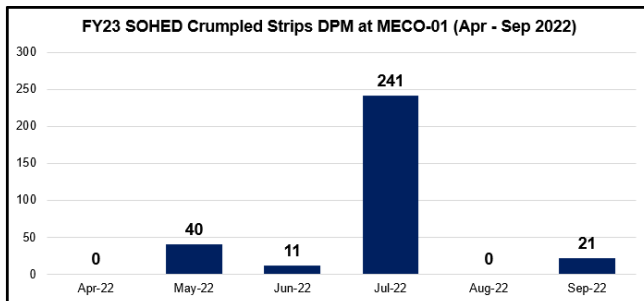
Figure 6. SOHED Crumpled Strips DPM at MECO-01.

SOHED at MECO-01 from Apr-Sep 2022 is at 52 (see Figure 6).

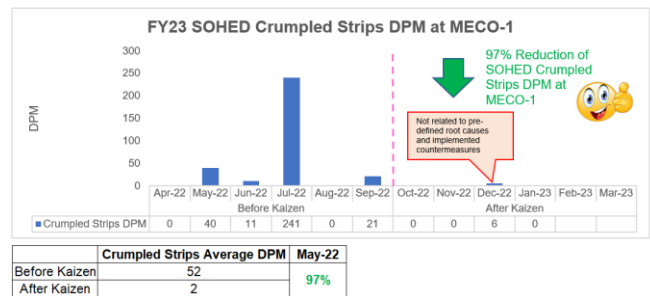
Figure 15: SOHED Crumpled Strips DPM at MECO-01 Before and After Kaizen.

Based on 4-month post-Kaizen data (Oct 2022 to Jan 2023), the SOHED crumpled strips had decreased from 52 DPM to 2 DPM after implementation of corrective actions, which translates to 97% DPM reduction. One occurrence was encountered in Dec 2022, but the root cause was not related to implemented countermeasures. However, this will still be tackled in future studies. On the other hand, from a total of 3 MRB cases in MECO-01, it was lowered down to zero after implementation of countermeasures (see Figures 15-16).
