# REDUCTION OF OVER REJECTION AT 5 SIDES VISION OF TEST & TAPE MACHINES

Jiannina Zocor B. Manalo

Test Process Engineering Onsemi, Tarlac, Luisita Industrial Park, SEPZ, San Miguel, Tarlac City Jiannina.Manalo@onsemi.com

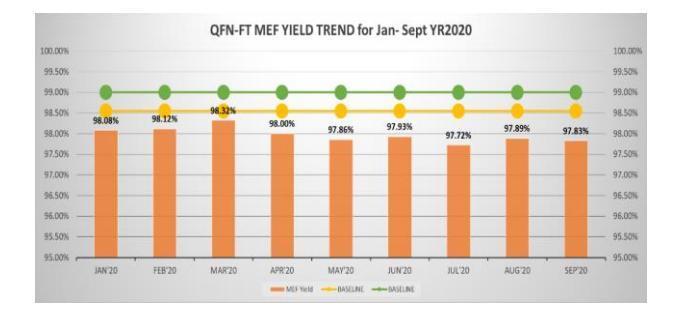
An alarming situation was experienced on the span of nine consecutive months, from January to September of 2020, when QFN Mechanical Finish (MEF) yield was not consistently met as shown on Fig 2. With this problem, Operations group and Engineering group observed an increased in defect count during and after each lot processing, unwanted machine downtimes and a slower output after test and tape, thus also affecting the cycle time of post processes after test & tape. This impacted the entire site not only because of low yield but also due to high scrap cost accumulation. Thus, the need to study and stop this situation began.

Fig 2 QFN Final Test MEF Yield Trend (Low Yield). Target yield = 99.0%, Baseline = 98.50%. Both target were not met consecutively.

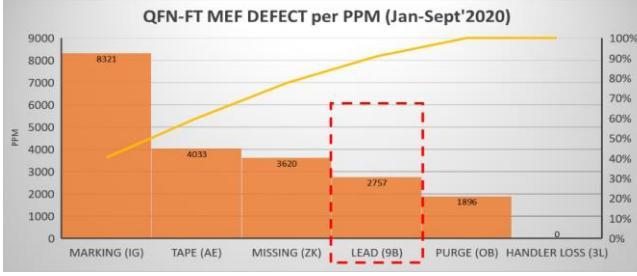
Based on reject bin analysis, Lead defect/5Sides reject was top 4 on the major yield loss contributors.

Fig 5 QFN FT MEF Defect per PPM

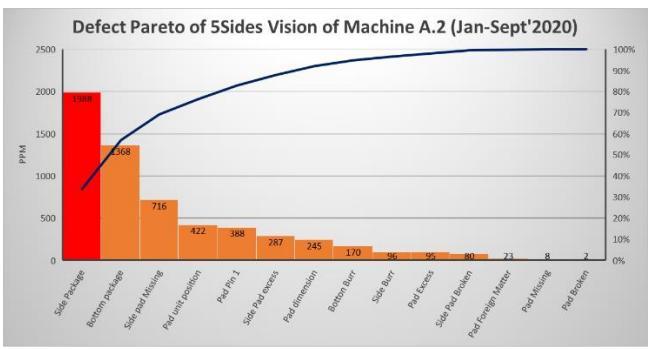
There are 13 specific reject type under 5Sides defect, and Side Package is the top among other as shown in Fig 6. This will be the focus of the project.

Fig 6 5Sides reject, Side Package fail is the top.

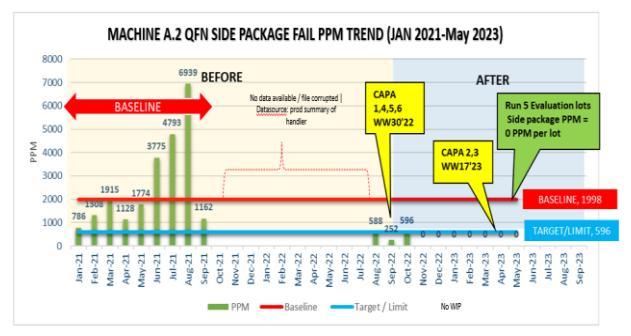
Fig 23 shows the overall performance comparison of Machine A.2 in terms of 5Sides Overjection before and after the implementation of defined actions. The target of 70% reduction, equivalent to 596 PPM was achieved and after completing all the identified actions, it was further reduced to zero (0) PPM, thus almost eliminating the Side Package Over rejection on Machine A.2 for the pilot package.

Fig 23 Performance of Machine A.2 in terms of Side Package Fail PPM, hitting the target of 70% reduction (596 PPM) and further achieving 0 PPM after completing all actions.
