REDUCTION OF OVER REJECTION AT MARKING, ORIENTATION, AND PACKAGE (MOP) VISION INSPECTION OF DEVICE X

Test Process Engineering onsemi Tarlac, Luisita Industrial Park, SEPZ San Miguel, Tarlac City, Philippines Einna. Tadeja@onsemi.com

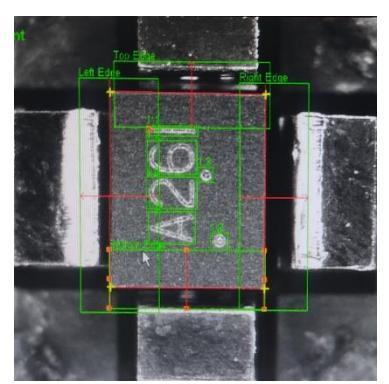
Fig.1. Known Good Unit under Marking, Orientation and Package (MOP) Vision Inspection.

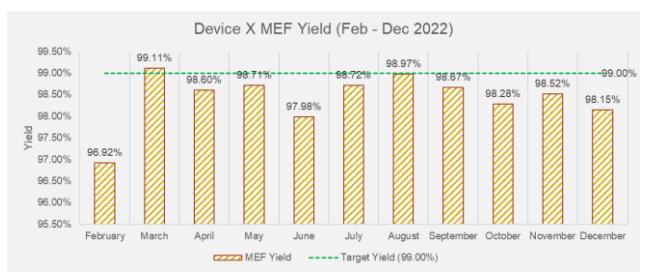
Among all devices of a particular Business Unit (BU), Device X had the highest scrap cost contributing to 49.48% among all other devices for the year 2022. Digging a little deeper on the issue, an alarming situation was found out that the Mechanical Finish (MEF) Yield for Device X was not consistently met as shown on Figure 2. With this issue, the need to study and stop this situation began.

Fig.2. Device X MEF Yield Trend. Target Yield of 99% is not consistently achieved throughout the year 2022.

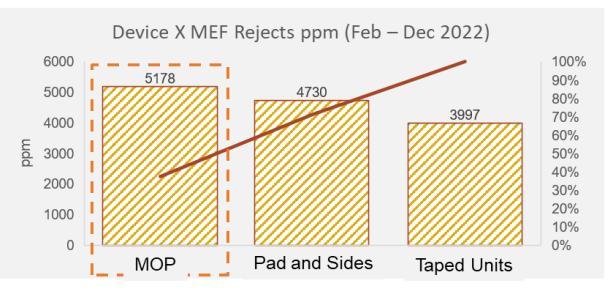
Based on the MEF reject bin analysis of Device X, the top yield loss contributor was rejects from MOP inspection (see Fig.3). From a defect baseline of 5178 PPM of MOP rejects, the study aims to reduce the defect rate by 50% (2589 PPM).

Fig.3. MEF reject bin distribution for Device X shows MOP inspection has the highest yield loss contribution.

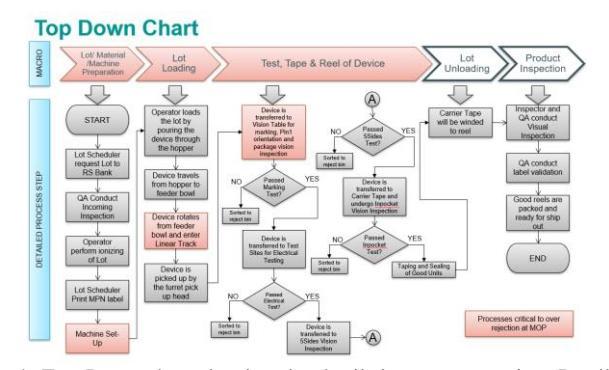
Fig.4. Top Down chart showing the detailed process mapping. Detailed process step highlighted in red are the processes critical to the occurrence of MOP Over Rejection.

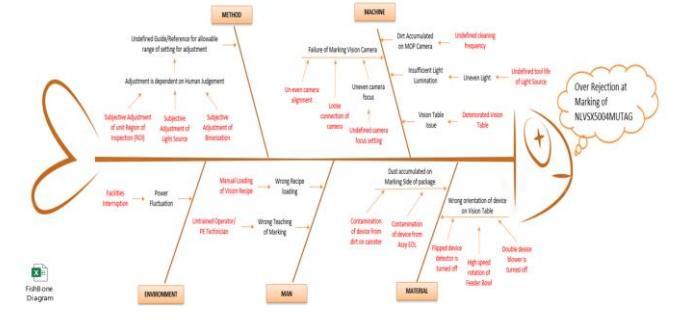
Appendix A – Fishbone Diagram

To identify the potential causes of over rejection during MOP inspection, different tools were used. From the Top Down Chart completed during process mapping, a SIPOC (Supplier, Input, Process, Output, Customer) analysis was done. Another tool used to identify potential root causes is the Fishbone diagram (see Appendix A). Initially, thirty-five (35) KPIVs were identified from the SIPOC and Fishbone Analysis.

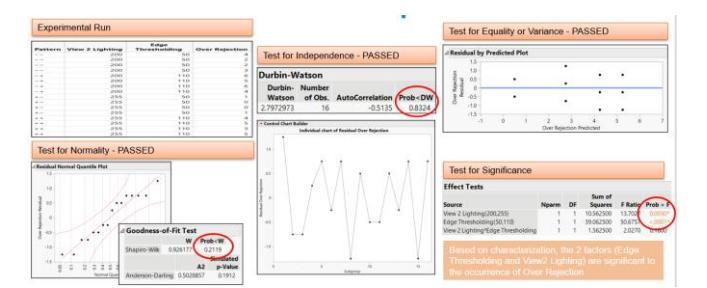
<u>Appendix B – Characterization DOE of Vision Settings</u>

Vision system parameters play a vital role during inspection. Unoptimized parameters result to unreliable data of judgement of good and no good units. Over rejection due to vision system failing to detect the package edge was experienced. To validate that vision settings are the root cause of the issue, Characterization DOE (Design of Experiment) was performed. Appendix B presents the data collected during DOE. KPIV that Unoptimized Vision Settings are found to be valid based on the different test from the DOE.
