REDUCTION OF 3RD OPTICAL INSPECTION YIELD OFF AND FALLEN UNITS AT GTS FRONT OF LINE

ABSTRACT

32nd ASEMEP National Technical Symposium

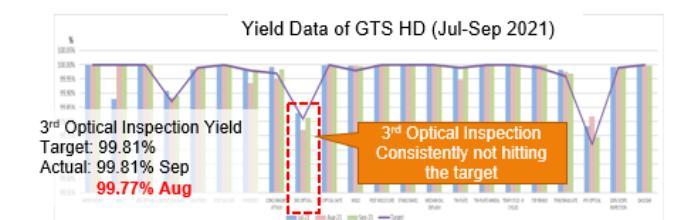
Grasping the yield off data, of GTS FOL and End of Line (EOL), 3rd Optical Inspection of FOL are consistently not hitting the target of 99.81% (Fig 1) and based on Material Review Board Data, allowable number of cases are 12 Cases, however GTS Assembly had 16 Cases on which 11 Cases was contributed by Assembly GTS FOL (Fig 2).

Fig. 1. Yield Data of GTS HD from July to September 2021

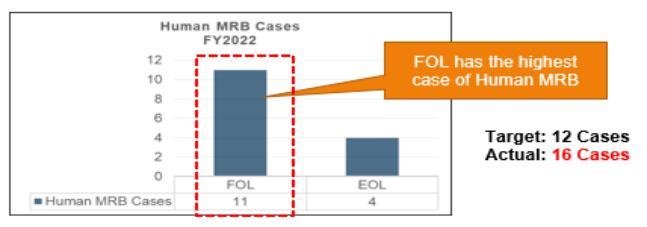
Fig. 2. Human Material Review Board (MRB) Data of FY22

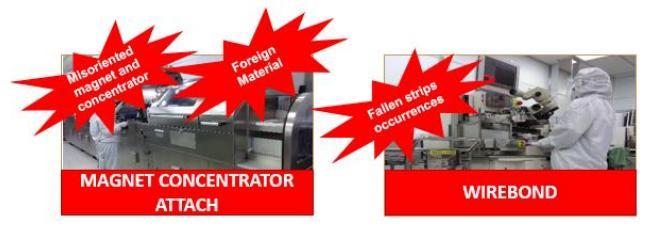
In Order to determine the cause of the identified problem the team conducted Gemba Walk. During the Gemba Walk, the team conducted process mapping and clearly identified the stations where the problem occurred. Foreign materials and Misoriented Magnet and Concentrator occur at Magnet and Concentrator attach process and Fallen units is at Wirebond attach process.
