OPTIMIZATION OF 2DID MARKING PROCESS THROUGH DUPLICATE ELIMINATION

Corina R. Urbina
Derick A. Quinto
Christian D. Tinsay

Final Test – Equipment Engineering Department
onsemi Tarlac, Luisita Industrial Park, SEPZ San Miguel, Tarlac City, Philippines
Corina.Urbina@onsemi.com
Derick.Quinto@onsemi.com
Christian.Tinsay@onsemi.com

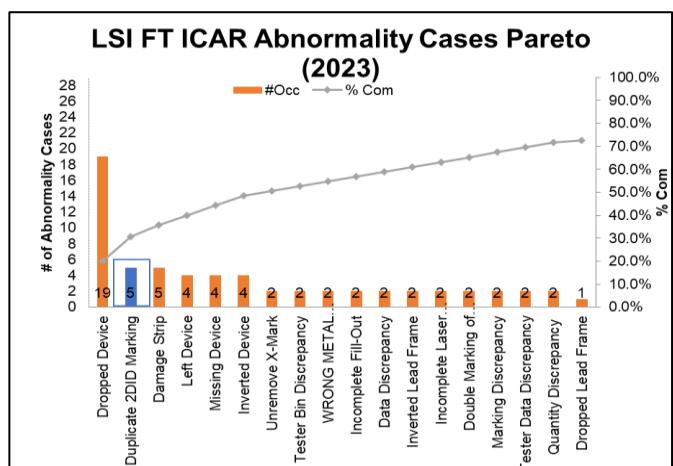
Fig. 2. Duplicate 2DID Marking as top 2 abnormality case in LSI Final Test Abnormality Cases

A significant number of abnormalities were recorded in the FT process of Large-Scale Integration (LSI) devices. Based on data shown on Figure 2 “Duplicate 2DID Marking” were identified a priority issue—not due to frequency alone, but because of its high impact on traceability and downstream operations.

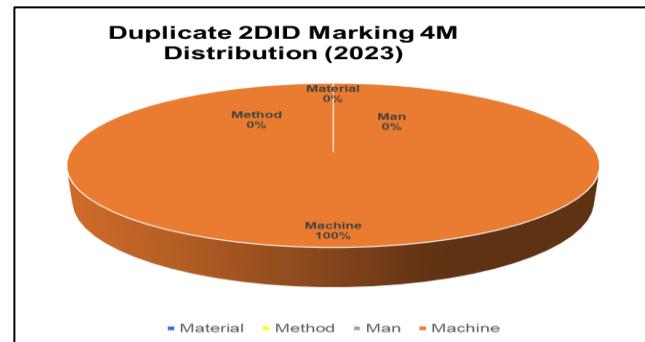
Fig. 3. Duplicate 2DID Marking 4M Contribution at LSI-FT 2023

A 4M analysis revealed that 100% of the abnormality cases were attributed to machine-related factors, with no contribution from material, method, or manpower. Given this result, the project will focus exclusively on machine-induced causes of duplicate 2DID generation. The primary goal is to eliminate recurrence by identifying failure modes within the marking equipment and associated systems that compromise device traceability.

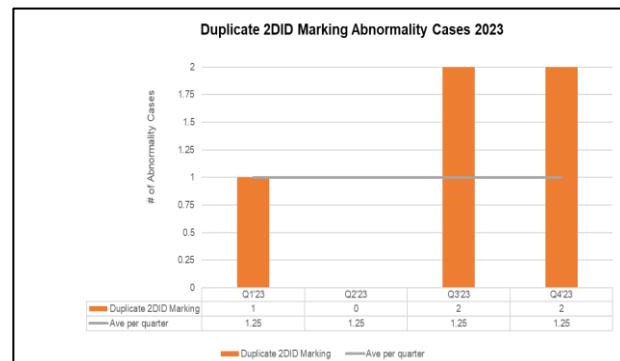
Fig. 4. Duplicate 2DID Marking is evidently increasing with a maximum of 2 cases per quarter.

Analysis of 2023 ICAR data shows at Figure 4 a rising trend in Duplicate 2DID Marking abnormalities, with a maximum of two incidents recorded in both Q3 and Q4. The quarterly average stands at 1.25 cases. This upward trajectory indicates a recurring issue, primarily attributed to machine-related factors, as established in the Define Phase.

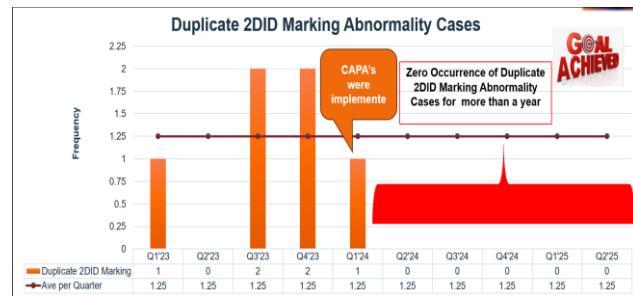
Fig. 8. Corrective and Prevention Action Effectiveness

The implementation of the updated software program effectively addressed the root cause of the duplicate 2DID marking issue specifically, the weakness in the program's control sequence logic. The corrective action introduced robust verification logic that cross-checks each 2DID code before execution, thereby preventing duplication at the source. Key results include the following:

- Successful installation and validation of the new program across 10 qualification lots, all yielding 100% pass rates.
- Improved software logic has been integrated into the standard operating process, supported by updated OCAPs and personnel training.
- No recurrence of duplicate 2DID code marking observed post-deployment (starting January 2023) up to present.

The software enhancement included the integration of a real-time verification logic that flags duplicate codes prior to marking. This system now checks the equipment's temporary registry and halts duplication by skipping codes already recorded during post-vision inspection.
