## GOLDEN LINE-DRIVEN DESIGN AND PROCESS SOLUTIONS FOR MOLD FLASH ELIMINATION IN HIGH-DENSITY WLF QFN MANUFACTURING

TI Clark Assembly Engineering Group

Texas Instruments Inc., Clark Freeport Zone, Gil Puyat Avenue, Angeles City, Philippines 2009

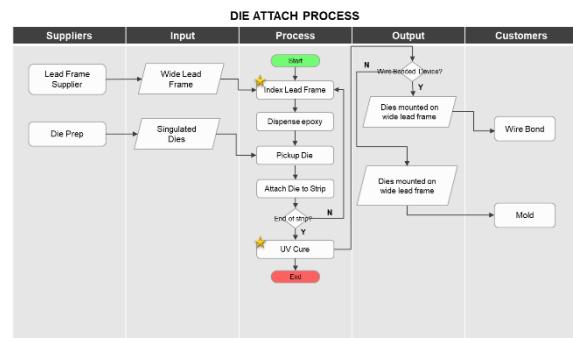
**Figure 3.** Supplier-Input-Process-Output-Customer (SIPOC) diagram of Die Attach Process.

In **Figure 3**, the die attach process steps found to be most relevant to mold flashing and would induce the most warpage on the leads are the indexing process and UV cure. Indexing involves mechanical clamping that may introduce some areas of nonplanarity on the strip due to the applied force. Additionally, unoptimized temperature profile may also cause the lead frame to warp during the cure process.

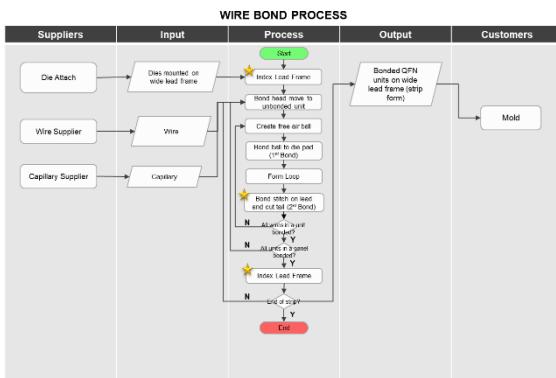
Figure 4. Supplier-Input-Process-Output-Customer (SIPOC) diagram of Wire Bond Process.

For wire bond, the key steps identified to have the most impact on mold flashing are the indexing and 2<sup>nd</sup> bond processes (See **Figure 4**). These processes directly apply some pressure or force on the lead frame thereby causing buckling on the strip. In particular, the combination of heat, force, and ultrasonic energy during 2<sup>nd</sup> bond and tail cutting may put on too much stress on the leads and/or result in leads bouncing. When the latter occurs, it is possible that the tension from the bonded wire may hold the nonplanar position of the leads in place, giving an opening for mold compound to seep through.

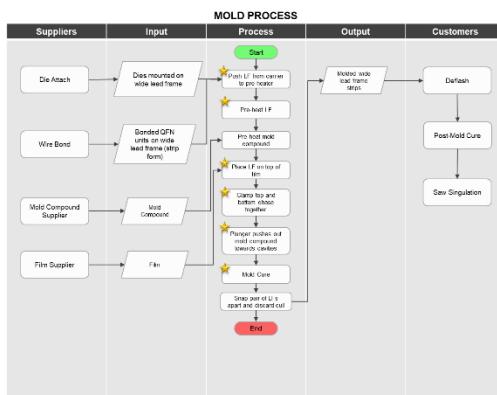
Figure 5. Supplier-Input-Process-Output-Customer (SIPOC) diagram of Mold Process.

Although most of the processes in mold inherently contributes to flashing, those that would most likely cause mechanical stress on the lead frame and those that are relevant to the top mold flash signatures were highlighted in **Figure 5**. Logically, the mold transfer profile dictates the mold flow, hence, the parameter settings in step 6 would impact flashing. Similarly, if the clamping pressure is excessive or insufficient, mold flashing can also arise. Temperature plays a significant role in determining the mold transfer profile, thereby the pre-heat and cure steps are also critical factors to consider. On the mechanical side, if too

much force is applied when pushing the lead frame from the carrier to the pre-heater, or if an error occurred during this step, dents may be introduced on the strip and cause flashing. Moreover, when the lead frame is not placed flatly on the mold release film, or if misalignment occurs during molding, flashes would appear on the back side of the strip.

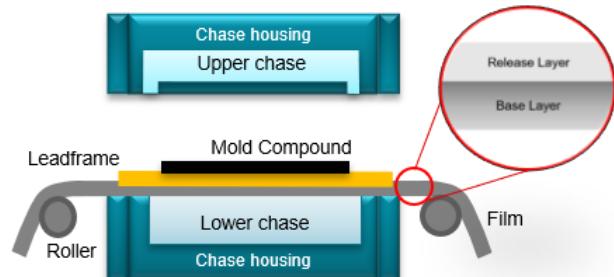
Figure 6. Mold chase configuration and mold film layers

Mold release film is composed of base layer and adhesive layer. Base film forms contact with the mold chase while the release layer adheres to leads and pads. Release layer acts as cushion to cover lead frame contours and blocks excess mold compound flowing into the pad and leads. Mold compound

may seep into areas between film and lead frame due to factors such as non-planarity on the leads and lead frame, the chase, or the film itself.
