INVESTIGATING PACKAGE BACKSIDE SOLDER BUMPS INDUCED POST BURN-IN

Ampleon Manufacturing Philippines Inc.

ABSTRACT

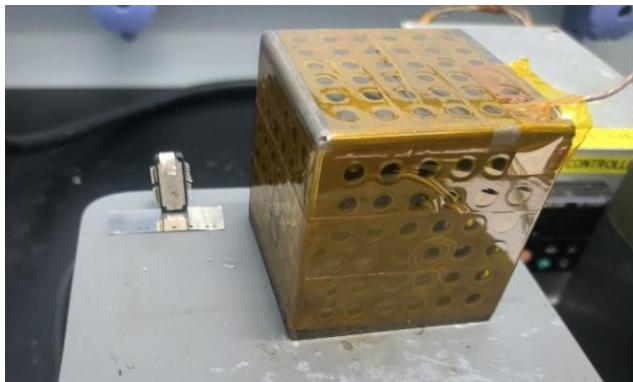
Fig 3.2 Improvised heating setup to induce the bump defect.

In the methodology done in the study, it was first made sure that the temperature was stable through the thermocouple before units were placed inside the enclosure. The samples were left inside for 20 seconds before being removed. Visual inspection was done to inspect if the failure mode was replicated in the samples. This was done from 140 Celsius up to the max melting point of tin at 232 °C, in 10-degree increments. Three samples, heated in succession, were used per temperature setting.

The samples are in an upright position, as seen on Fig 3.2, due to the orientation of the affected samples as they are loaded on the board. This can be seen on Fig3.3 below.

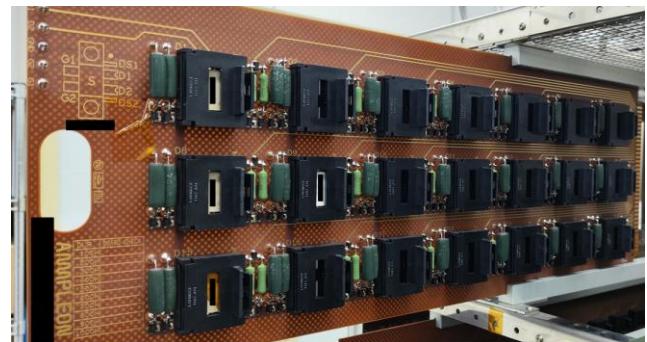
Fig 3.3 Sample burn-in load board

The factor identified to induce the defect was excessive temperature exposure of the unit while in burn-in. At the time of analysis. The most practical way to do this was to heat the samples on a sideways orientation. This follows how the units are oriented on the burn-in boards (see Fig 3.3).
